VINTAGE RADIO

The Ferris 214 Portable Car Radio

Ferris Radio concentrated predominantly on producing car radios, some of which were “portable” (and heavy) and could be used in a car on 6V or 12V or in the home on 240V AC. Here we look at their model 214 portable car radio which used germanium transistors.

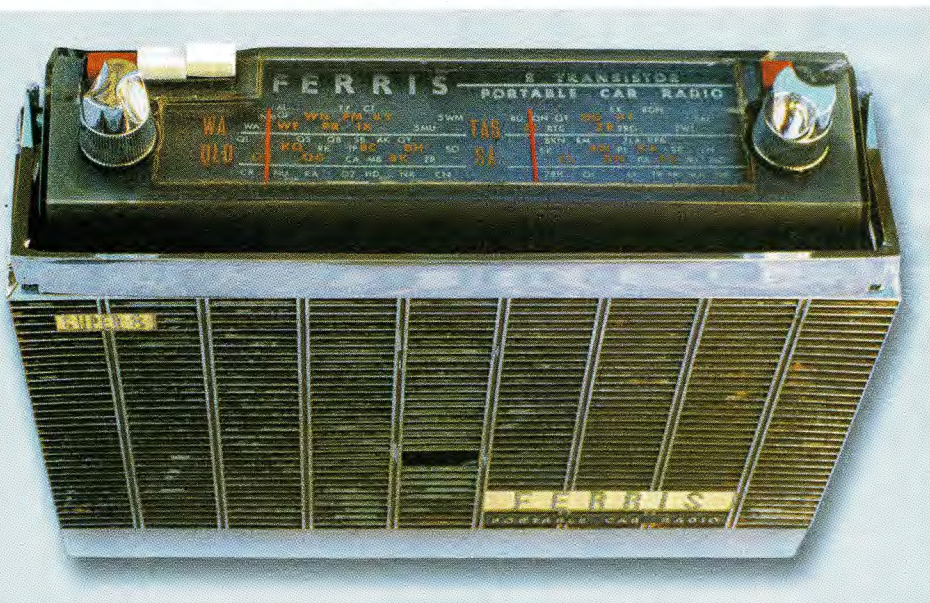
The more immediate problem was the horrible performance of the receiver. The set was removed from the vehicle and it really looked little the worse for wear – rather surprising considering its 30 years of portable and in-vehicle use. A couple of bars in the speaker grille had been broken but in other respects, the case's condition was quite fair.

Despite its age, the old Ferris car radio was in remarkably good condition. For in-car use, the unit slid into a cradle mounted under the dashboard and was switched to use the vehicle's antenna.

As mentioned earlier, the case was marked but it wasn't practical to repaint the painted sections. However,

the chrome work came up quite well using automotive polish and a little elbow grease. The scratches are not obvious now.

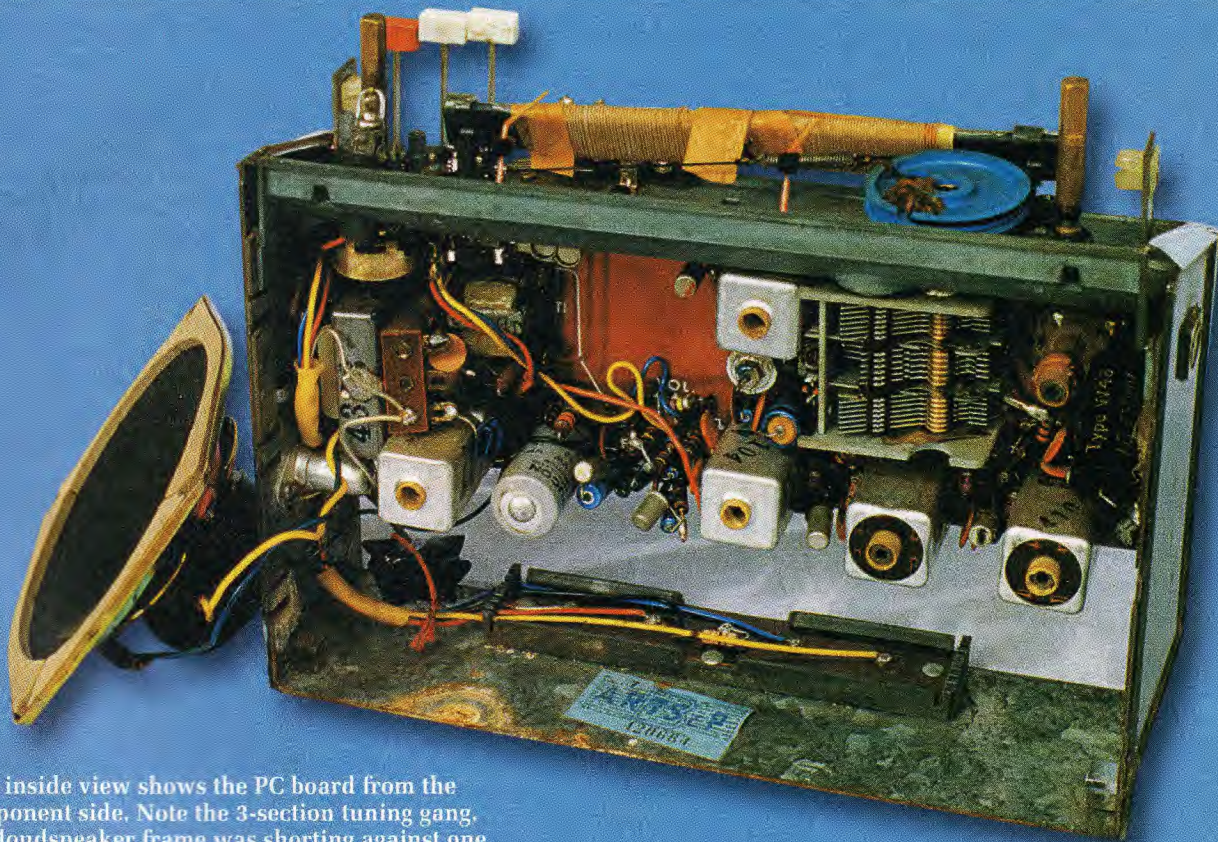
This inside view shows the PC board from the component side. Note the 3-section tuning gang. The loudspeaker frame was shorting against one of the metal cans when the covers were fitted.

Dismantling the set revealed that the short disappeared when the back was removed. Some plastic electrical tape was put over the vulnerable sections of the PC board but the short reappeared when the back was replaced. I pulled the front and back covers off and the short disappeared again. At this stage, I suspected a short from the circuit board common (+) to the loudspeaker frame (-).

In this set, the speaker fits between the transistors, various other components and the coil cans. Using a dentist's mirror, I observed that one coil can did seem to be very close to the speaker frame. I put some tape over the can and that fixed the problem – success at last.

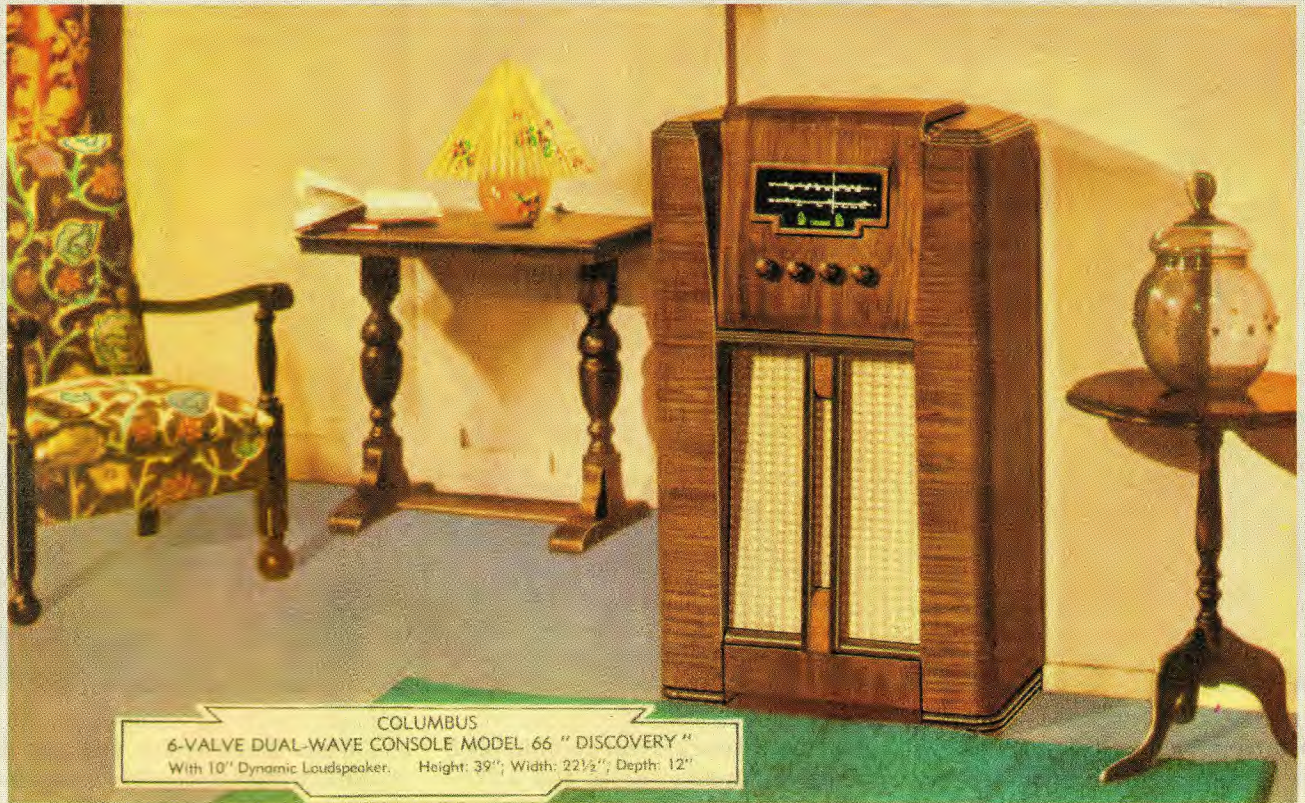
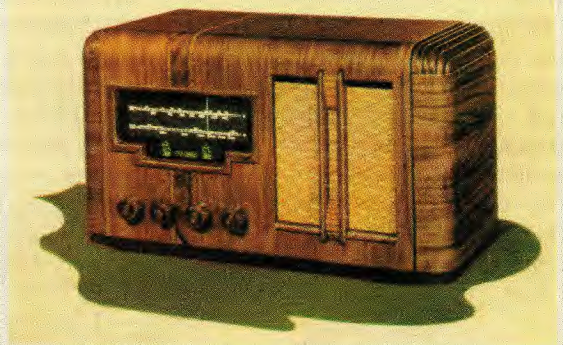
Photo Gallery: Columbus Discovery Model 66

Manufactured by Radio Corporation of New Zealand during the 1940s, the Columbus Discovery Model 66 was a 6-valve 2-band receiver that came in both console and mantel models. They were fairly conventional superhet receivers with 455kHz IF stages and covered the broadcast band from 550-1600kHz and a shortwave band from 9.4-15.6MHz. The valve line-up was as follows: 6K7 (RF amplifier); 6J8 (converter); 6B8 (IF amplifier, detector & AGC); 6J7 (audio amplifier); 6V6 (audio output); and 6X5 (rectifier). (Photographs & diagram courtesy Ted Sherman, Kawhia, NZ).

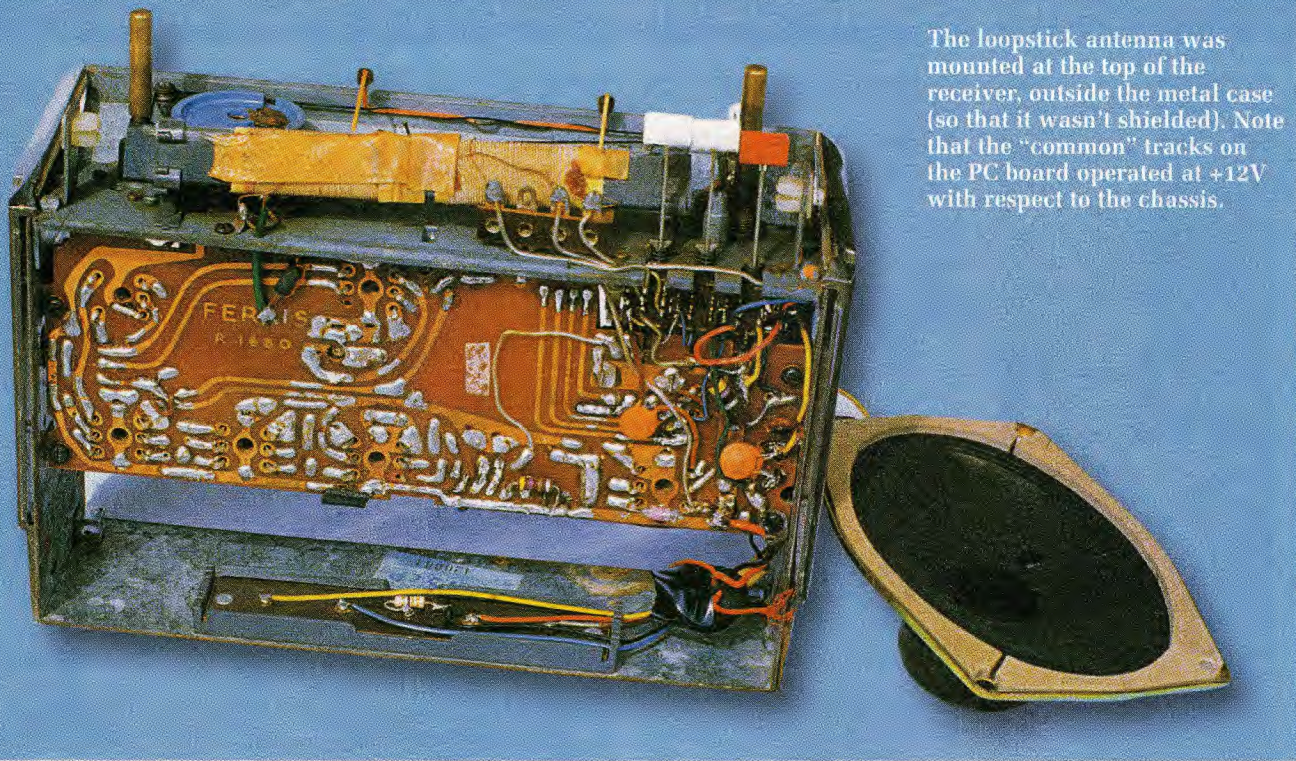
The loopstick antenna was mounted at the top of the receiver, outside the metal case (so that it wasn't shielded). Note that the "common" tracks on the PCB operated at +12V with respect to the chassis.

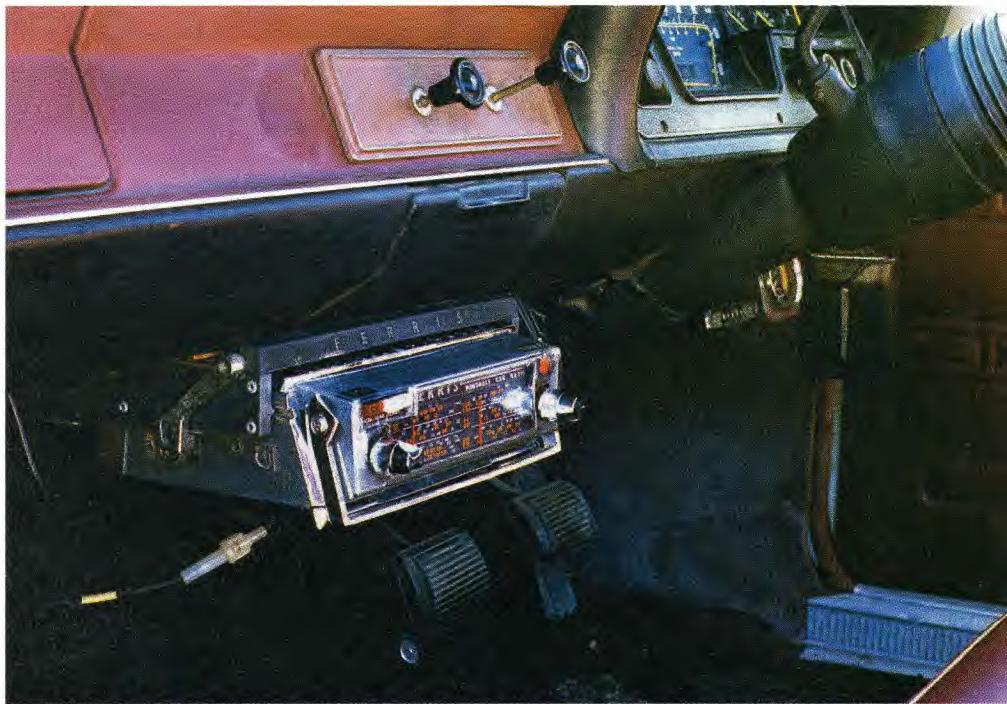
The final test of the receiver was when it was mounted back in the Valiant utility. The reception was initially quite fair but when the engine was started up, the interference was horrendous. It looked as though I'd have to do some work on the vehicle's antenna system.

tenna and the reception was now delightful, with virtually no interference – the antenna system was in good order.

This view shows the Ferris receiver sitting in its cradle, beneath the dashboard of the old Chrysler Valiant utility. They don't make 'em like this any more!
