VINTAGE RADIO

The 4-valve Precedent mantel receiver (circa 1953)

Designed for those on a budget, the 4-valve Precedent mantel receiver was released onto the Australian market in the early 1950s. It's a relatively simple set with many cost-cutting features but it still worked quite well in suburban areas.

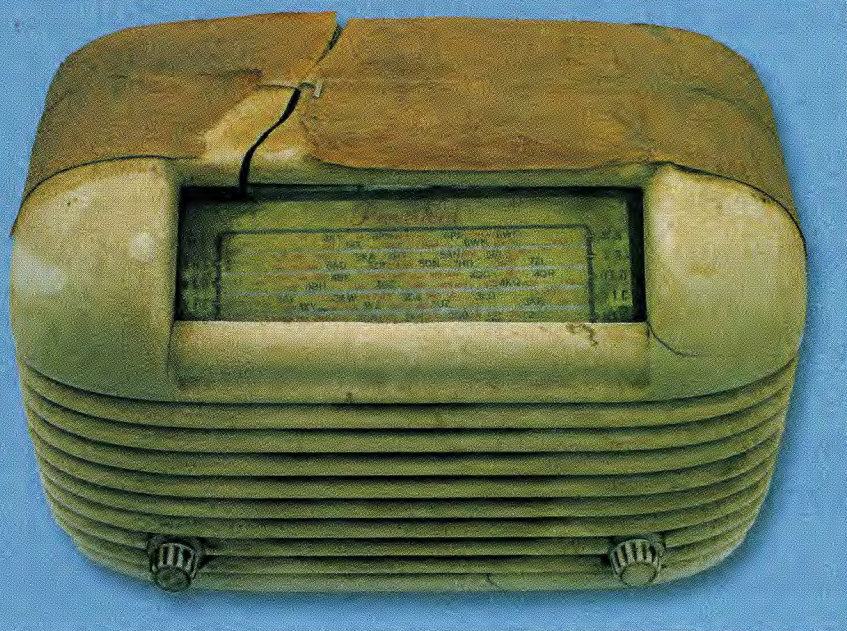
The 4-valve receiver featured in this article was in a rather sorry state when it first came to me, as can be seen in

the photographs. The cabinet was cracked, the works were covered in a layer of muck, the power lead had perished and exposed power wires were quite evident at the back of the set. In addition, parts of the chassis and the power transformer were showing extensive rust.

This is the 4-valve Precedent mantel set before restoration. Its cabinet had a bad crack at the top and was held together by masking tape.

cracked and it had been "repaired" using masking tape. Obviously, a much better repair was needed and so the cabinet was scraped clean of the masking tape and then placed into the laundry wash tub, together with the knobs. It was then thoroughly cleaned using a scrubbing brush and soapy water.

The cabinet was then rinsed in clean water as the cracks needed to be free of any "muck" before being glued together later on. Both the cabinet and knobs looked first class after cleaning and were then set aside so that other work could be done.

The techniques described in the article in the July 2001 issue were used to repair the Bakelite cabinet. Fortunately, it was just a matter of fixing the cracks and breaks and no sections had to be fabricated as is sometimes necessary.

Unfortunately, I couldn't get the break in the top of the cabinet to mate, despite using quite a bit of pressure. As a result, I had to glue it first and then apply fibreglass to the underside of the cabinet top. I also scraped out

some of the glue on the top of the cabinet and then filled the resulting grooves with fibreglass that had been mixed with some craftwork paint.

Cream isn't an easy colour to match but the finished cabinet looks quite reasonable. And, at least, it won't fall to pieces.

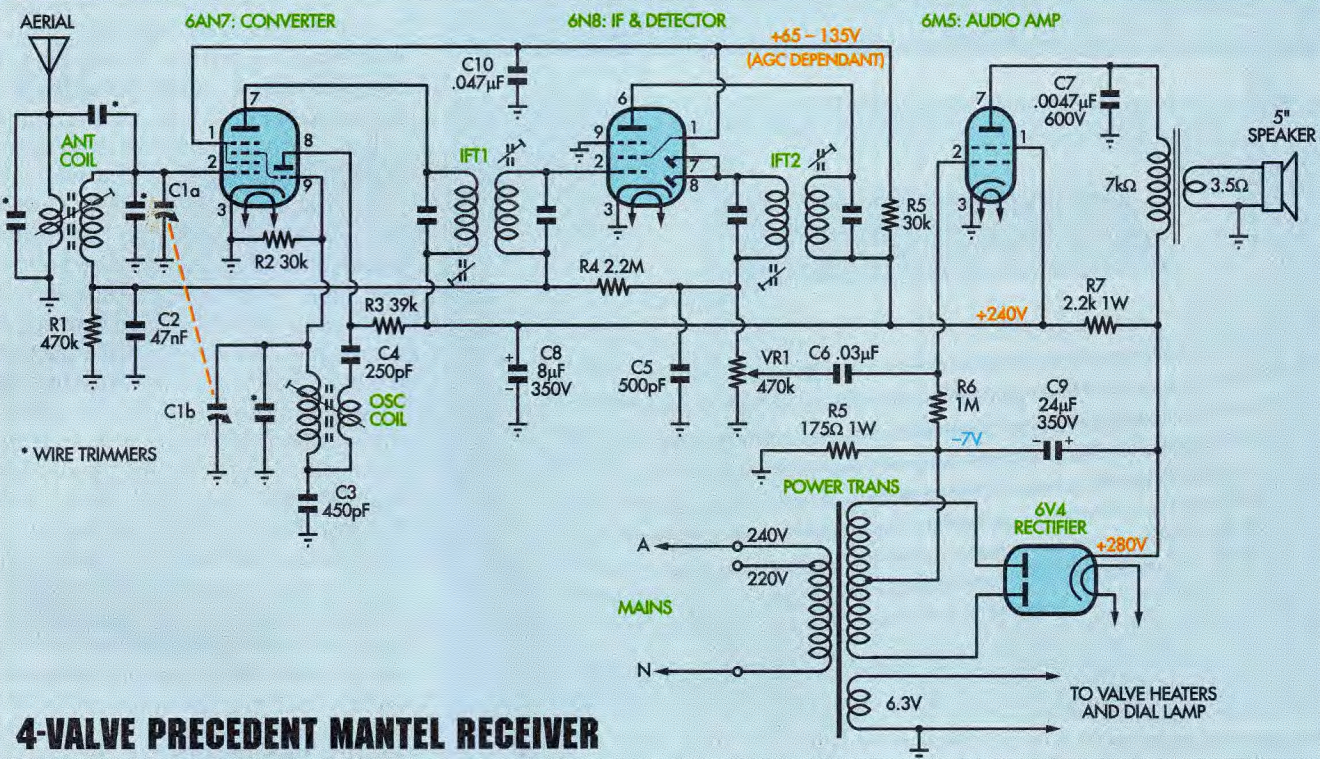
4-VALVE PRECEDENT MANTEL RECEIVER

Fig.1: the circuit for the Precedent receiver is a fairly conventional "austerity-model" 4-valve superhet.

According to the markings on the loudspeaker transformer, it was probably made in 1953 but I was unable to find a circuit anywhere. In the end, I had to trace the circuit out with the aid of a valve data book and a multimeter. Fig.1 shows the details and as can be seen, it is a conventional "aus-terity model" 4-valve superhet.

The AGC system used in this set is actually quite simple. However, it is a bit strange in that only one fifth of the developed AGC voltage is actually applied to the 6N8 and 6AN7 valves by virtue of the voltage divider formed by resistors R1 and R4. This was done to ensure that the AGC-controlled valves worked at nearly at full performance - even with strong signals - so that good audio volume could be achieved.

This set isn't easy to align, not because it's a difficult procedure but because the IF transformer slugs are well sealed. In addition, all the trimmer capacitors marked with an asterisk (*) on the circuit are in fact made from a thick piece of enamelled copper wire which is overwound with thin enamelled copper wire.

In this set, the oscillator is a little different to normal in that it's shunt fed, with no DC voltage on either of the oscillator coil windings. However, capacitor C3 provides paddler feedback to ensure reliable oscillator operation across the band.

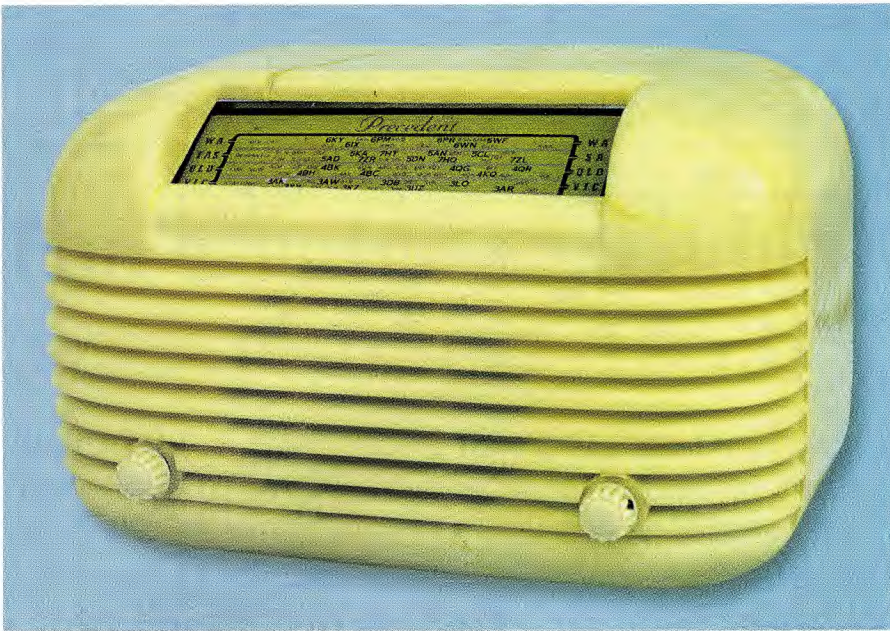
The restored receiver is barely recognisable from the rather sorry mess that arrived in my workshop. The cabinet was repaired using fibreglass mixed with cream craft paint.

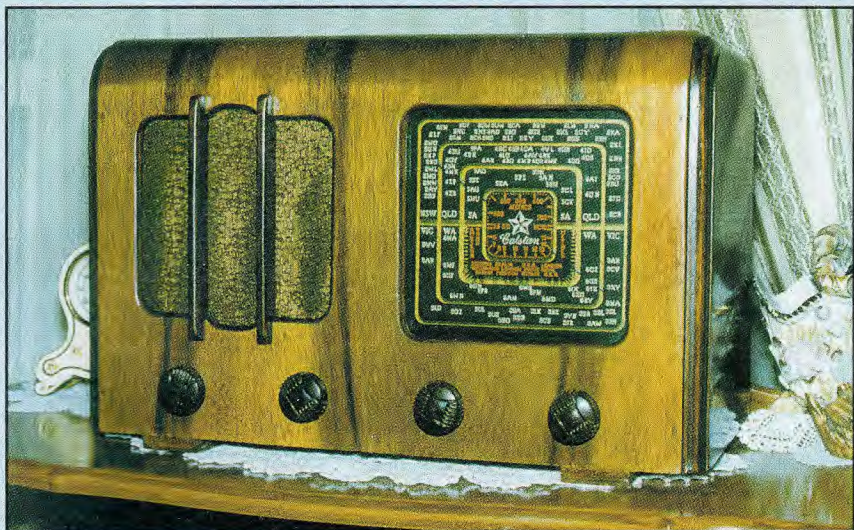
Photo Gallery: Zenith Radio Calstan Receiver (1947)

Manufactured by Zenith Radio Co Pty Ltd (Sydney) in 1947, the Calstan was a medium-sized, 5-valve receiver which was housed in a handsome timber cabinet. It used the following valve line-up: 6A8-G frequency changer; 6U7-G IF amplifier; 6B6-G detector, AVC rectifier and 1st audio amplifier; 6V6-GT audio output stage; and a 5Y3-GT rectifier. The Calstan brand was also well-known at the time for a range of test equipment, the word being an abbreviation of the phrase "calibrated-to-standard". (Photo courtesy Historical Radio Society Of Australia (Inc.).
