# Vintage Radio

## The mysterious 32V DC Monarch D671/32 from Astor

**It's not often that I come across an Australian-made set for which I have no information. Made by Astor, the 32V DC Monarch D671/32 falls into that category and may have been a pre-production model.**

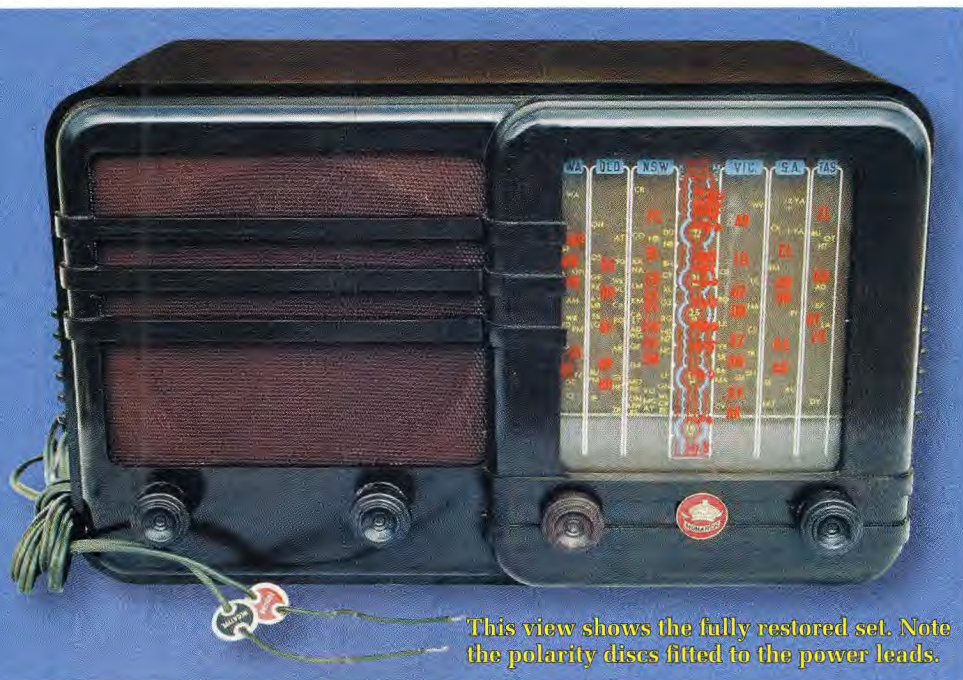
This view shows the fully restored set. Note the polarity discs fitted to the power leads.

The 32V power supply is connected to the receiver via a 2-core lead and each lead is identified by a small brass label which indicates whether it is positive or negative. This is a useful feature that I haven't seen on other DC-powered radios.

The polarity labels (mentioned earlier) were also cleaned with automotive cut and polish. This also removed the paint, so they were resprayed using black paint for the negative label and red paint for the positive label. Once the paint had dried, I used a razor blade to scrape it off the raised sections

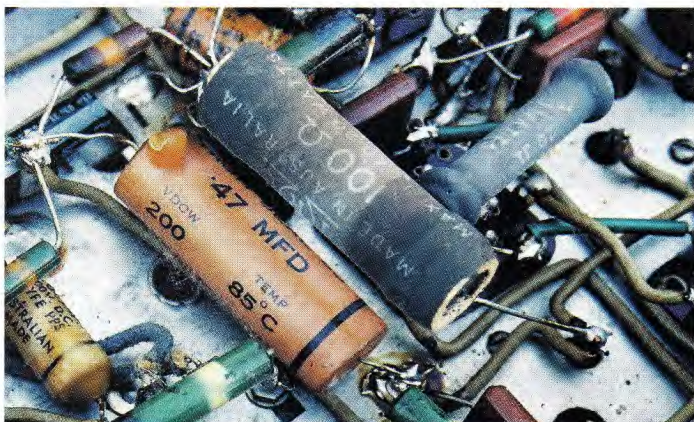
The old Monarch D671/32 was fitted with a gear driven tuning capacitor, as shown in the photo at left. The close-up above shows an overheated 0.47µF paper capacitor that's located too close to a high-wattage resistor.

would have been substantially reduced. The result of this heating can be seen in one of the photographs, which shows a 0.47μF capacitor with the 100Ω 20W resistor immediately above it.

The dial light is a 6V 300mA unit which is fed from the 32V rail via a 100Ω 20W resistor. However, by using a 12V 150mA dial lamp (available when this set was built) and changing the series resistor to 170Ω, the current would have been halved. In addition, the amount of under-chassis heating

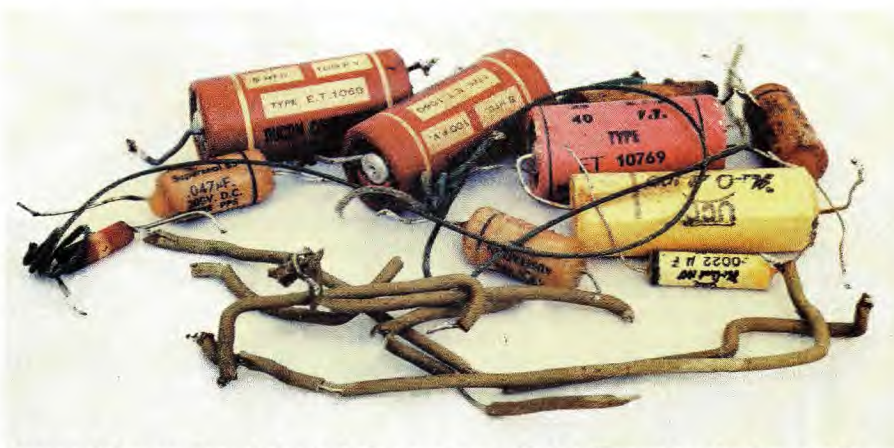
Many of the paper and electrolytic capacitors had to be replaced, along with some of the wiring which had cracked insulation.

and is unlikely to do so if left undisturbed. However, the insulation on some of the wiring had cracked and that meant it had to be replaced (see photo).

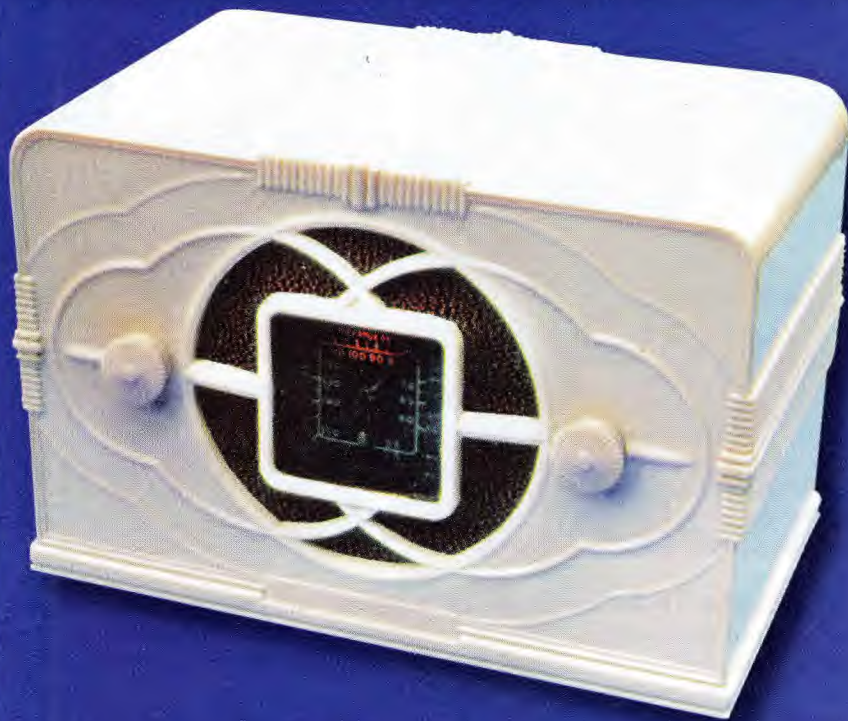
## Photo Gallery: Astor Mickey Mouse Model EC

Manufactured by Radio Corporation, Melbourne, in 1939, the “Mickey Mouse” EC was a 5-valve superheterodyne receiver fitted with metal valves. Using an output valve that gave good performance at relatively low operating voltages allowed the size of the power transformer to be reduced and also reduced the heat build-up in the small Bakelite cabinet (the white cabinet shown here was not common). The valves fitted were as follows: 6A8 frequency changer; 6K7 IF amplifier; 6Q7 audio amplifier/detector/AGC rectifier; 25A6 audio output; and 5Z4 rectifier. Photo: Historical Radio Society of Australia, Inc.
