Vintage Radio

The AWA Radiola B29 8-transistor radio with battery eliminator

Manufactured in the 1960s, the AWA B29 is an interesting 8-transistor radio that could be run from batteries or an external power adapter.

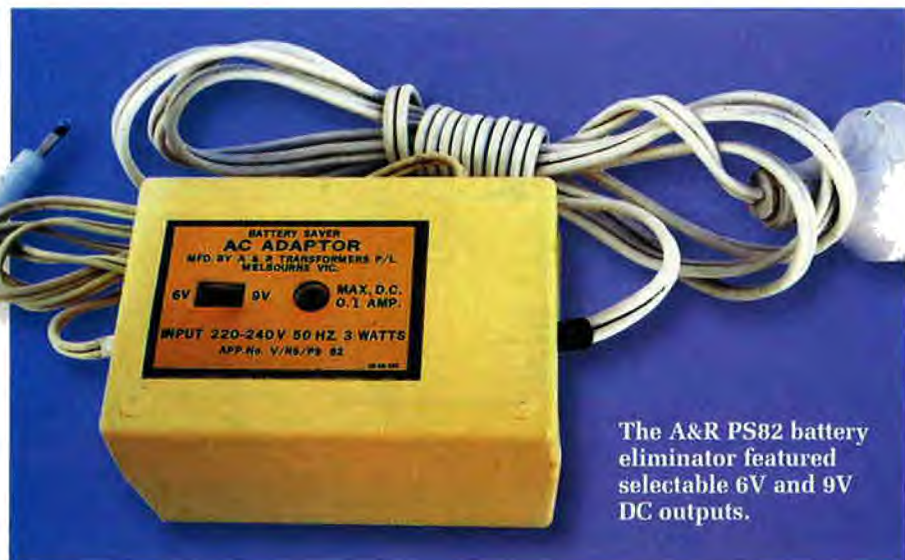
One such company was A & R Transformers and their PS82 battery eliminator was very popular at the time. This unit was double-insulated and featured switchable 6V and 9V (100mA) DC outputs.

The A&R PS82 battery eliminator featured selectable 6V and 9V DC outputs.

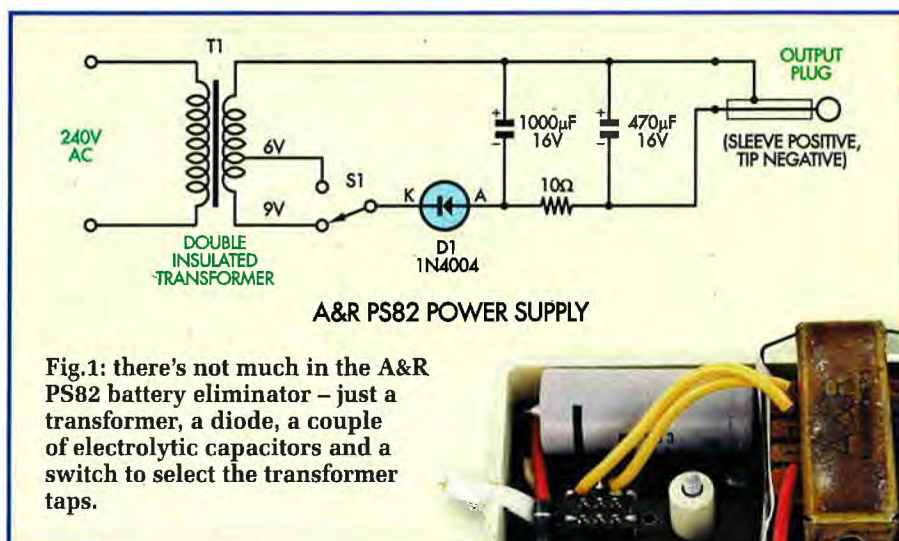
One advantage of the PS82 is that it is easily dismantled for service, requiring just one screw to be removed to split the case in half. As shown in Fig.1, the circuit is really quite simple and uses diode D1 as a half-wave rectifier. The 6V and 9V settings are selected by switching taps on the transformer secondary, while two electrolytic capacitors and a 10Ω resistor filter the output from D1.

Fitting four diodes in a bridge rectifier circuit would have achieved better voltage regulation under load, so why wasn't this done? The reason is probably to do with cost. Silicon diodes were much more expensive then than they are now and so this would have sharply increased the cost.

Fig.1: there's not much in the A&R PS82 battery eliminator – just a transformer, a diode, a couple of electrolytic capacitors and a switch to select the transformer taps.

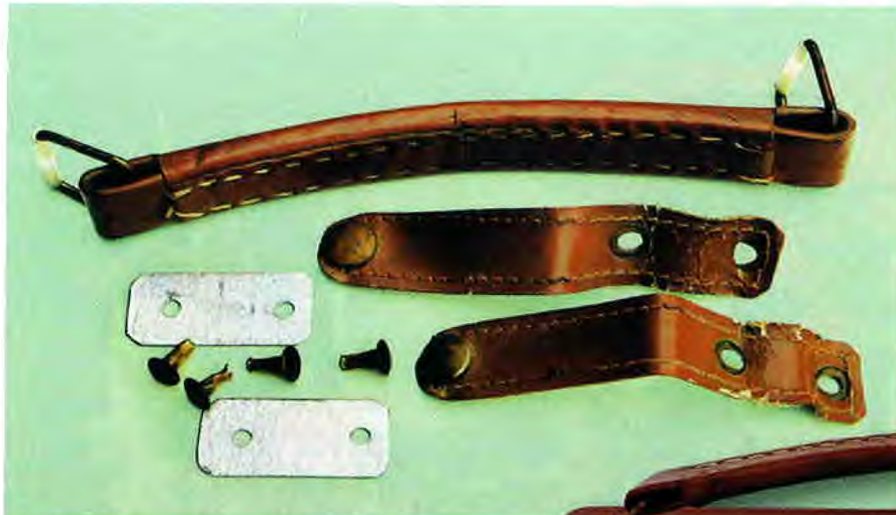
As can be seen in one of the photographs, the carrying handle had come adrift from the lugs on the top of the case. This method of attaching the handle was obviously inadequate, so I looked at making some improvements here. Unfortunately, this involved dismantling the set and that wasn't all that easy.

The handle assembly on the old B29 was repaired and strengthened using two small metal brackets (above and right). The restored receiver looks good and gives reasonable performance.

This gave access to the four bifurcated rivets that hold the handle in place. These rivets (along with the handle) were then removed.

That done, I cut some light-gauge galvanised flashing (try your local hardware store) into two small rectangles. These were then bent into semi-circular straps, after which two holes were drilled in each strap to match the holes in the leather handle assembly.

The idea behind these metal straps is that they would take all the pressure off the leather handle. The accompanying photographs shows the basic scheme.

Re-attaching the handle assembly to the case took a little while but the scheme worked well. It may not look 100% due to the damage that has been done to the various parts over the years but it’s a lot better (and stronger) than it was.

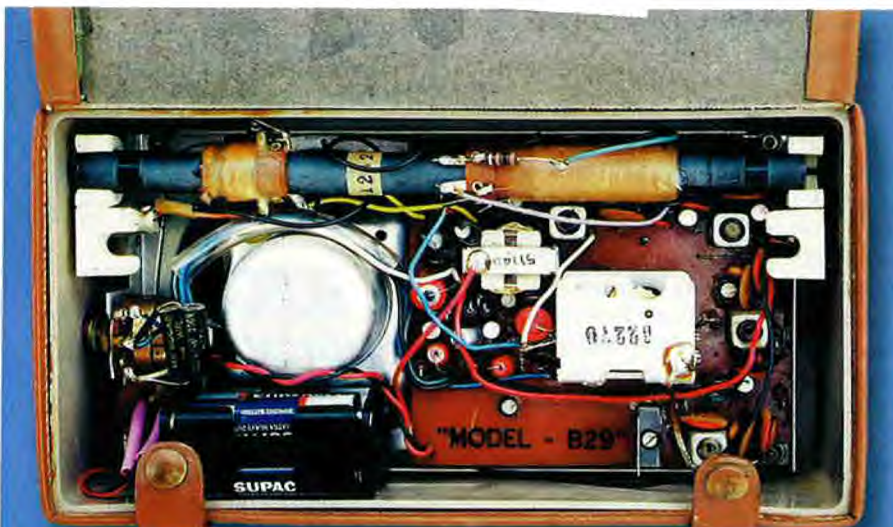
The original 2364 battery type used in the B29 is no longer available but six AA cells in a holder can be used instead.

Type 2364 batteries are now unobtainable, so I decided to see if six C-cells could be fitted into the receiver's case. Unfortunately, the holder was just a little too large but a pack of six AA-cells in a holder can be fitted and will give reasonable life. It is only necessary to solder a battery snap lead to the 2364 battery plug and the B29 is ready to use as a portable.

To prevent any shorts, a couple of pieces of plastic tubing were placed

over the exposed lugs on the 2364 battery plug. The 6-cell pack fits snugly inside the case, as can be seen in the photograph.

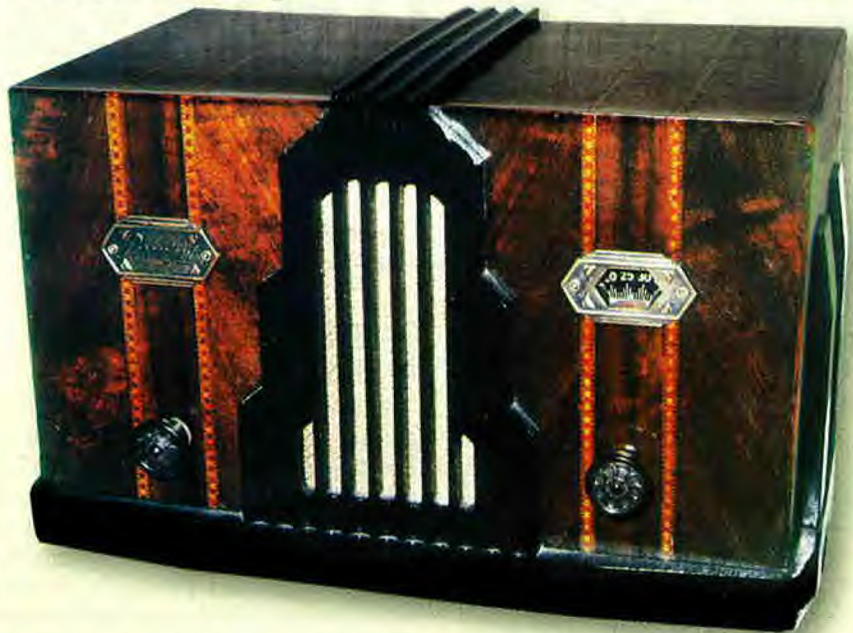
Photo Gallery: Precedent 5-Valve Receiver

Designed and manufactured by Firth Brothers, Melbourne, the Precedent c1933 was a stylish table model receiver that tuned the medium-wave band. The valves fitted were as follows: 57 autodyne mixer; 58 IF amplifier; 57 anode bend detector; 2A5 audio output; and 80 rectifier. Photo: Historical Radio Society of Australia, Inc.
