Vintage Radio

The 1951 AWA Radiola 433MCZ 4-valve battery receiver

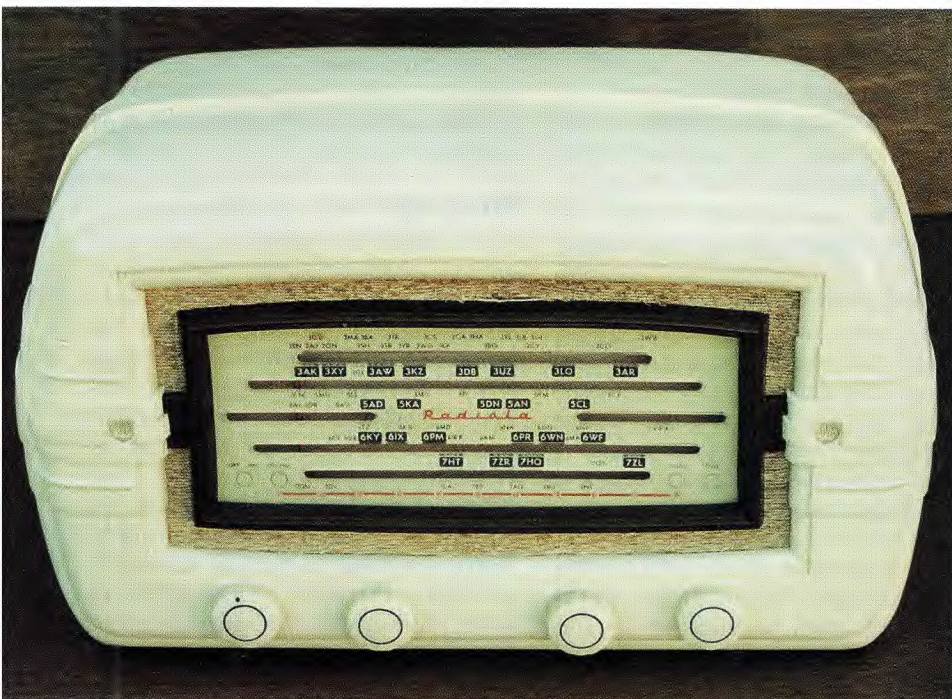
This view shows the fully-restored receiver. It turned out to be quite a reasonable performer, especially after it had been aligned correctly.

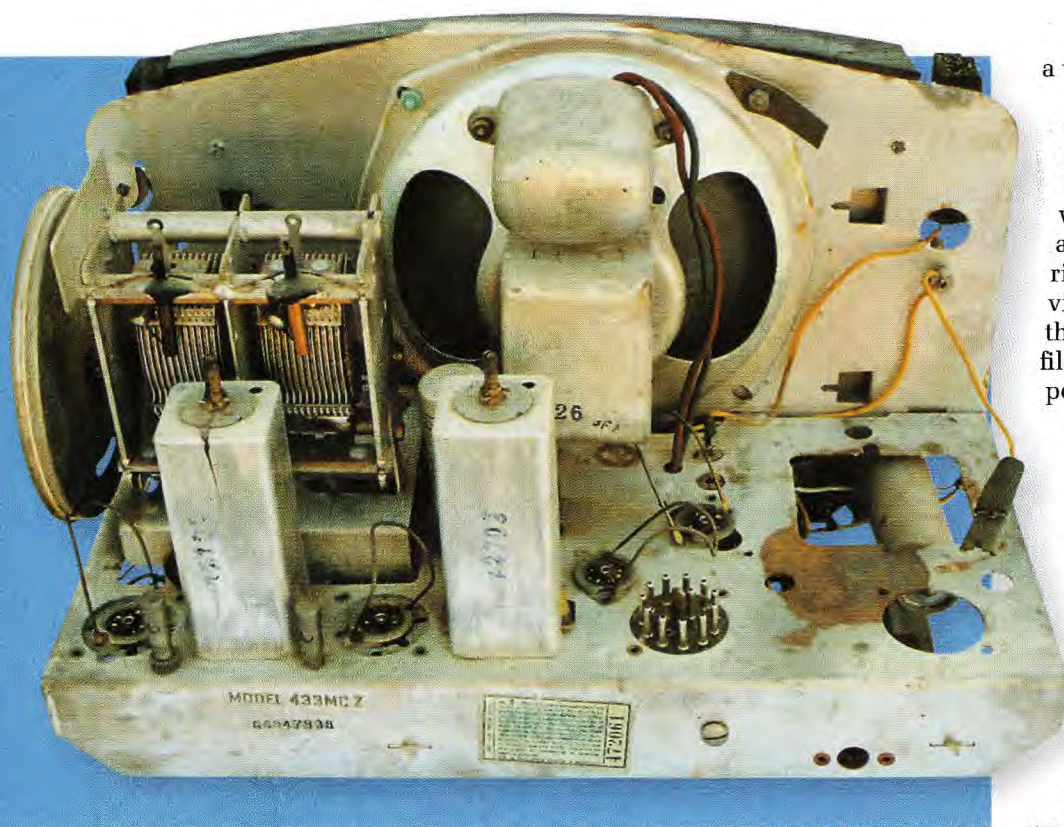
The old Radiola 433MCZ was in relatively good condition, although there was some corrosion on the chassis due to leakage from the dial-lamp battery.

The set was generally in quite good condition. However, the 3V battery used for the dial lights had corroded through its case and spilled electrolyte onto the chassis. As might be expected, this caused some rusting and general corrosion of the steel plating in the area affected by the spill (see photo).

After cleaning up this corrosion, the cabinet and the chassis itself were dusted using a brush and then the valves, cabinet and knobs were washed with soapy water. These parts were then rinsed in clean water and left to dry.

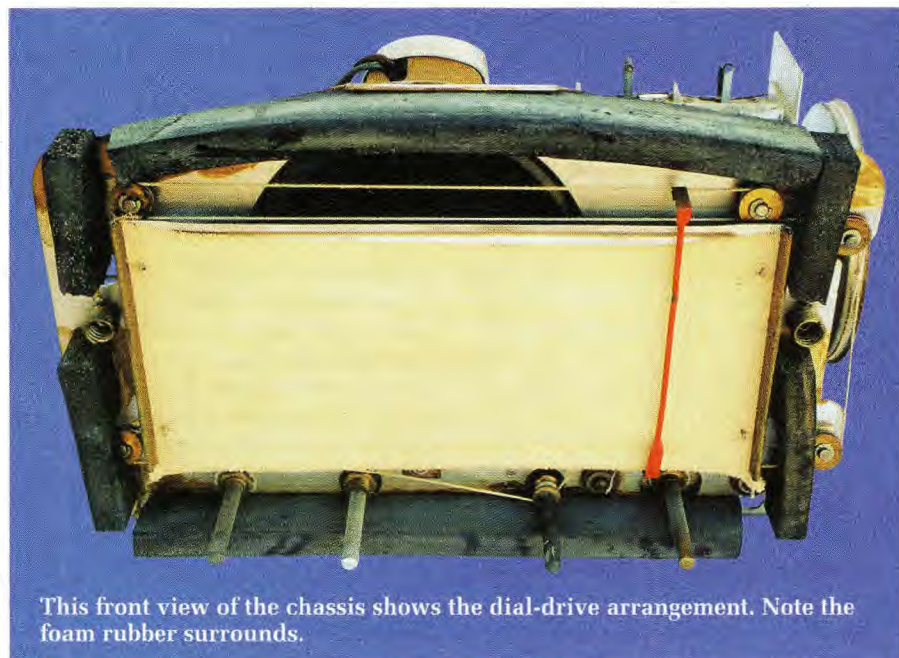
This front view of the chassis shows the dial-drive arrangement. Note the foam rubber surrounds.

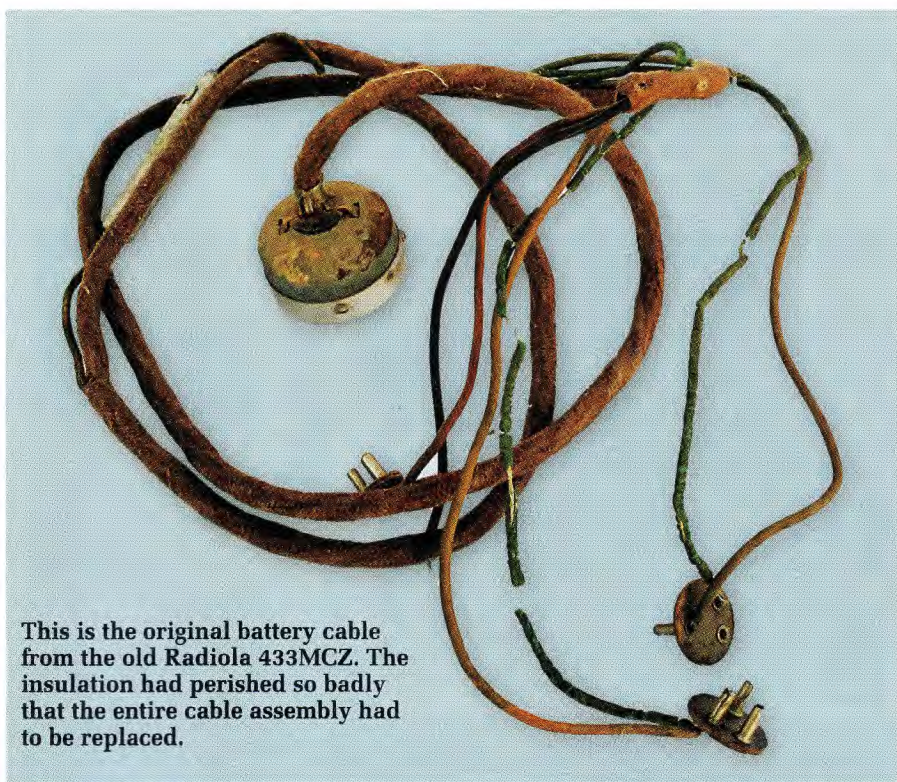
This is the original battery cable from the old Radiola 433MCZ. The insulation had perished so badly that the entire cable assembly had to be replaced.

It was now time for the circuit restoration. First, the rubber insulation on the battery cable leads was in poor condition and so they were replaced with plastic covered leads of the same colour. These leads were then carefully wrapped in insulation tape as far as the cable socket.

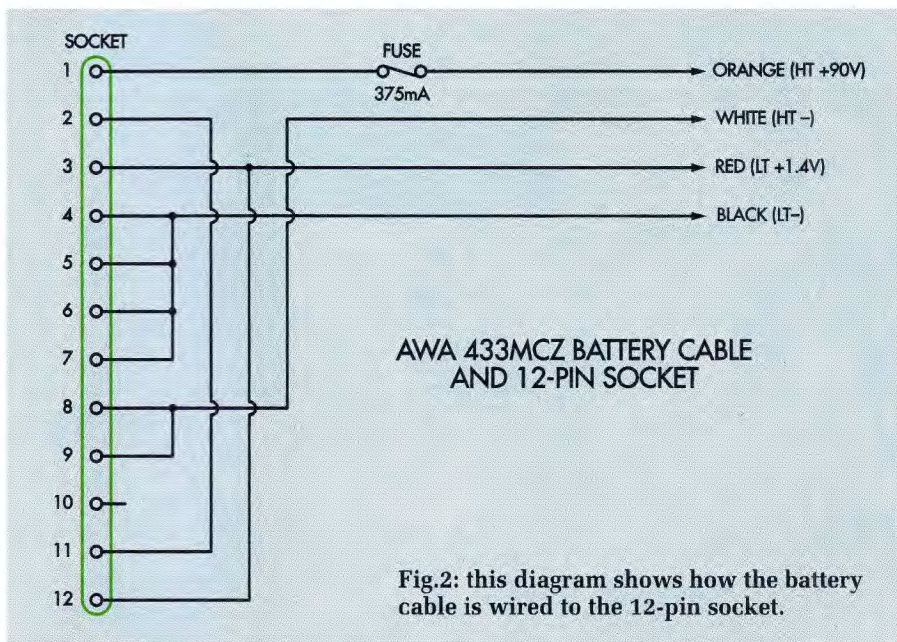
Fig.2: this diagram shows how the battery cable is wired to the 12-pin socket.

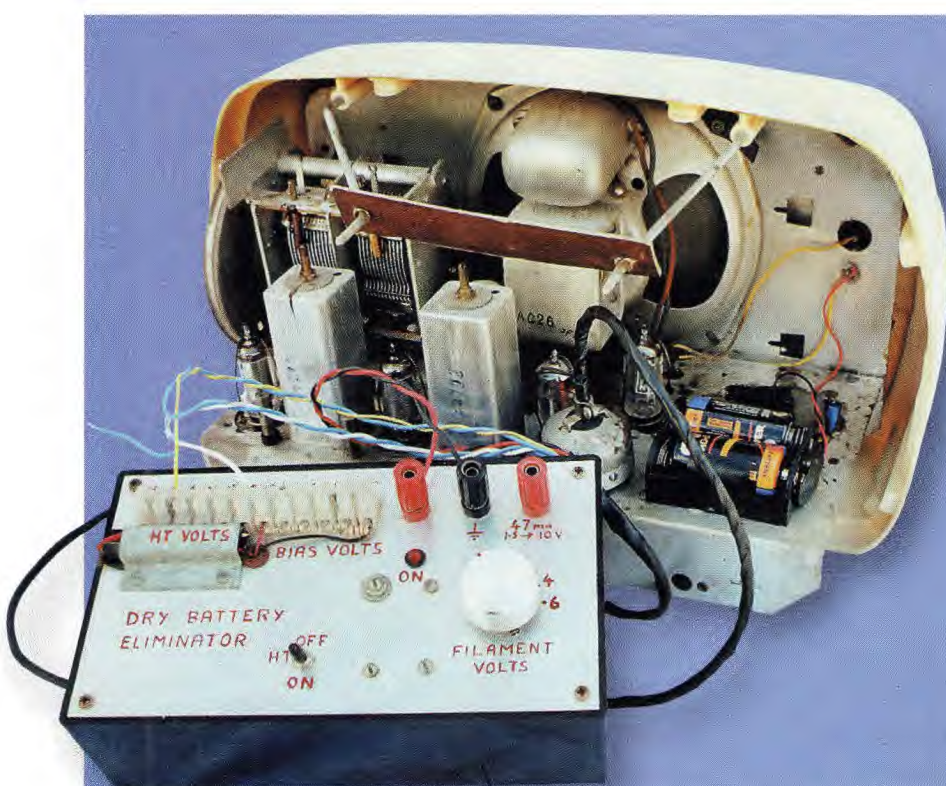
Powering battery-operated receivers is no problem if you build a mains-powered dry-battery eliminator.

Powering a battery receiver is a problem for many collectors, as the batteries are now either unobtainable or very expensive. I first realised this about 15 years ago and decided to do something about it by building the supply shown in one of the photographs. It will handle most battery sets from the mid 1930s onwards, as well as 6V vibrator receivers that draw no more than 1A.

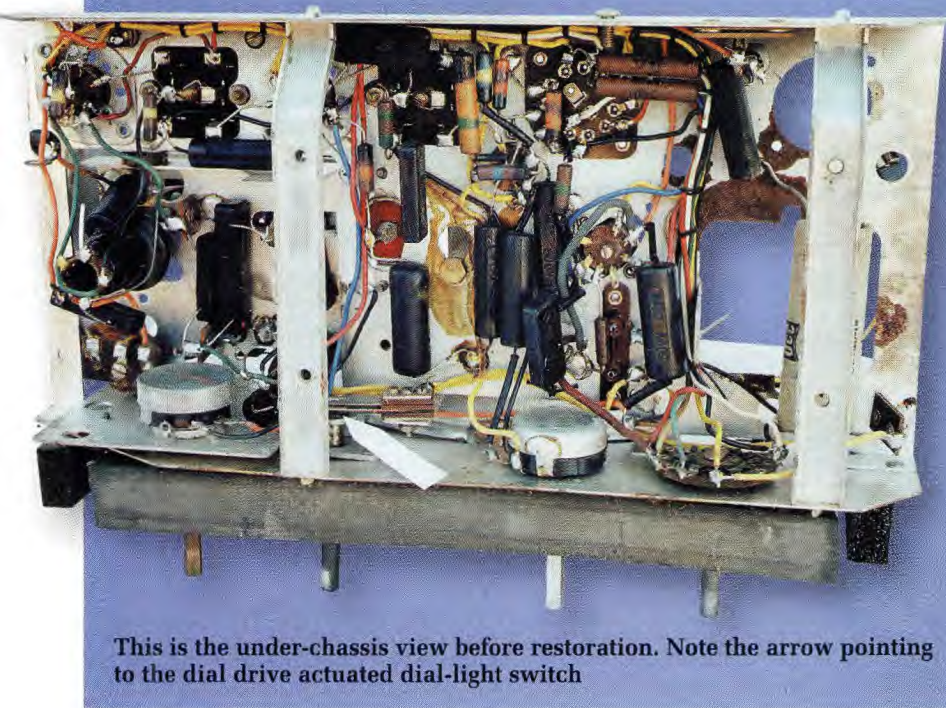
This is the under-chassis view before restoration. Note the arrow pointing to the dial drive actuated dial-light switch
