Vintage Radio

The rare Edison R6 console receiver

Built into an ornate timber cabinet, the Edison R6 console was a high-performance TRF receiver with nine valves. It's quite a rare receiver with some interesting design features.

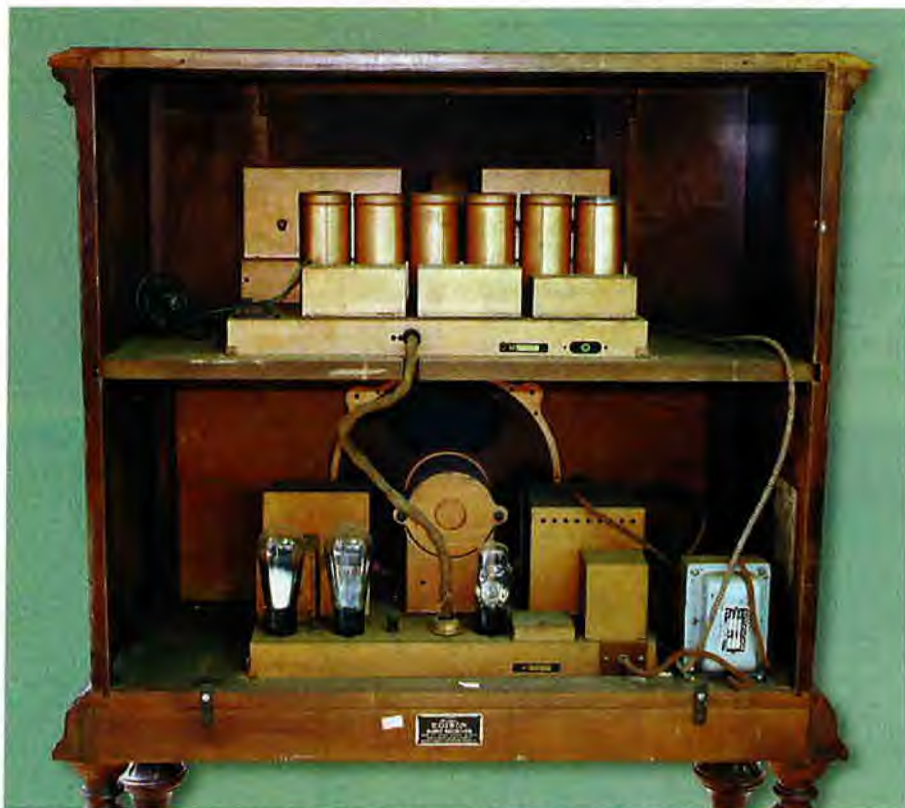
The RF chassis (top) sits on a shelf, while the audio output/power supply chassis rests on the bottom of the cabinet. Note the retrofitted 240V-to-110V mains transformer at bottom right.

A rear view of the set reveals two large chassis mounted at different levels of the cabinet. The upper chassis contains the radio frequency (RF) amplifiers, the detector, automatic volume control circuit (AVC/AGC) and two stages of audio amplification. The lower and much heavier chassis houses the power supply and the audio output stages. Both chassis are in quite good condition, despite the set now being 75 years old.

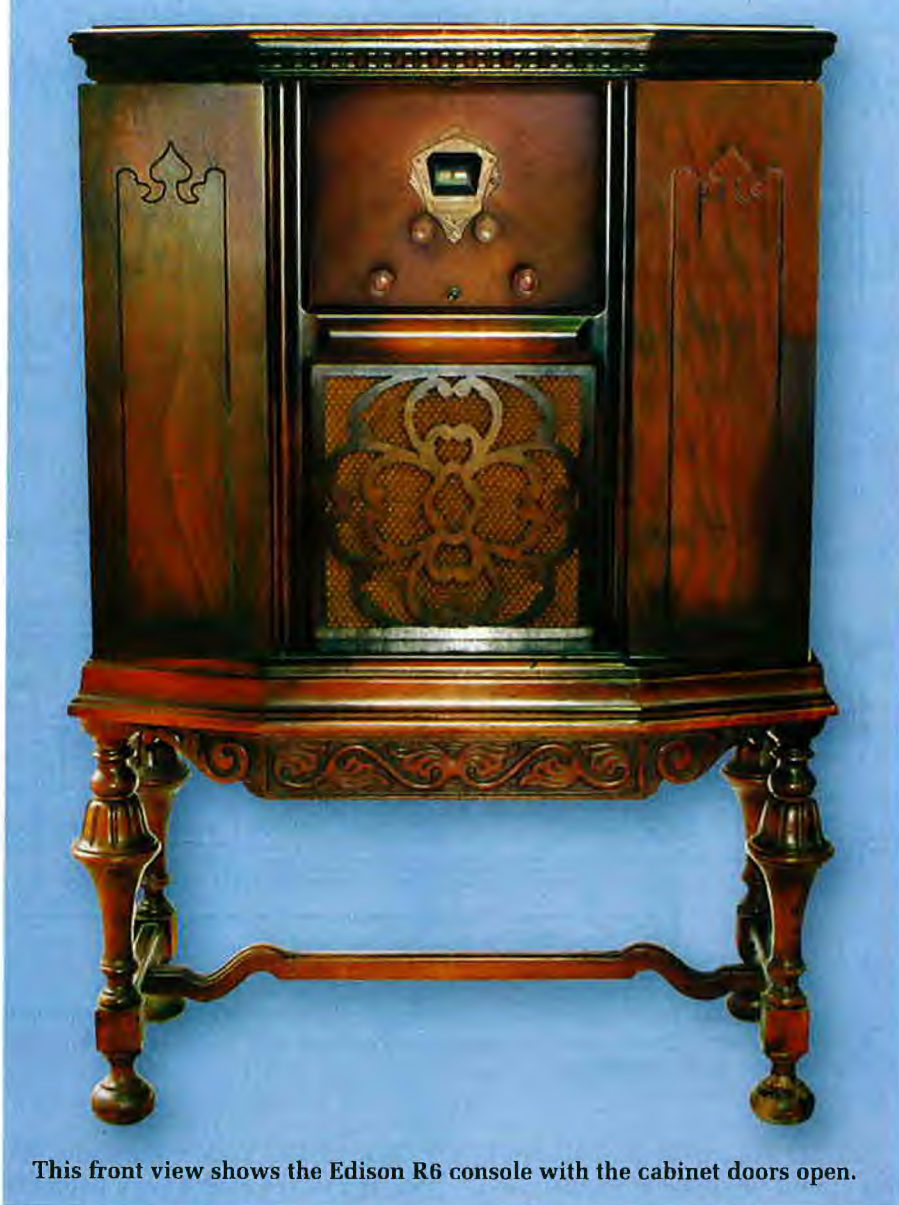
This front view shows the Edison R6 console with the cabinet doors open.

The cabinet is quite attractive and would have complemented the decor of the typical 1930s lounge room. It has two doors which are folded out when the receiver is in use. In addition, it features a fancy loudspeaker fretwork cut-out that looks rather like a large 4-leaf clover and sets the speaker section of the cabinet off very nicely.

Immediately above the speaker section is the dial scale and the five controls. These are, from bottom left to right, volume, on/off and tone; and from top left to right, local/distance and tuning. The "Light-O-Matic" is a fancy name for the dial-lamp switch. It is a mechanical switch that illuminates the dial lamp when the set is tuned to a selected station. This switching is accomplished by a contact on the dial drive system.

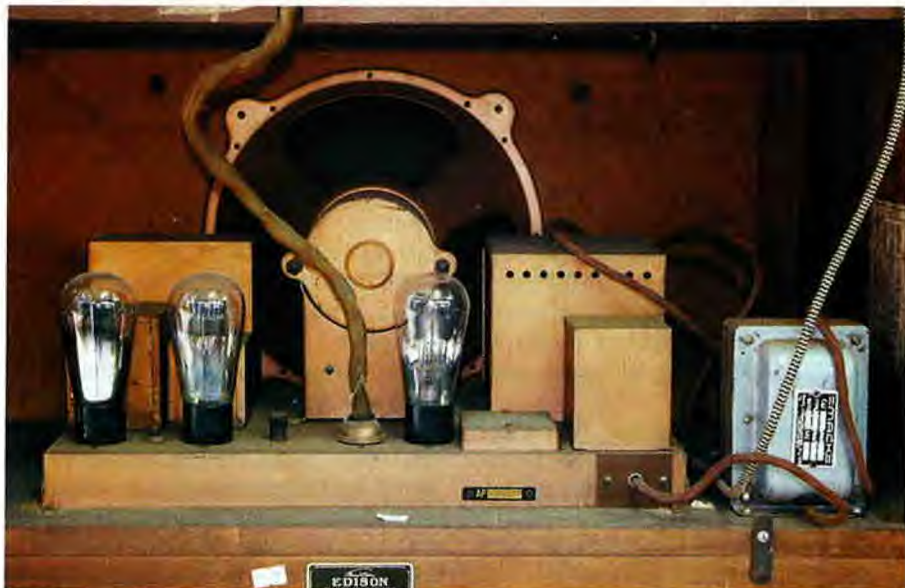
A close-up view of the audio output/power supply chassis and the large electrodynamic loudspeaker. The added 240V/115V transformer looks out of place.

The power supply is conventional, with considerable attention paid to filtering. The primary of the transformer is tapped at 105V, 115V and 125V, hence the use of an additional stepdown transformer in this particular unit.

The HT secondary of the mains transformer is fed to an 80 rectifier valve (the 80 and 5Y3GT are electrically equivalent). The resulting DC is then applied to a tapped choke in the positive supply line, along with three filter capacitors. The field coil of the electrodynamic speaker acts as a filter in the negative line.

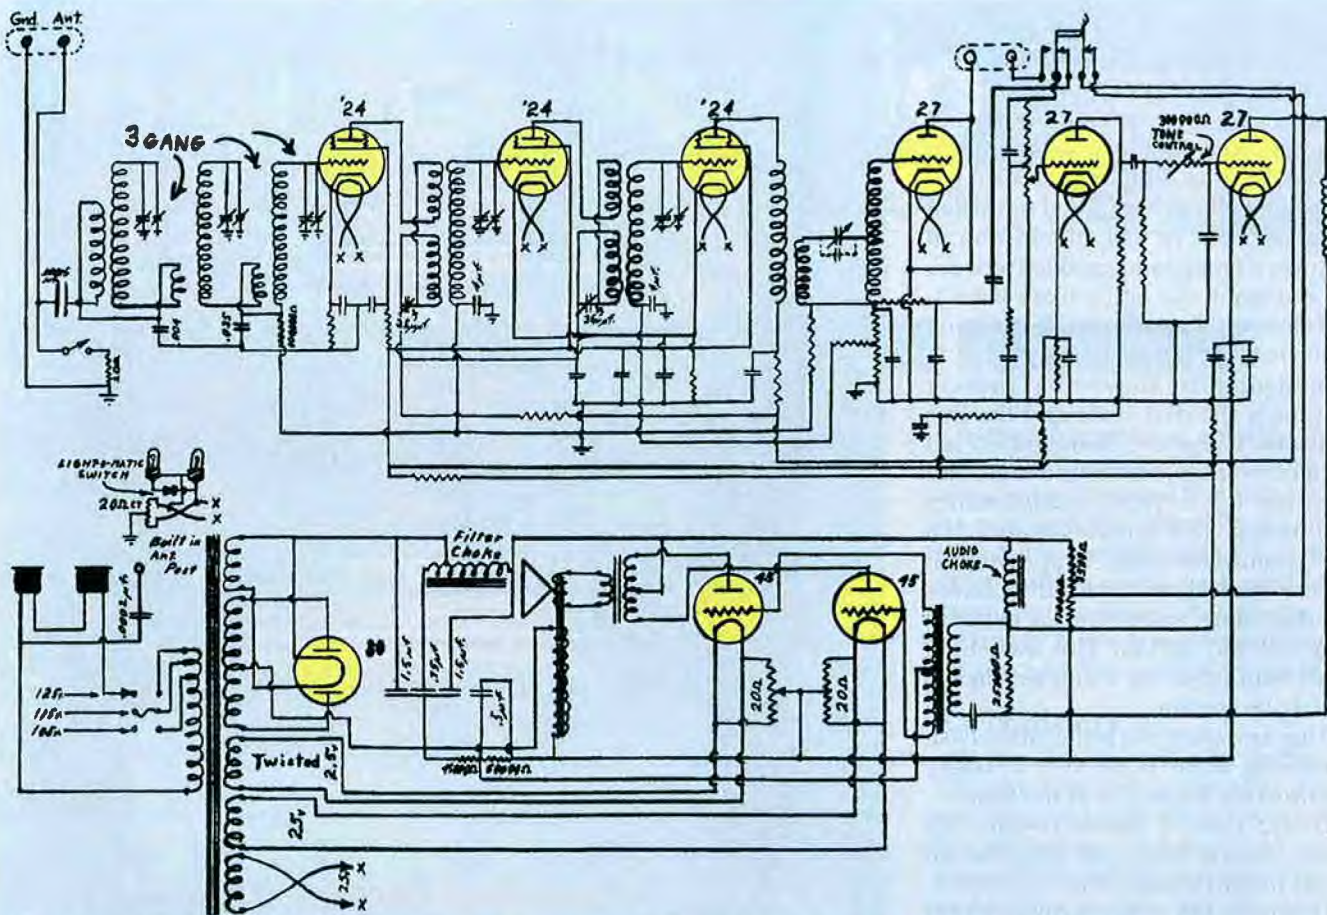
Fig. 1: the Edison R6 is a 9-valve TRF receiver with three RF amplifier stages (224) and a diode detector based on a 227. Two more 227s act as audio stages, while the final audio stage consists of two 245 valves operating in push-pull. The 80 valve is the rectifier.

The 227 is actually a triode but in this circuit the plate is earthed (as a shield) and the grid acts as the diode plate. Using a diode as the detector can be considered an advanced feature in this set. Most other sets used either anode bend or grid detectors.

The RF (radio frequency) section uses no less than three tuned circuits before the 224 (2A) first RF amplifier stage. Following this stage is another tuned circuit and a second 224 RF amplifier. A third 224 RF amplifier is tuned in the grid circuit but the plate circuit has what appears to be a broadbanded circuit which feeds a 2Z7 diode detector and AGC circuit.

Another innovative feature was the use of AGC on the three RF valves. AGC was a rarity around 1930. Only partial AGC is applied to the third RF amplifier – the 224 is a relatively sharp cut-off valve and applying a lot of AGC bias to this stage could cause distortion. As it is, a local-distance switch is fitted to alleviate the problem of overloading the RF valves with strong signals.

Following the detector, two more 227 valves amplify the audio signal which is then fed to a push-pull audio transformer. This then feeds the grids of a pair of 245 valves operating in push-pull, which in turn drive an output transformer and an electrodynamic speaker.

To minimise hum in the audio, the two 245 valves each have a potentiometer across the filament transformer windings. These two pots have a ganged moving arm which goes to earth and is adjusted for minimum hum in the output.

One interesting feature is the provision of a capacitor on the primary side of the transformer. The idea here was that this could be connected to the aerial (antenna) terminal, so that the mains could act as an aerial. However, this type of aerial system was usually quite noisy due to electrical interference on the mains. In addition, there was always a risk that the capacitor

Finally, there are four filament windings on the secondary of the transformer, one five volt for the rectifier and three 2.5 volt ones for the rest of the receiver.

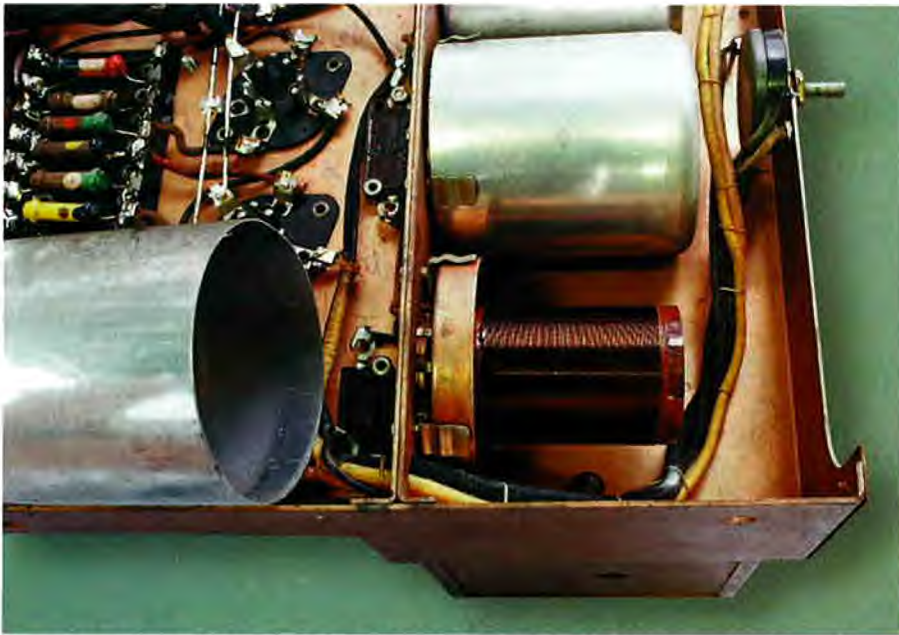
Removing the coil covers shows that all the coils are still in excellent condition, despite now being more than 75 years old.

Access under each of the chassis is quite good, with, all components neatly laid out and quite easy to get at. Access to the RF coils is also good, and the coil winding is still in excellent condition after all these years.

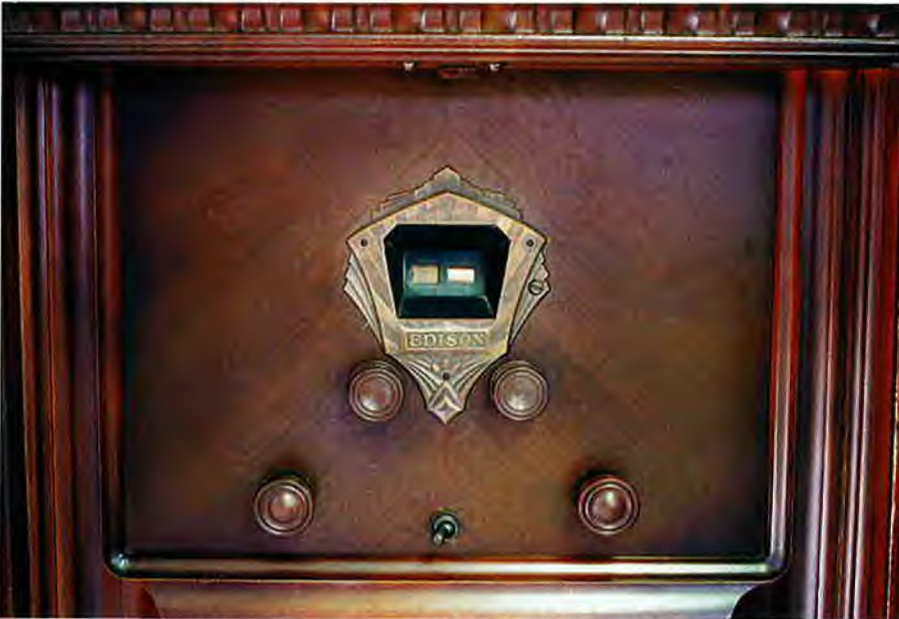
A close-up view of the Edison R6's control panel: from bottom left to right, volume, on/off and tone; and from top left to right, local/distance and tuning.

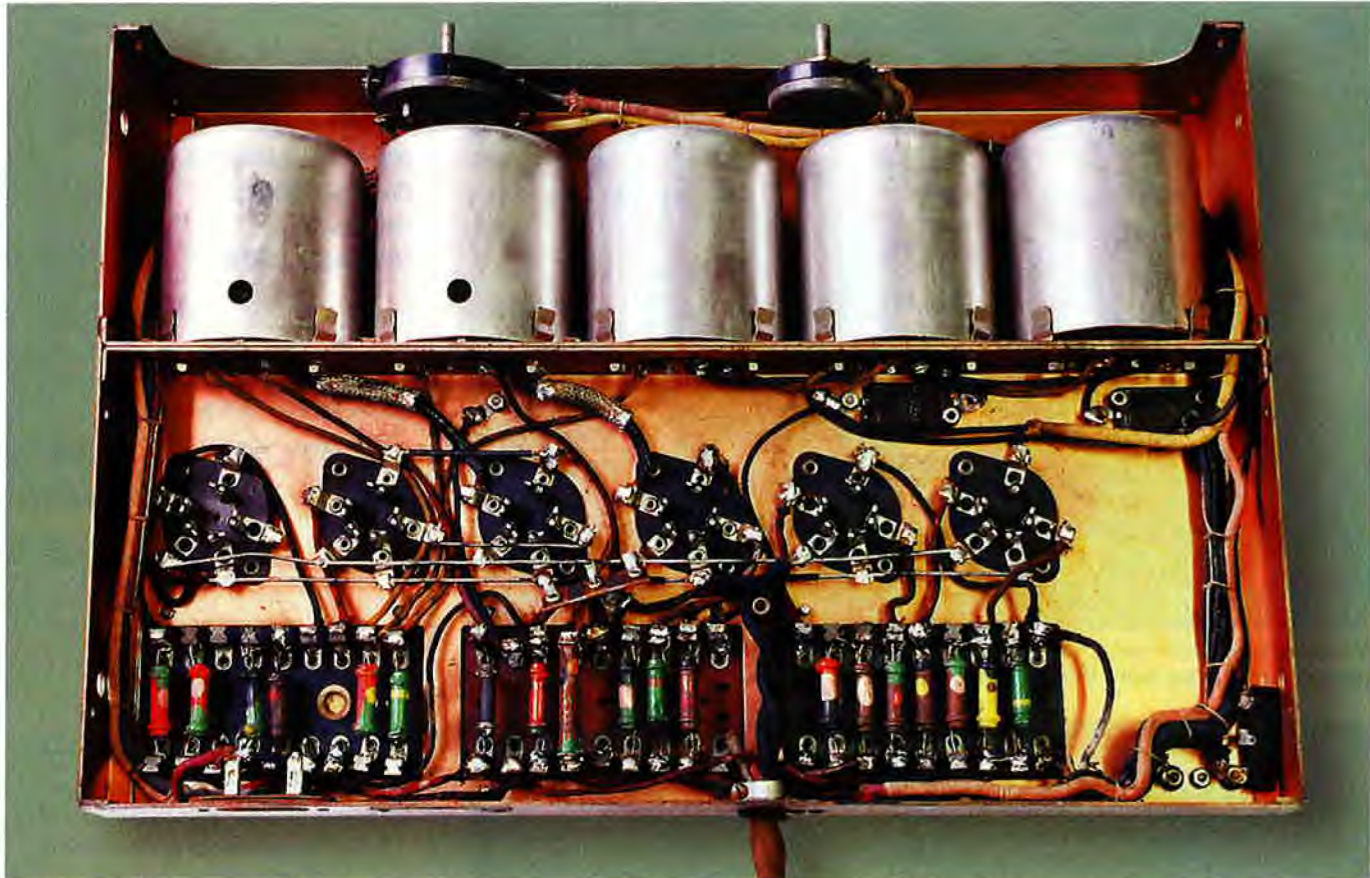
The parts on the underside of the RF chassis are very neatly laid out and easy to access. Note the row of coils at top.

Most of the fixed capacitors in this set were replaced in the not too distant past. In this case, the old capacitors had been removed from their cases and the new ones substituted to keep the chassis looking original. Certainly, this job has been extremely well done, the step-down mains transformer be-

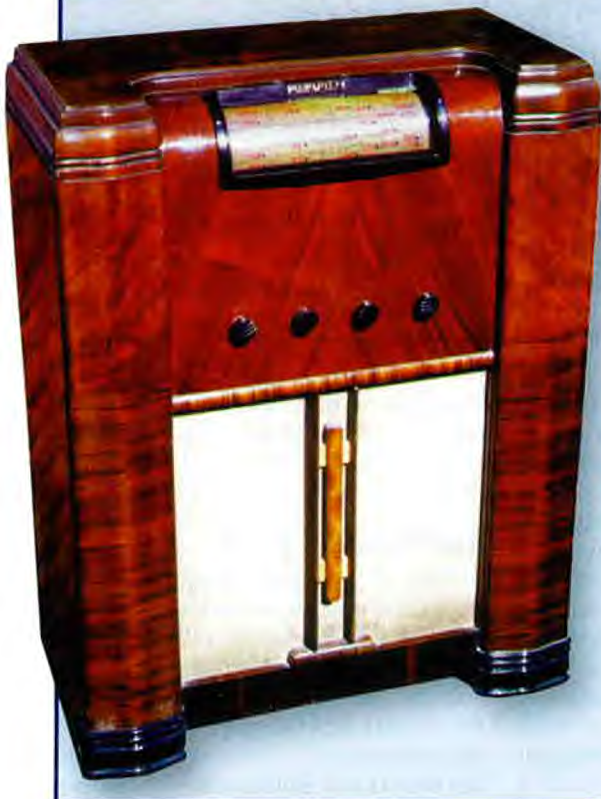
Photo Gallery: Healing 527E 5-Valve Console

MANUFACTURED BY A. G. Healing, Melbourne, in 1946, the model 527E is an early post-war broadcast band console receiver. It featured a large rotating "barrel" type dial and a 30cm loudspeaker and combined good performance with attractive styling. A companion model, the 577E, was also produced and this included a shortwave band that tuned from 7.89MHz to 24MHz.

The valve line-up was as follows: 6J8-G frequency changer; 6U7-G IF amplifier; 6B6-G detector/audio amplifier/AVC rectifier; 6V6-G audio output; and 5Y3-G rectifier. Photo: Historical Radio Society of Australia, Inc.
