Vintage Radio

The Kriesler 41-29 “Trans-Mantel”

Developed during the early 1960s, the Australian-made Kriesler 41-29 “Trans-Mantel” was a 7-transistor receiver based on PNP germanium transistors. It was an excellent little set that could be used both as a mantel receiver and as a portable.

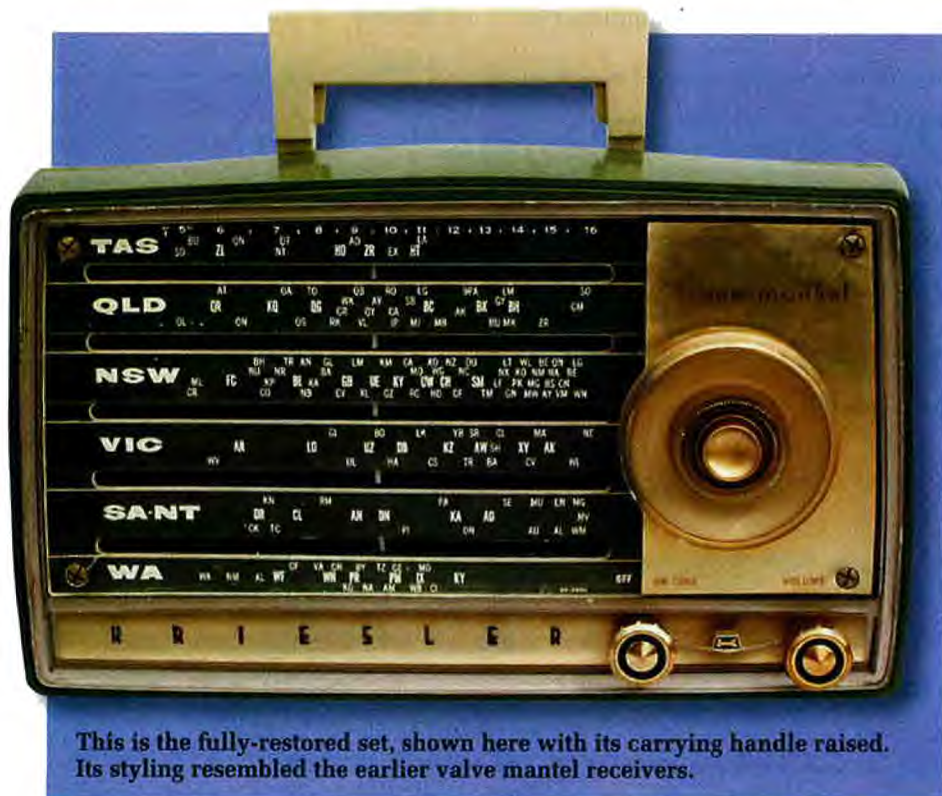
This is the fully-restored set, shown here with its carrying handle raised. Its styling resembled the earlier valve mantel receivers.

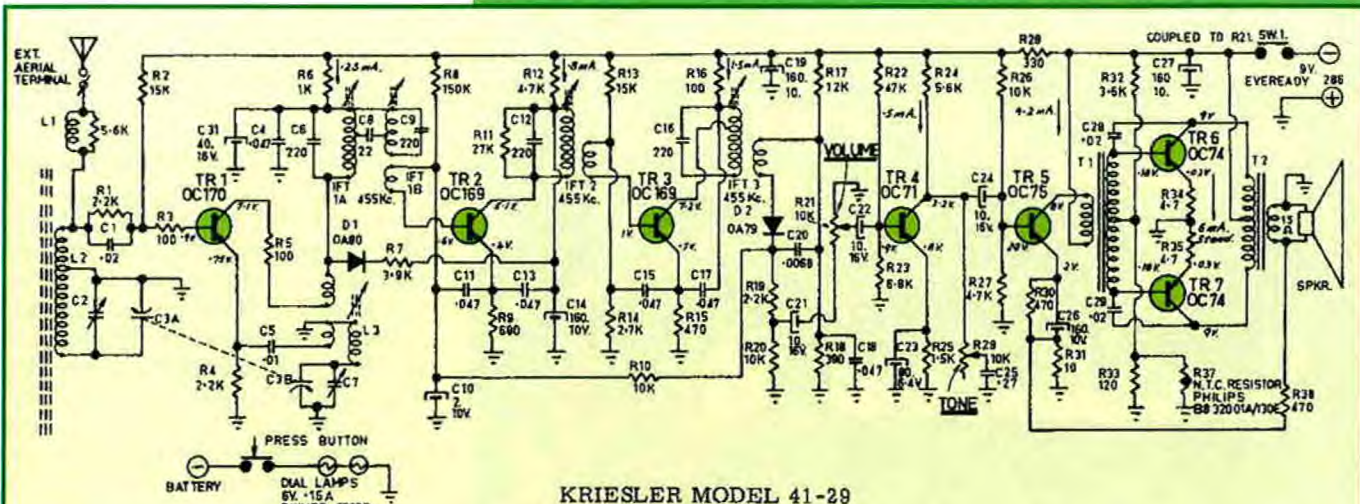
Fig.1: the Kriesler Model 41-29 employed a conventional superhet circuit based on seven PNP germanium transistors.

The circuit configuration is similar to many other transistor receivers of the era – see Fig.1. It's a standard 7-transistor superhet circuit, with the front-end using an OC170 transistor as an autodyne converter.

Kriesler economised on the windings on the loopstick antenna by connecting the low-impedance section of L2 to both the base of TR1 (via R1, C1 & R3) and to the antenna via a broadly-tuned coil (L1). Coils used in the L1 position are usually tuned below the broadcast band when used with a 7-10m long antenna. This coil boosts the performance at the low-frequency end of the dial, as the performance here is usually inferior to that at the high-frequency end.

The output from TR1 is fed via 455kHz IF (intermediate frequency) transformers IFT1A and IFT1B to the base of the first IF amplifier (TR2, OC169). It then goes to IF amplifier stage TR3 (OC169) and from there to detector stage D2 (OA79) which also provides the AGC voltage. Resistors R17 and R18 forward bias D2 almost to the point of conduction, thereby

As the signal strength increases, D2 applies an increasingly positive voltage to R10 and hence to the base of PNP transistor TR2. This AGC voltage in turn causes TR2 to draw less current as it cuts off. As a result, the voltage at the junction of IFT2 and R12 becomes more negative (note: the circuit is positive earth).

Now let's consider the action of diode D1 (OA90), which is effectively wired between the collector circuit of TR1 and the collector circuit of TR2.

Normally, D1 does not conduct as TR1's collector is at -7.1V and TR2's is -5.1V (ie, D1 is reverse biased). However, as TR2 shuts down due to AGC action, its collector voltage progressively becomes more negative. When this voltage goes below about -7.3V, D1 becomes forward biased and conducts, thus causing the signal from TR1 to largely bypass TR2 and go straight to TR3 (via IFT2).

As a result, the gain of the set is reduced on strong signals. At the same time, the selectivity is also reduced, as IFT1 is bypassed and only IFT2 and

IFT3 are effectively in circuit. This loss of selectivity probably doesn't matter a great deal and actually has the benefit of improving the audio quality on strong signals.

Following the detector, the audio is fed to volume control R21 and then to the first audio amplifier (TR4, OC71). This is then followed by audio stage TR5 (OC75) which in turn drives two class B audio transistors TR6 and TR7 (OC74s) via transformer T1. TR6 and TR7 operate in push-pull configuration and drive the loudspeaker via transformer T2. Negative feedback is applied from the loudspeaker voice coil to the emitter of TR5.

The output stage quiescent current is regulated by R37, a negative temperature coefficient (NTC) thermistor. Germanium transistors are particularly prone to thermal runaway as their temperature increases. In fact, it can be so bad in circuits like this that the transistors can self-destruct.

To overcome this, the NTC thermistor decreases its resistance with increased temperature, thereby reducing the forward bias on the bases of transistors TR6 and TR7. This compensates for the tendency of the TR6 and TR7 to conduct more heavily with increasing temperature.

Finally, note that the circuit indicates that the on-off switch is part of the volume control. In practice, it's part of the tone control instead, so someone didn't check the circuit too well.

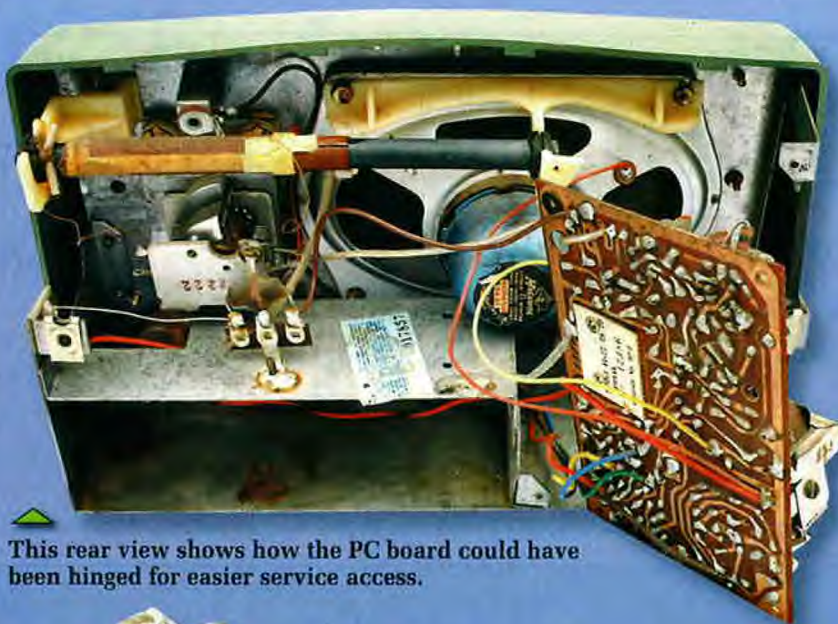
▲ This rear view shows how the PC board could have been hinged for easier service access.

remove as it could have been due to the location of the "earth", which is also the mounting plate for a screw holding the back of the set against the metal chassis.

First, the single-strand wire from the oscillator section of the tuning gang to the PC board has to be desoldered, after which the four screws holding the board in place are removed. The "earth" plate is then sprung outwards so that the board can be removed. In practice, the board can then be turned over (so that the parts face upwards) and a piece of cardboard or cloth placed underneath it to prevent shorts to the frame during testing.

This procedure could have been simplified by mounting the board in a slightly different position, so that it could be directly removed without the "earth" being in the way. In fact, with a little more thought, the board could have been hinged on the edge near the centre of the receiver, which would have made it a dream to service.

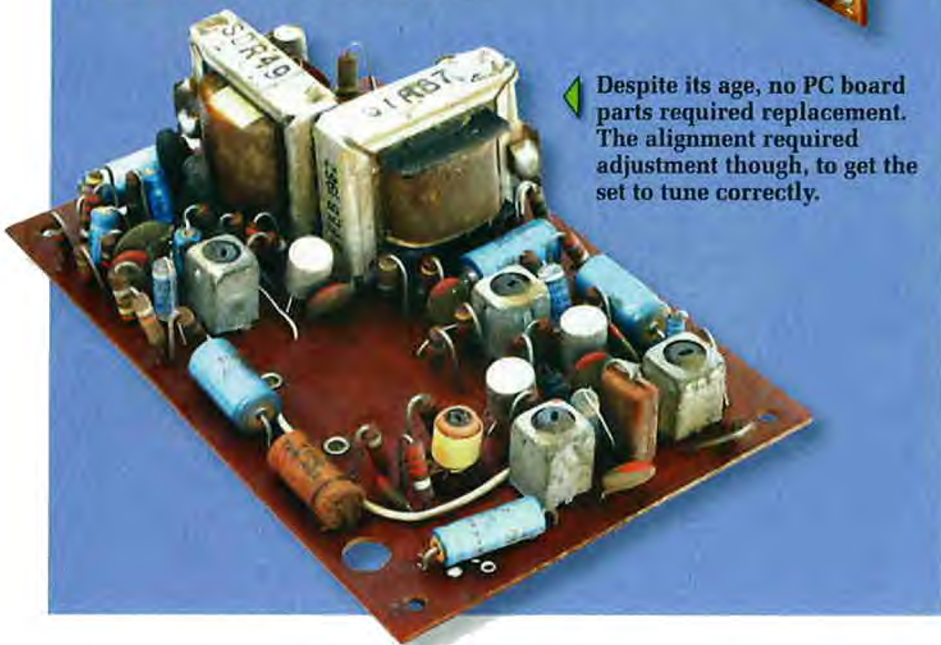
▲ Despite its age, no PC board parts required replacement. The alignment required adjustment though, to get the set to tune correctly.

The cores of the IF amplifier transformers had all been sealed but their alignment appeared to be pretty much spot on. However, I found that the set would only tune down to 600kHz in-

This was easily fixed. All I had to do was adjust the oscillator coil so that it tuned down to 525kHz with the gang shut, then adjust the oscillator trimmer so that it tuned to 1620kHz with the gang fully open. There seemed to be little interaction between these two adjustments so I then aligned the antenna circuit by adjusting the position of the loopstick coil for best performance at about 600kHz and the antenna trimmer for best performance at around 1500kHz.

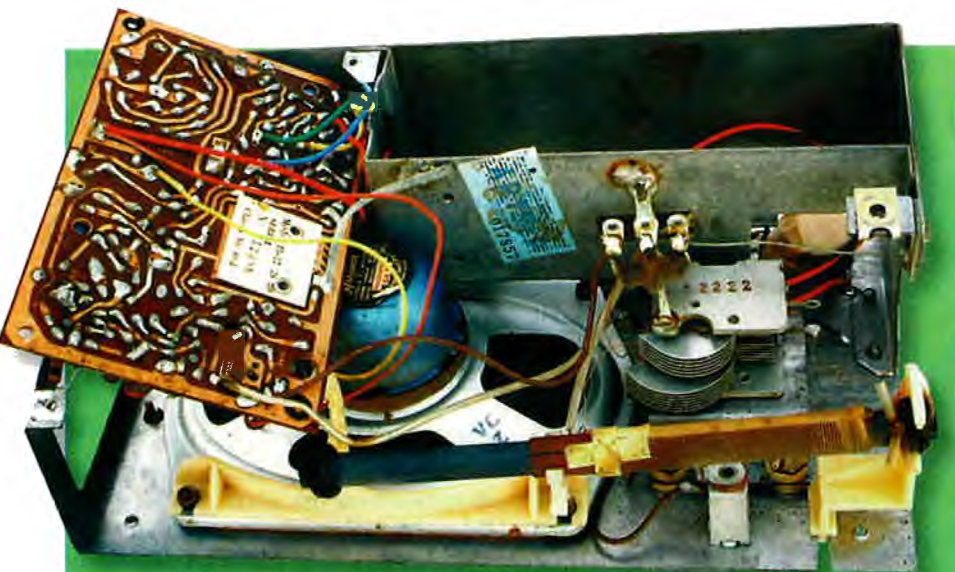
Despite its apparent simplicity, the Kriesler Model 41-29 Trans-Mantel is not all that easy to disassemble for service.

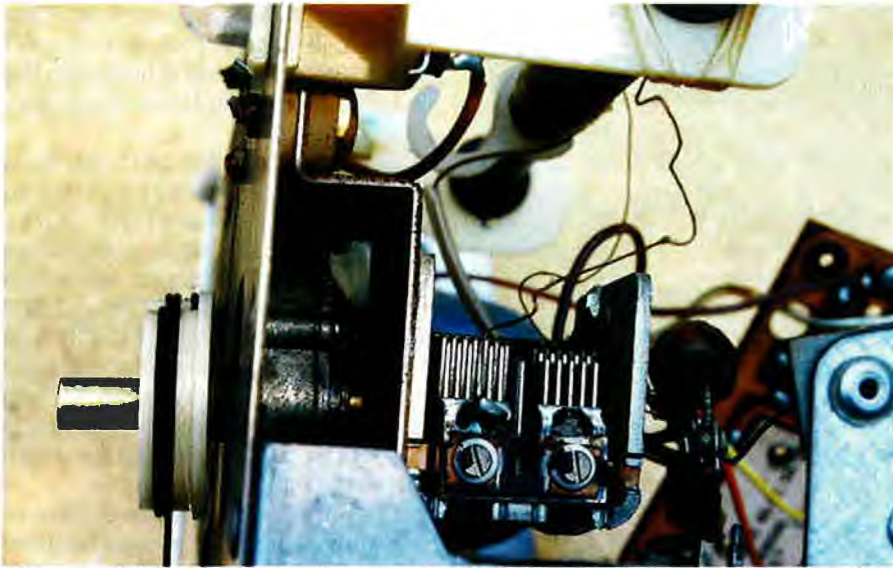
The geared drive for the tuning capacitor is inside the compartment to the left. This made difficult to drill a hole to lock the gear to the tuning capacitor shaft.

At this stage, I ran into a problem. The dial scale has a "start point" marked on it but I couldn't get it right. I tuned to either end of the dial and

the rest point for the pointer changed which wasn't good.

I then found that the plastic gear shaft on the dial reduction drive had expanded, so that when tuned to the end of the dial, you could keep turning it even though the tuning gang was now stationary. This was easily fixed by drilling through the plastic gear and the brass tuning capacitor shaft and then locking the two together with a wire pin.
