Vintage Radio

The HMV B11A 5-valve battery-operated mantel receiver

Manufactured around 1950, the HMV B11A is a battery-operated mantel receiver that was designed for use in rural areas. It was one of the first domestic receivers to use miniature 7-pin valves.

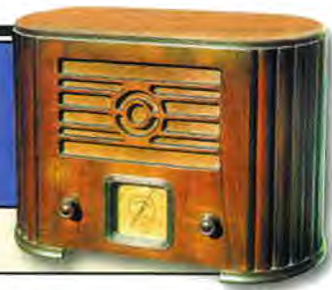
This is the fully-restored receiver in its cabinet. Automotive cut and polish can restore old bakelite cabinets to "as-new" condition.

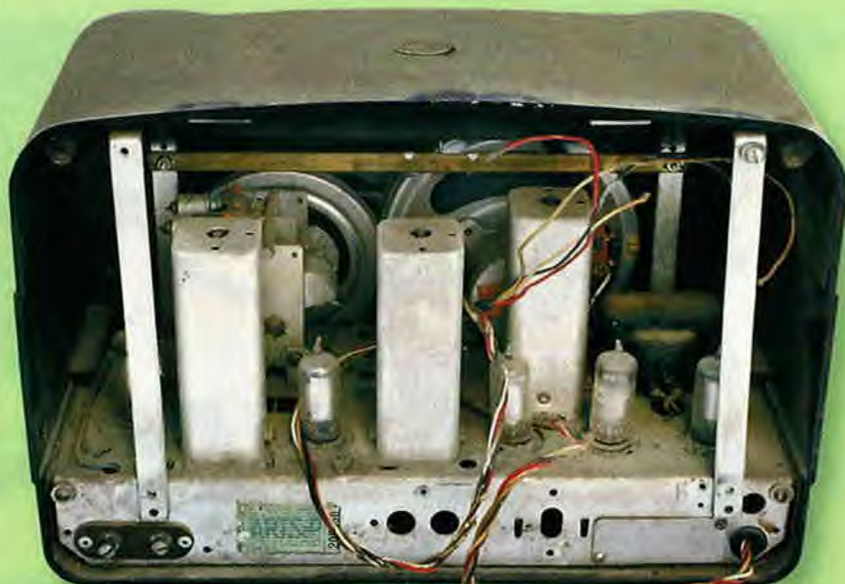
Despite its rather grubby condition, this set was relatively easy to restore as all the original parts were still in place. The chassis was cleaned by first dusting it with a paintbrush and then using a kerosene-soaked rag and a kitchen scourer.

The first thing I noticed was that the roll-over frame had four screws missing along the rear of the chassis. This problem was immediately fixed using some small self-tapping screws, after which the chassis was dusted using a paintbrush to remove any loose dirt. It was then rubbed down using kerosene and a kitchen scourer and a most of the muck came straight off.

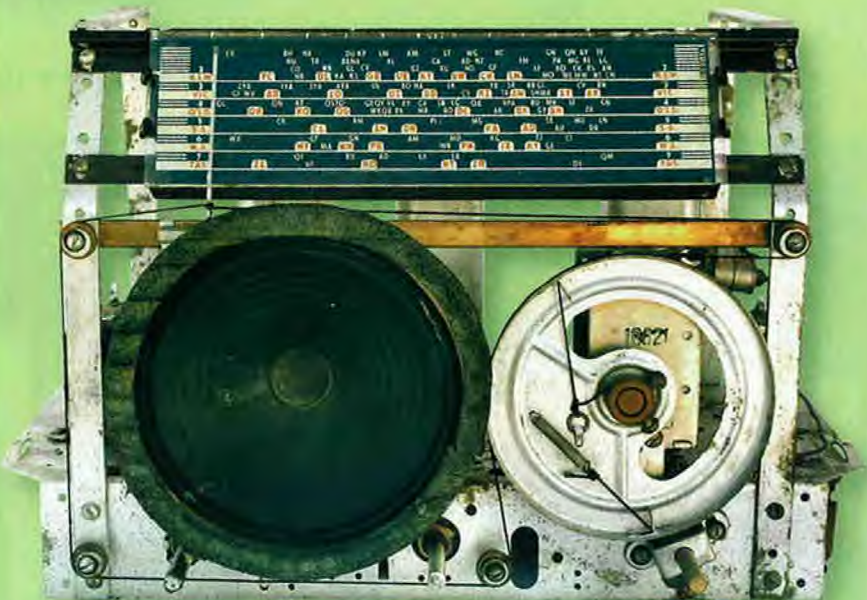
This view shows the front of the chassis after restoration. The dial-drum is driven by a rubber tyre assembly.

Having removed the grime, I oiled all the pulleys and bearings on the dial drive system, along with the various control shafts. That done, the dial-drive pointer guide was cleaned with a kerosene dipped rag and then oiled sparingly.

The mechanics of the receiver were now working as they should, with one exception: the dial drive was a little “lumpy” in its action due to a flat spot on the drive rubber. It wasn’t bad enough to worry about, however.

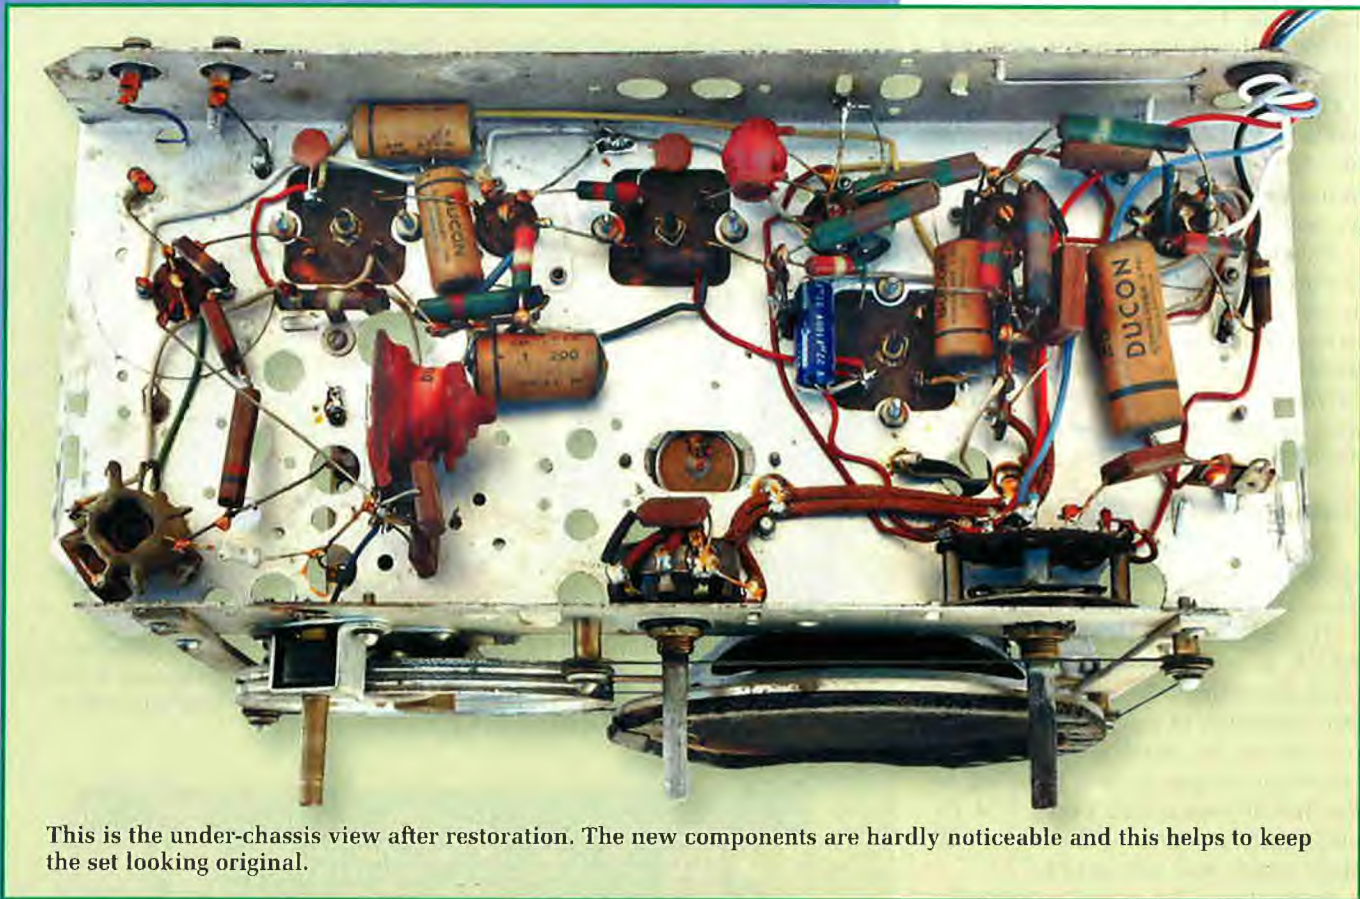
This is the under-chassis view after restoration. The new components are hardly noticeable and this helps to keep the set looking original.

However, once the set was working, I decided to take a closer look. Normally, I would replace audio coupler C24 and the two AGC bypass capacitors (C3 & C11). In this set, however, the audio coupler is a mica capacitor and had minimal leakage, so it wasn't worth replacing. And if the two AGC bypasses have high leakage, it won't harm the set – it just won't work as well and will probably overload on strong signals.

I checked the voltage on the grid of the 3V4 with a digital multimeter and it was normal. I then tuned the set to a strong station and measured -5V at the detector and only -2.5V on the AGC line. As a result, I replaced the two AGC bypasses and the voltage on the detector dropped to -3.5V (the voltage across the two AGC bypasses was also -3.5V). The AGC system was now working as it should and the audio output level was nearly the same on both strong and weak stations.

Next, I checked the paper capacitors on the HT line and replaced any that had excessive leakage (as measured on my high-voltage insulation tester). I also checked the HT filter electrolytic capacitor (C22) and found that it had dropped to just 1µF. This was replaced with a 22µF 160V electrolytic, as I didn't have the correct value (8µF).

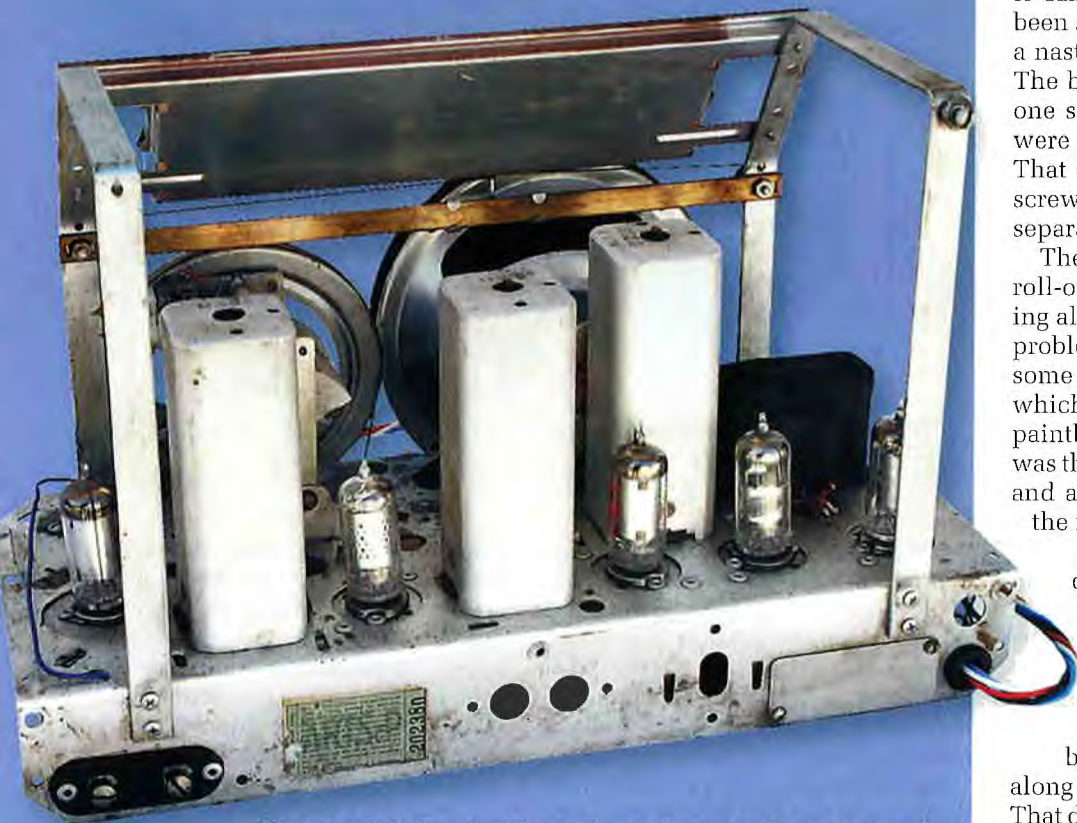
The chassis is fitted with a roll-over frame and can be tipped into any position for servicing without damaging other parts.

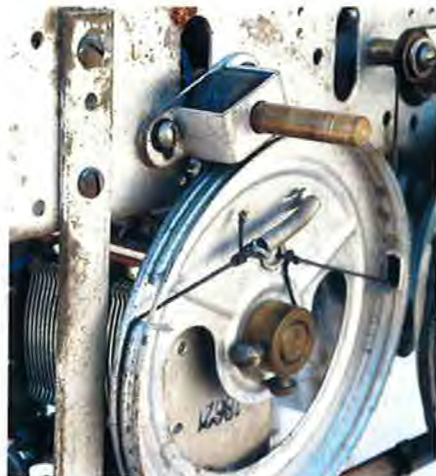
This close-up view shows the rubber tyre dial-drive system used on the B11A receiver.

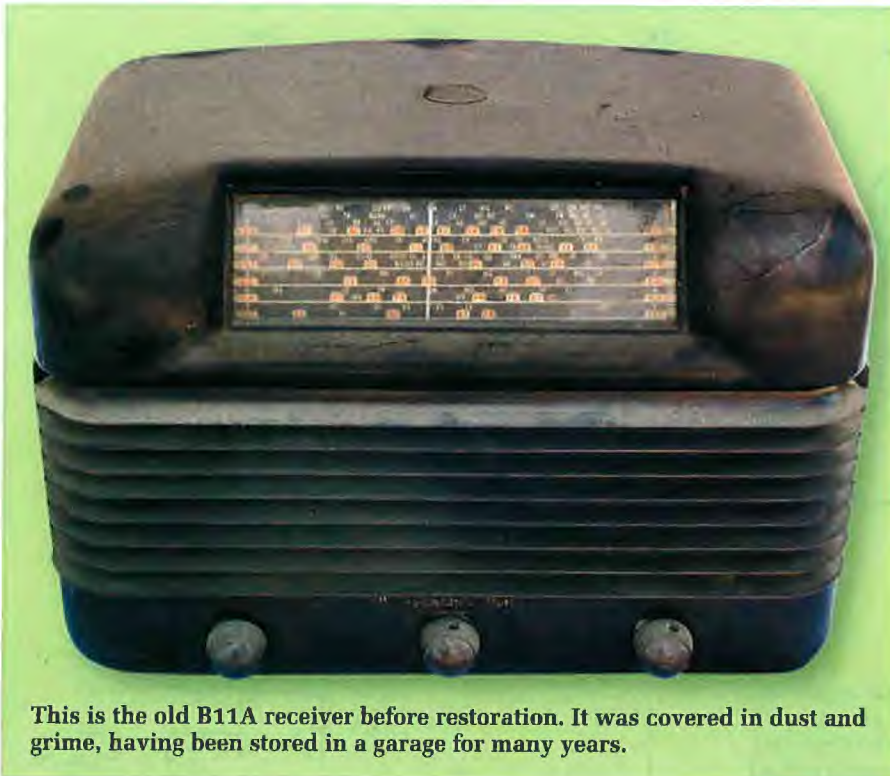
This is the old B11A receiver before restoration. It was covered in dust and grime, having been stored in a garage for many years.

Next, the speaker grill was removed (it’s attached to the main part of the cabinet by four speed nuts), after which the cabinet (which splits into two halves) and knobs were given a good scrub in soapy water. Once dry, these parts were then polished using automotive cut and polish and this brought the cabinet up to as-new appearance.
