# Vintage Radio

## The Admiral 5BW mantel receiver

**Domestic valve radios with PC boards were relatively uncommon, with most manufacturers sticking to point-to-point wiring until the end of the valve era. One exception to this rule was the Admiral 5BW mantel receiver.**

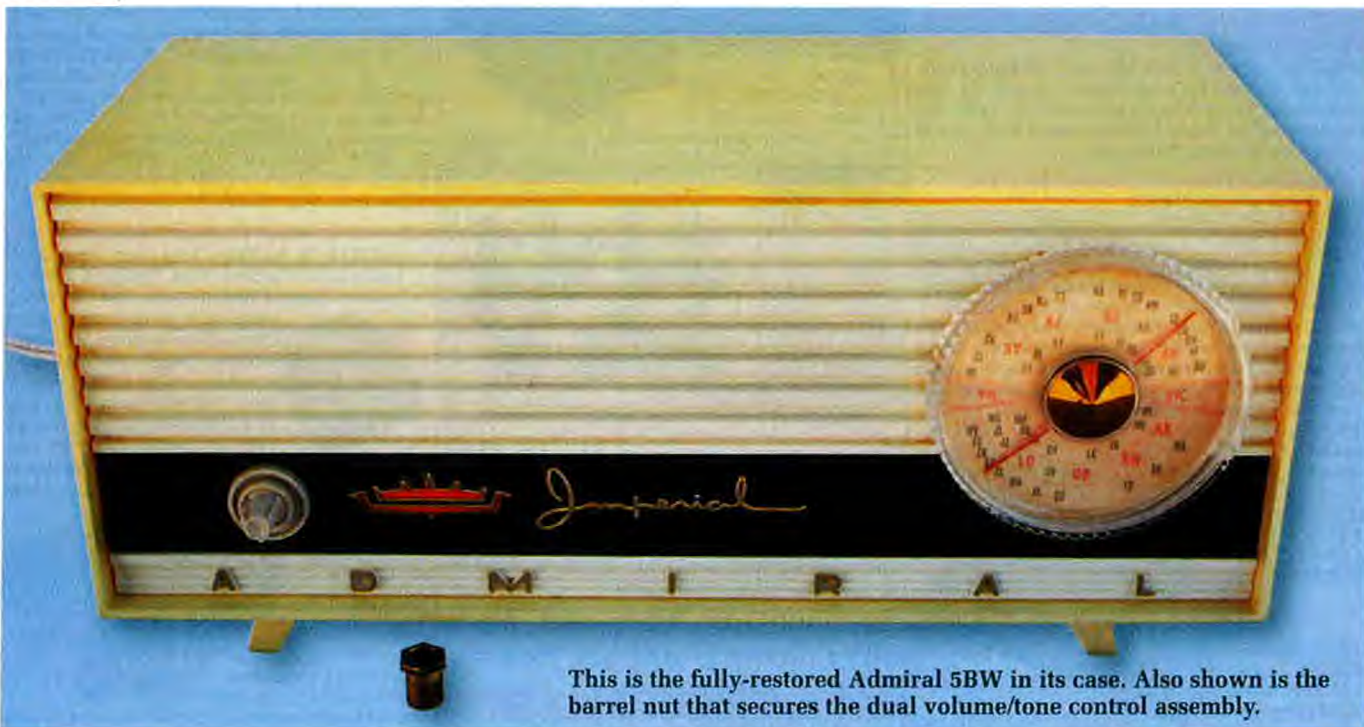
This is the fully-restored Admiral 5BW in its case. Also shown is the barrel nut that secures the dual volume/tone control assembly.

That done, the four screws used to secure the back of the cabinet were removed. There were no other screws holding the set in the cabinet but it was still fastened by the volume and tone controls. Closer inspection revealed that these controls are attached to the front panel by a barrel nut over the control shafts. Removing this then allowed the chassis to slide out of the cabinet as far as the speaker leads would allow.

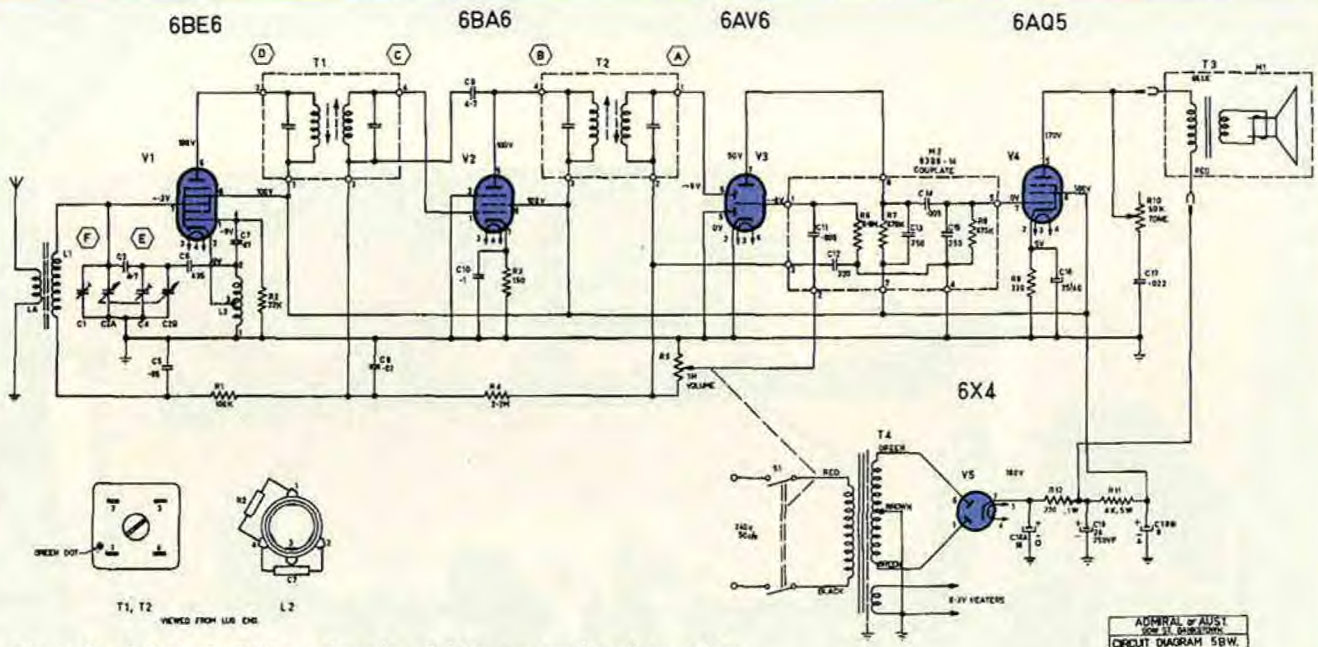
Fig.1: the Admiral 5BW receiver is a fairly conventional superhet receiver with five valves and a loopstick antenna.

Although the circuit is conventional, it has a few features that were not commonly used in Australian-designed receivers. For example, the input tuned circuit consists of a 200mm-long x 9mm-diameter ferrite rod with a coupling coil and lead so that an external antenna can be connected to the set. There is no earth lead as such – instead, the set relies on the capacitance between the primary winding of the power transformer and the other windings and the chassis to provide a defacto earth via the mains.

The converter stage uses a 6BE6 and is quite conventional, although it has little standing bias and relies on the fact that the high tension (HT) voltage is relatively low. In addition, the set will normally be tuned to a station and hence AGC voltage will be applied.

The 455kHz IF is amplified by a neutralised 6BA6 amplifier and this has cathode bias applied to it in addition to AGC voltage. The neutralising

capacitor is C9 (4.7pF ceramic) which is in a bridge circuit. Another arm of the neutralising circuit is C8 which is the AGC bypass capacitor.

The next valve in the line-up is a 6AV6 which serves a multiple role as the diode detector, AGC amplifier and first audio amplifier. The grid has contact potential bias applied to it and the coupling between the plate of the 6AV6 and the following 6AQ5 output valve is conventional.

The audio output stage uses a 6AQ5 with cathode bias. The speaker transformer is mounted on the loudspeaker frame, which in turn is mounted on the front of the cabinet. This assembly is connected via a flying lead and a 4-pin plug into a socket on the chassis.

Note that although the circuit shows only two leads from the transformer, there are in fact four wires in total because of negative feedback from the voice coil. As shown in Fig.1, the cathode of the 6AQ5 is connected via the voice coil to earth and the valve is supplied with back bias.

The tone control circuit in the plate circuit of the 6AQ5 is poorly thought out in my opinion. The potentiometer is "live" at 200V DC (not the 170V shown on the circuit diagram) which places some strain on its insulation and is also a trap for unwary fingers. If the position of the capacitor and the potentiometer had been transposed in the circuit, there would be no DC voltage on the potentiometer and the whole set-up would have been safer.

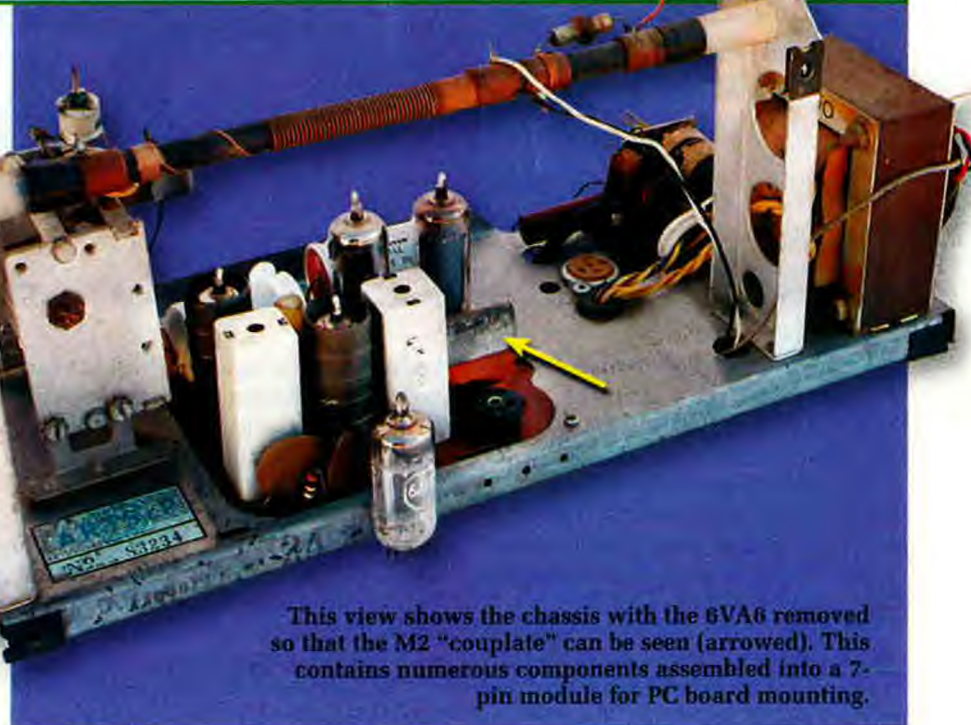
This view shows the chassis with the 6VA6 removed so that the M2 "couplate" can be seen (arrowed). This contains numerous components assembled into a 7-pin module for PC board mounting.

However, although the 6AV6 circuit is conventional, the way in which it is made is not. Instead of point-to-point wiring, all the parts (including three resistors and five capacitors) are assembled into a 7-pin module that's suitable for PC-board mounting.

The downside to this is that some faults require that the entire module

be removed for repairs. This isn't easy because of the limited room adjacent to it on the chassis. This is highlighted by the arrow pointing to the M2 "Couplate" in one of the photographs.

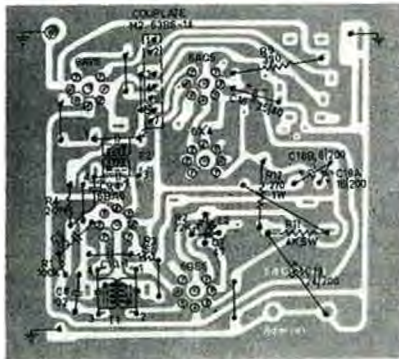
To simplify circuit tracing as well as locating and identifying individual circuit components, refer to figure 2.

Figure 2 refers to the foil side of the board and its schematic symbols illustrate what appears in approximately the same position on the reverse side of the board. Use figure 2 together with the schematic for circuit tracing as well as voltage and/or resistance measurements.

Fig. 2. View of WIRING SIDE of Printed Wiring Board APC27. White area represents printed wiring. Black symbols and lines represent components and connections on opposite side.

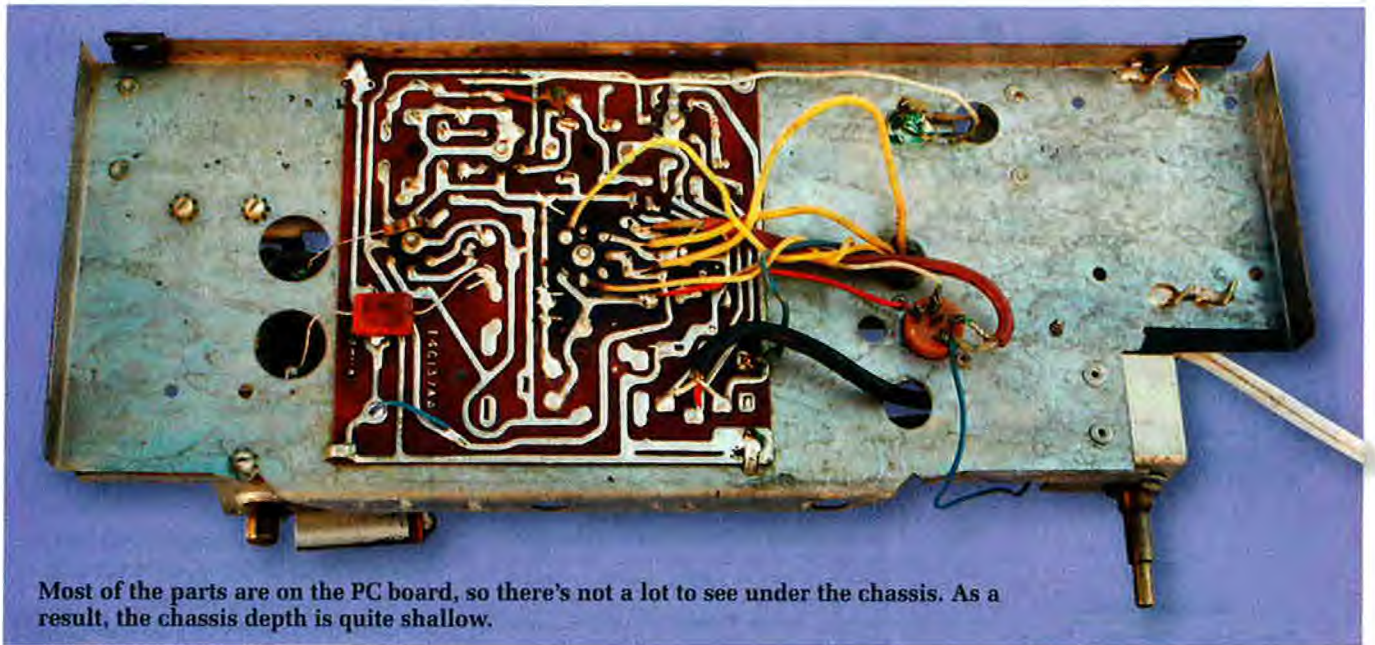
As shown in the photos, the chassis is very sparsely populated except on the PC board. Certainly, if the manufacturer had wanted to, the set could have been made much smaller.

Most of the parts are on the PC board, so there's not a lot to see under the chassis. As a result, the chassis depth is quite shallow.

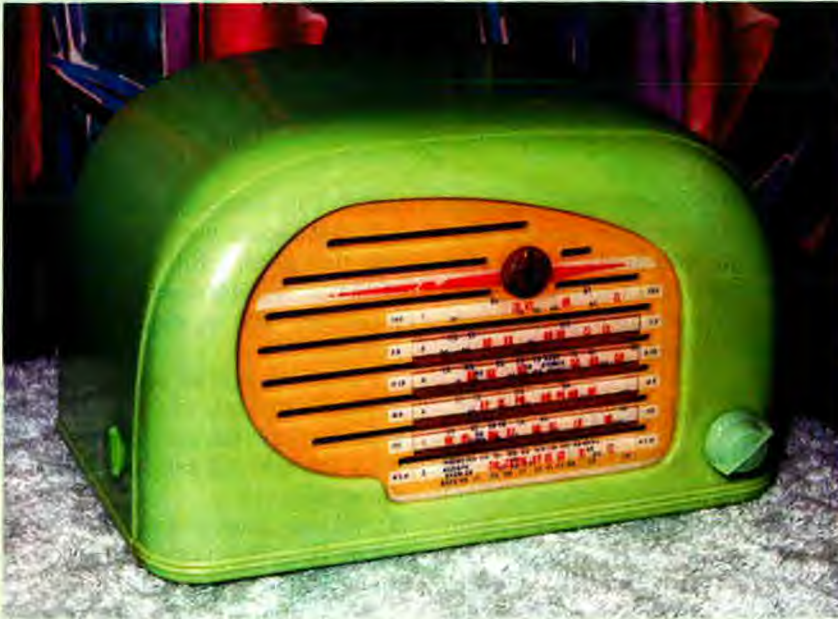
## Photo Gallery: Peter Pan BKM 4-Valve Radio

**MANUFACTURED IN 1948** by Eclipse Radio, South Melbourne, the Peter Pan BKM was a 4-valve reflex superheterodyne housed in a rounded bakelite cabinet that was very modern for the era. This example is housed in the less common green cabinet.

The valve line-up was as follows: 6A8-G frequency changer; 6B8-G reflexed IF amplifier/1st audio amplifier/detector/AVC rectifier; 6V6-GT audio output; and 5Y3-GT rectifier. Photo: Historical Radio Society of Australia, Inc.
