Vintage Radio

Radio Corporation's WS108 Transceiver

The “portable” radio equipment used by the military at the start of World War 2 was bulky, heavy and inefficient by today's standards. Here we take a look at Radio Corporation's WS108 transceiver, as used by the Australian army.

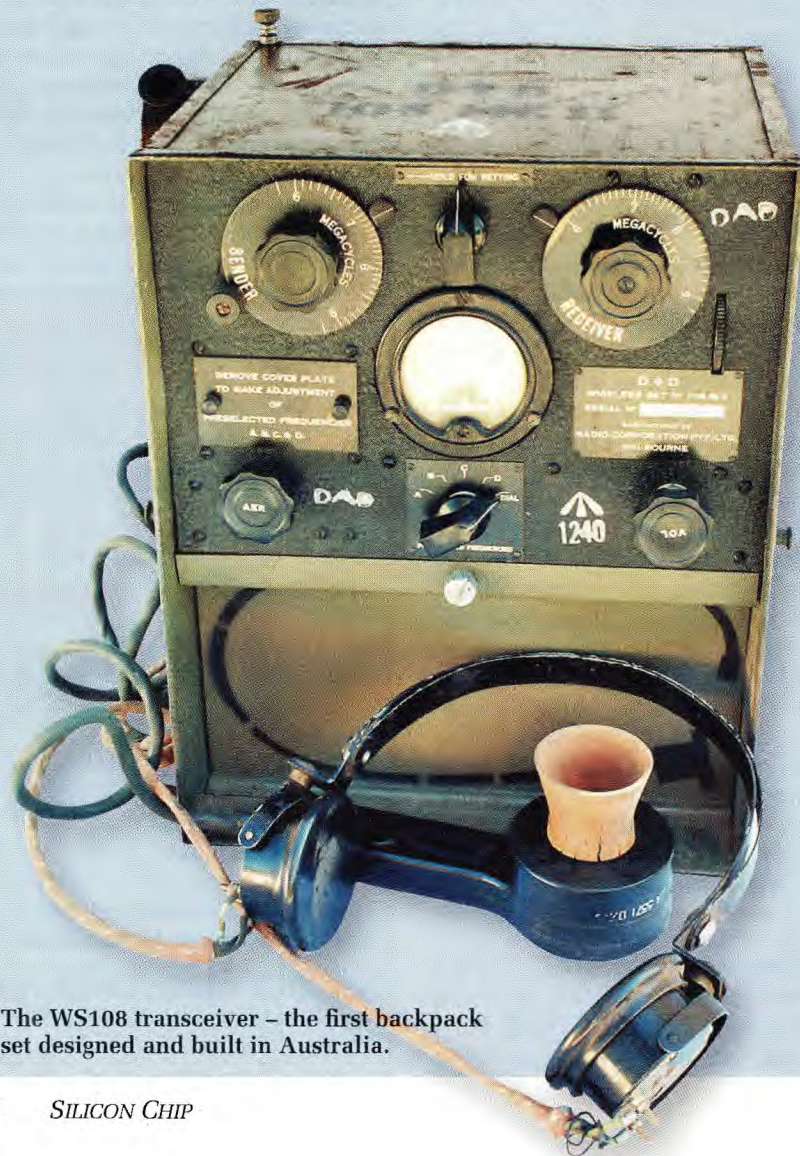
The WS108 transceiver – the first backpack set designed and built in Australia.

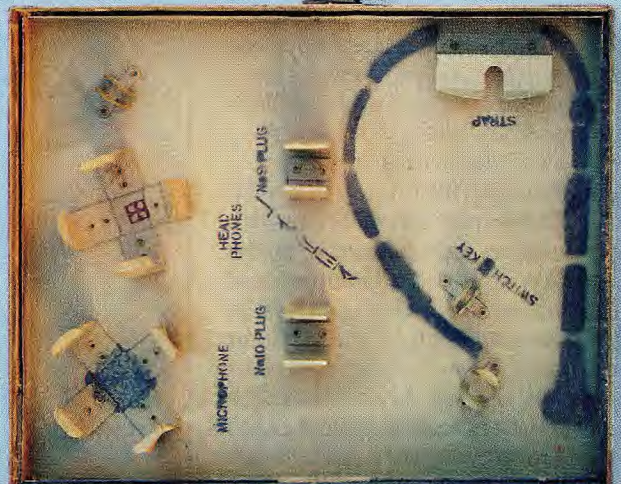
All accessories, including the headphones, microphone, a 3-position remote switch control and a small telescopic antenna are stored in the lid of the case (the black and white photo at left is from the manual). Most of these items are missing from the author's set.

Unfortunately, I have only a few of the bits and pieces that make up the complete station. For example, I don't have the antenna or the control cables and had to "make do" with a microphone and set of headphones from another military set.

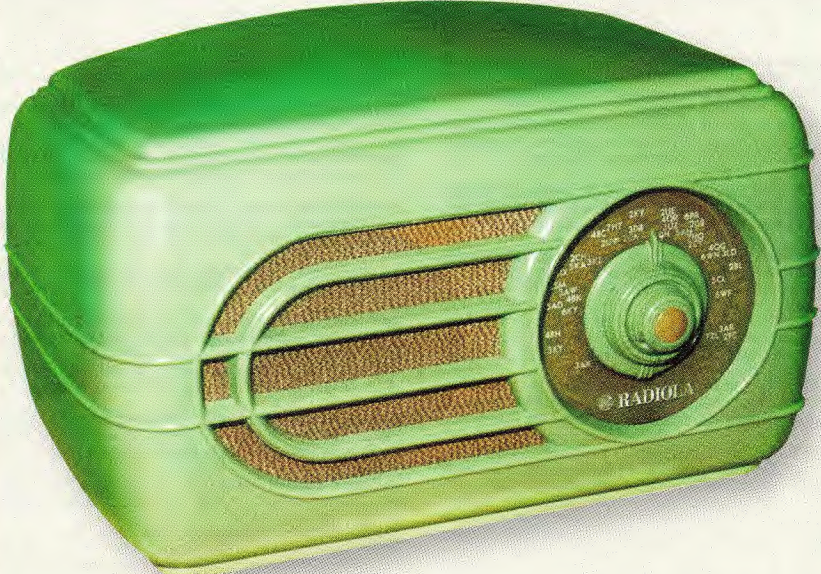
Photo Gallery: AWA Model 517M (1948)

MANUFACTURED BY AWA in 1948, the 517M was a very popular 4-valve mantel receiver housed in a bakelite cabinet. It featured concentric volume control and tuning knobs in the middle of a circular dial and was produced in several colours. The green cabinet shown here is now hard to find.

The valve line-up was as follows: 6A8-G frequency changer; 6G8-G reflexed IF amplifier/1st audio amplifier/detector/AVC rectifier; 6V6-GT audio output; and 5Y3-GT rectifier. Photo: Historical Radio Society of Australia, Inc.
