Vintage Radio

DC-to-AC Inverters From The Valve Era

There have always been odd little offshoots from the mainstream technology of radio and DC-to-AC inverters are one such offshoot. This month, we'll take a look at two of those early inverter circuits and describe their restoration.

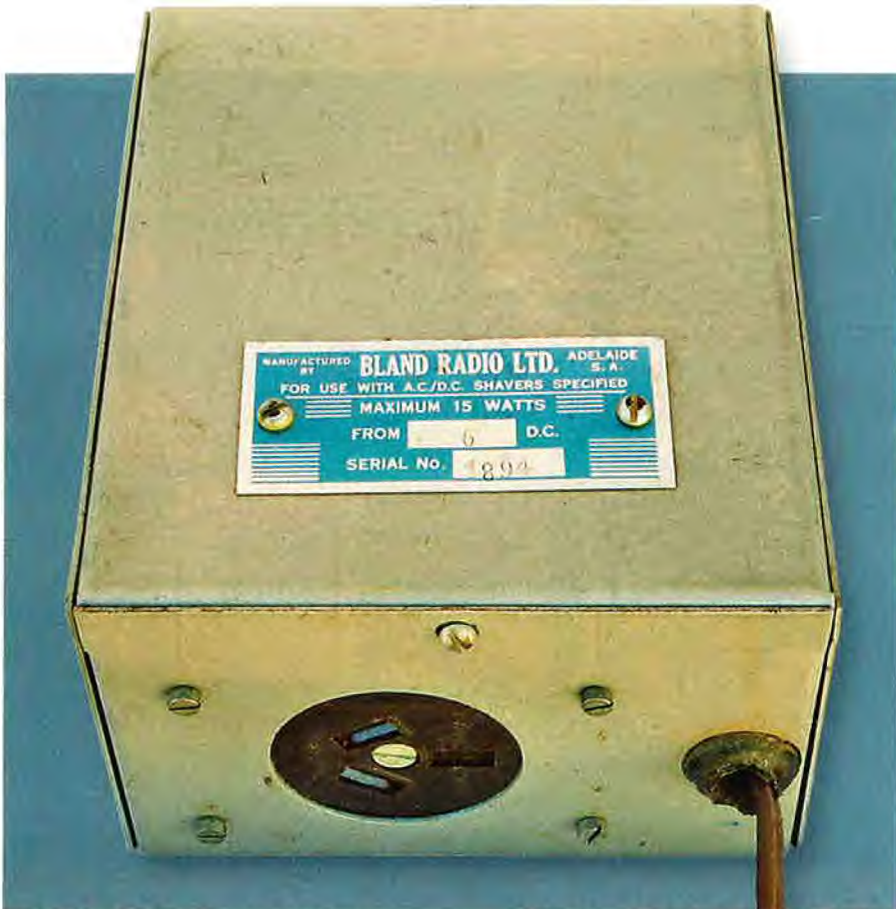
This simple 6V DC to 24VAC inverter was made by Bland Radio Ltd of Adelaide and was designed to power electric shavers.

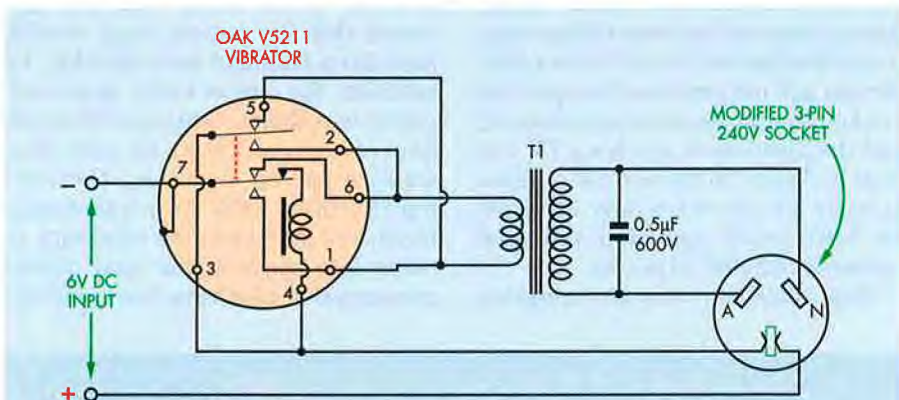
Fig.1: the Bland Radio inverter circuit. Its mains socket used a 2-piece earth terminal which functioned as a switch for the 6V DC input (a scheme that would now be illegal). This meant that the mains plug fitted to the appliance had to have an earth pin in order for the inverter to work.

Basically, the earth pin on the appliance's 240V plug is used as the switch to turn the device on – see Fig.1. As shown, the earth terminal on the inverter's 240V socket was modified so that it had two separate sections. Plugging in the appliance connected these two sections (via the earth pin on the plug), thus allowing the inverter to operate from the 6V supply.

In practice, this means that the inverter will not operate until a 3-pin plug is inserted. It then turns off automatically when you remove the plug. It's quite a neat scheme but I wonder how many men complained that the unit didn't work, not knowing that their shaver needed to have a 3-pin plug and not a 2-pin plug!

primary winding is used but the current through the winding is reversed at the end of each half cycle.

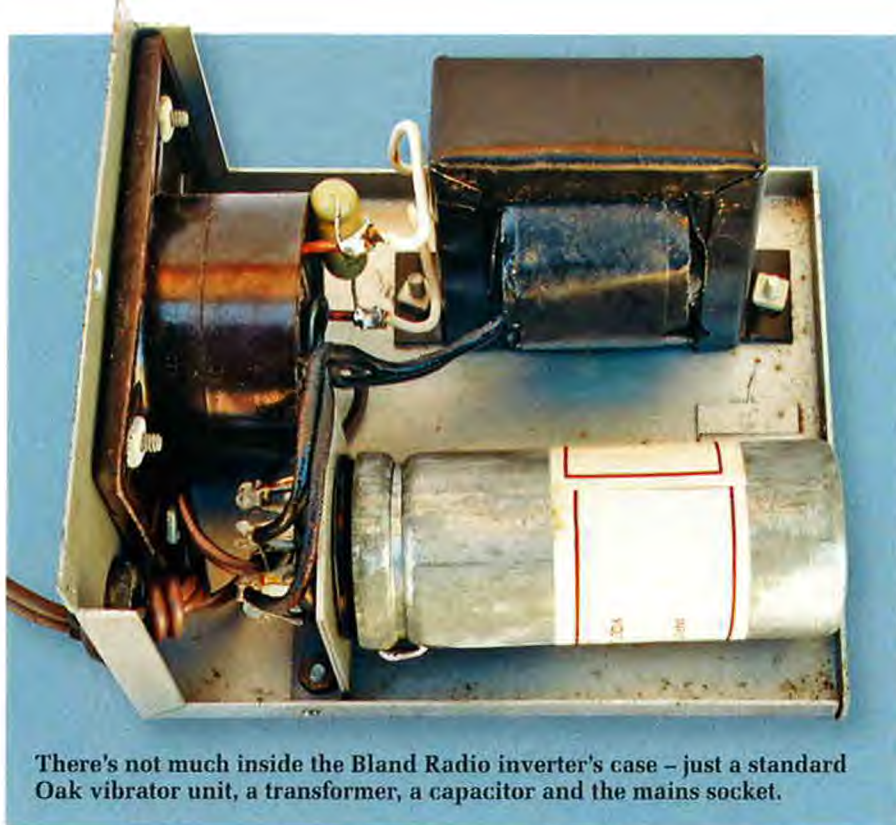
There's not much inside the Bland Radio inverter's case – just a standard Oak vibrator unit, a transformer, a capacitor and the mains socket.

My unit was obtained when a friend decided to reduce his radio collection. When I subsequently pulled the cover off the unit to see what was inside I found an Oak V5211 vibrator, an iron-cored transformer and a 0.5 μ F 600V buffer capacitor. These buffer capacitors can be unreliable so I immediately replaced it with a new polyester type with a slightly higher voltage rating than the original unit.

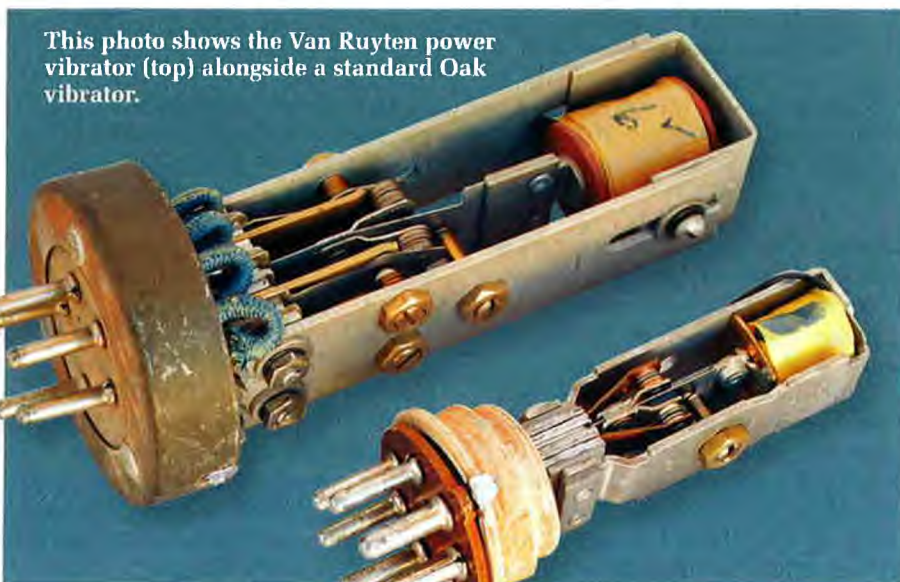
This photo shows the Van Ruyten power vibrator (top) alongside a standard Oak vibrator.

I don't have any spare 32V vibrators so I dismantled the unit that was in the inverter. This was done by desoldering the two solder joints between the base and the can and then sliding the vibrator out.

A close inspection of the points showed that one pair out of the five sets had a “dag” on one contact which mated with a hole in the other point. This was fixed by releasing the adjustment screw and filing the dag away. I then cleaned all the points with fine wet and dry paper.

That done, I re-installed the adjustment screw and rotated it until I had the same gap as the other parallel set of points. A feeler gauge was then used to make the adjustment as accurate as possible. I then connected the vibrator to a 12V supply to check that the reed drive worked properly.

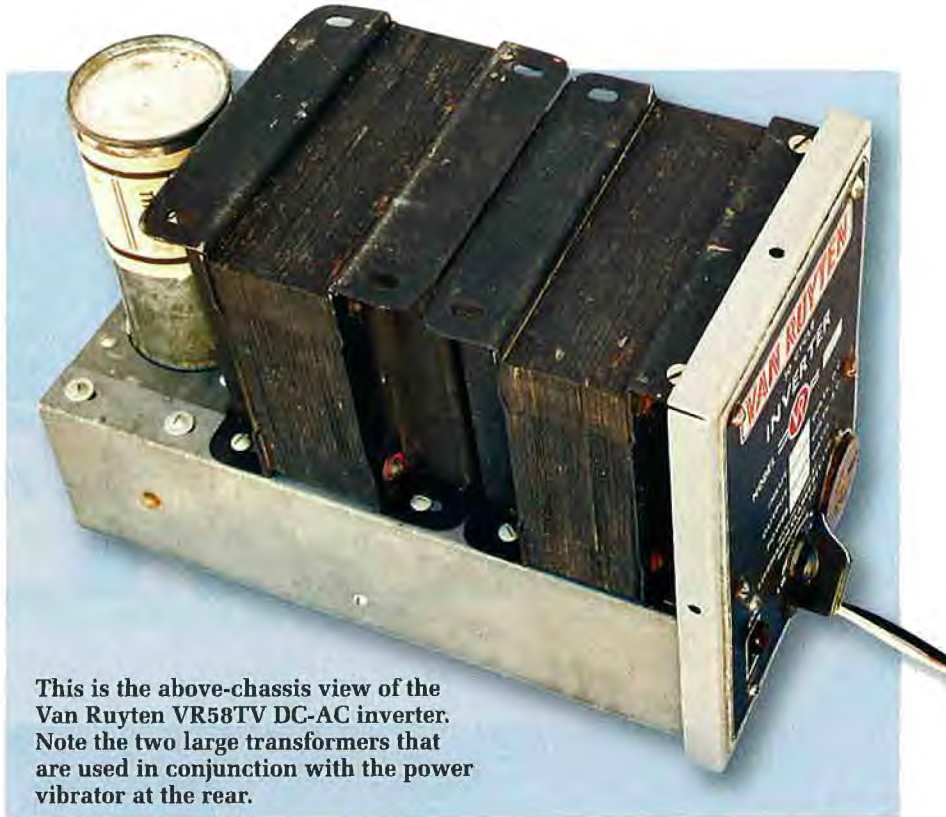
This is the above-chassis view of the Van Ruyten VR58TV DC-AC inverter. Note the two large transformers that are used in conjunction with the power vibrator at the rear.

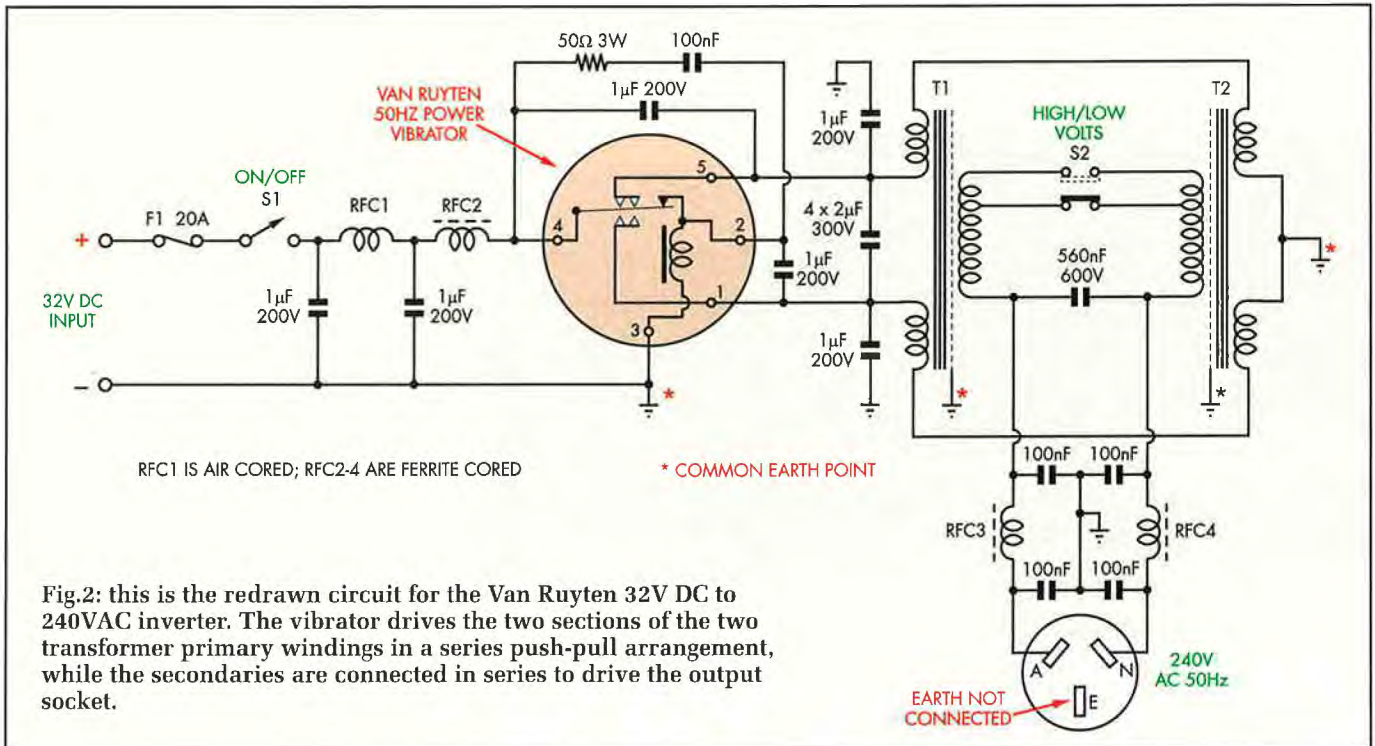
Fig.2: this is the redrawn circuit for the Van Ruyten 32V DC to 240VAC inverter. The vibrator drives the two sections of the two transformer primary windings in a series push-pull arrangement, while the secondaries are connected in series to drive the output socket.

The vibrators in these inverters often had a hard life due to the uncertainty of whether the load would be inductive or capacitive. C5-C8 and C11 are the buffer capacitors which “tune” the inductances so that the circuit resonates to around 50Hz.

The answer is that the actual voltage across them is in fact considerably higher than the supply voltage, as the circuit is roughly resonant at 50Hz. As a result, considerable voltage is developed across the total inductance of the primary windings as they are completely charged and discharged 100 times a second.

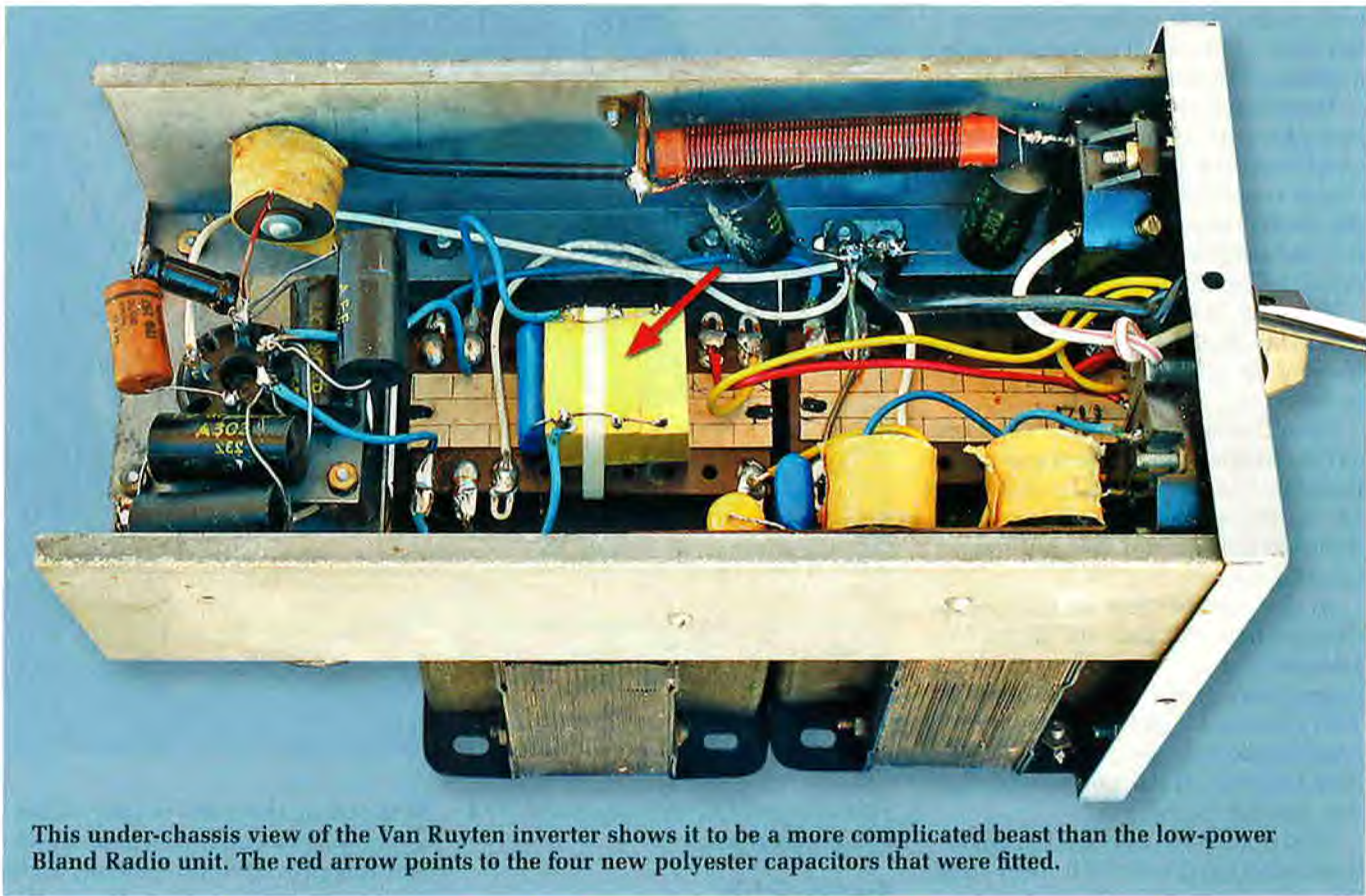
This under-chassis view of the Van Ruyten inverter shows it to be a more complicated beast than the low-power Bland Radio unit. The red arrow points to the four new polyester capacitors that were fitted.

Unfortunately, it didn't stay that way for long – the next time I came back, there were tiny bits of silver paper and other tiny bits of powdery material like confetti near the inverter. The inverter was still running quite happily so I turned it off to investigate. When I looked under the chassis, I was greeted by two capacitors that had blown their insides out.

The two capacitors involved were among the primary circuit buffers (C5-C8). They had overheated so badly that foil had been blown out of them. The inverter had kept going despite this catastrophic failure and none of the foil shorted anything out.

It was easily fixed – the “confetti” was cleaned out and the four capacitors (which were still quite hot) removed from the chassis. These original paper capacitors were then replaced with a batch of four polyester type capacitors.

As shown in one of the photos, the replacement capacitors were glued together with contact adhesive and then tied to the tag strip on the bottom of one of the transformers using a plastic cable tie.

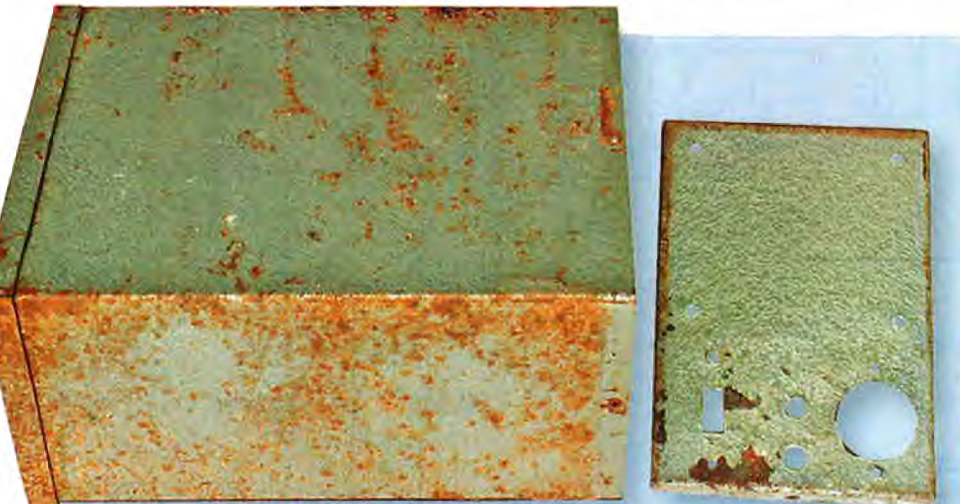
When I obtained the inverter, it looked pretty shabby, with rust showing through the paint work, the voltage adjustment knob missing and the front panel hanging loose. Unfortunately, I didn't have any knobs that exactly matched the type used so I used one that suited the era.

This is the Van Ruyten inverter's case before restoration. The rust was removed using a drill fitted with a wire brush, after which the unit was repainted so that it now looks almost like new.

Once they had dried, I set about removing the rust and old paint from these items using an angle grinder. The two parts were then sprayed with grey hammertone paint and the unit now looks almost like new. It's certainly vastly better than the rusty unit it was before restoration.

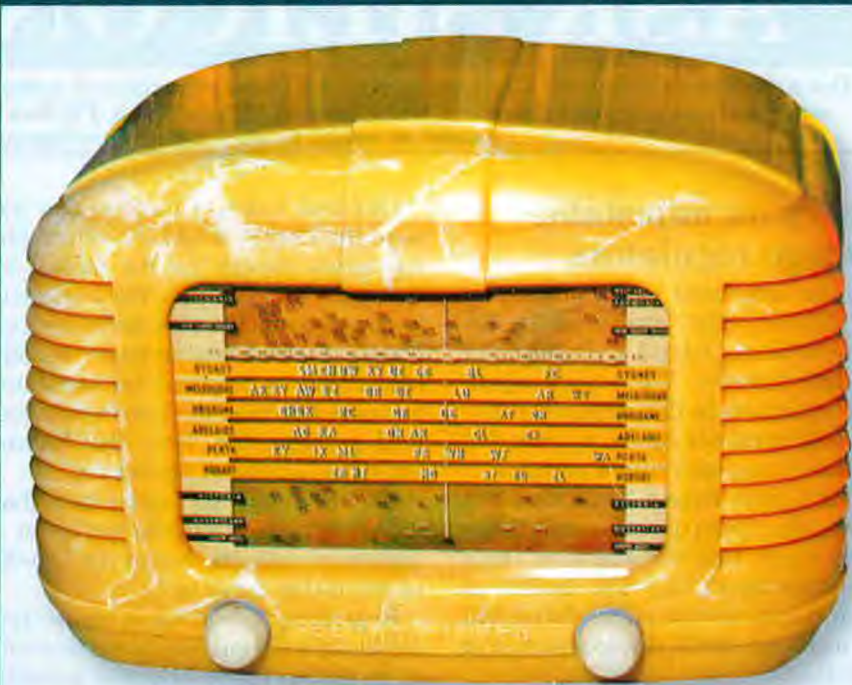
Photo Gallery: Astor Mickey Model DL

MANUFACTURED BY RADIO CORPORATION, MELBOURNE in 1947, the “DL” was another model carrying the “Mickey” name. It was fitted with a full-width (almost) glass dial, with the loudspeaker mounted at the side of the cabinet. This set did not employ the reflex circuit that was later to become popular with “Mickey” models until the end of the series. Brown and cream were probably the most common cabinet colours and this mottled yellow example is unusual.

The valve line-up was as follows: 6A8-G frequency changer, 6B8-G reflexed IF amplifier/1st audio amplifier/detector/AVC rectifier, 6V6-GT audio output and 5Y3-GT rectifier. Photo: Historical Radio Society of Australia, Inc.
