# Vintage Radio

## Kriesler 11-59 5-Valve Dual-Wave Mantel Receiver

**Like many manufacturers, Kriesler built numerous 5-valve, dual-wave receivers with quite good performance. The 11-59 receiver was aimed at the low-priced end of the market but its performance was still quite acceptable, with good reception on the shortwave stations.**

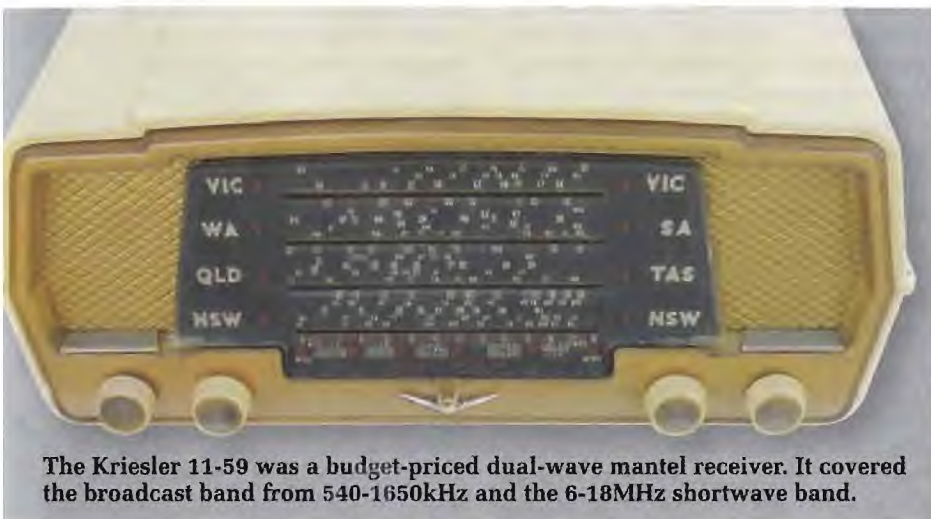
The Kriesler 11-59 was a budget-priced dual-wave mantel receiver. It covered the broadcast band from 540-1650kHz and the 6-18MHz shortwave band.

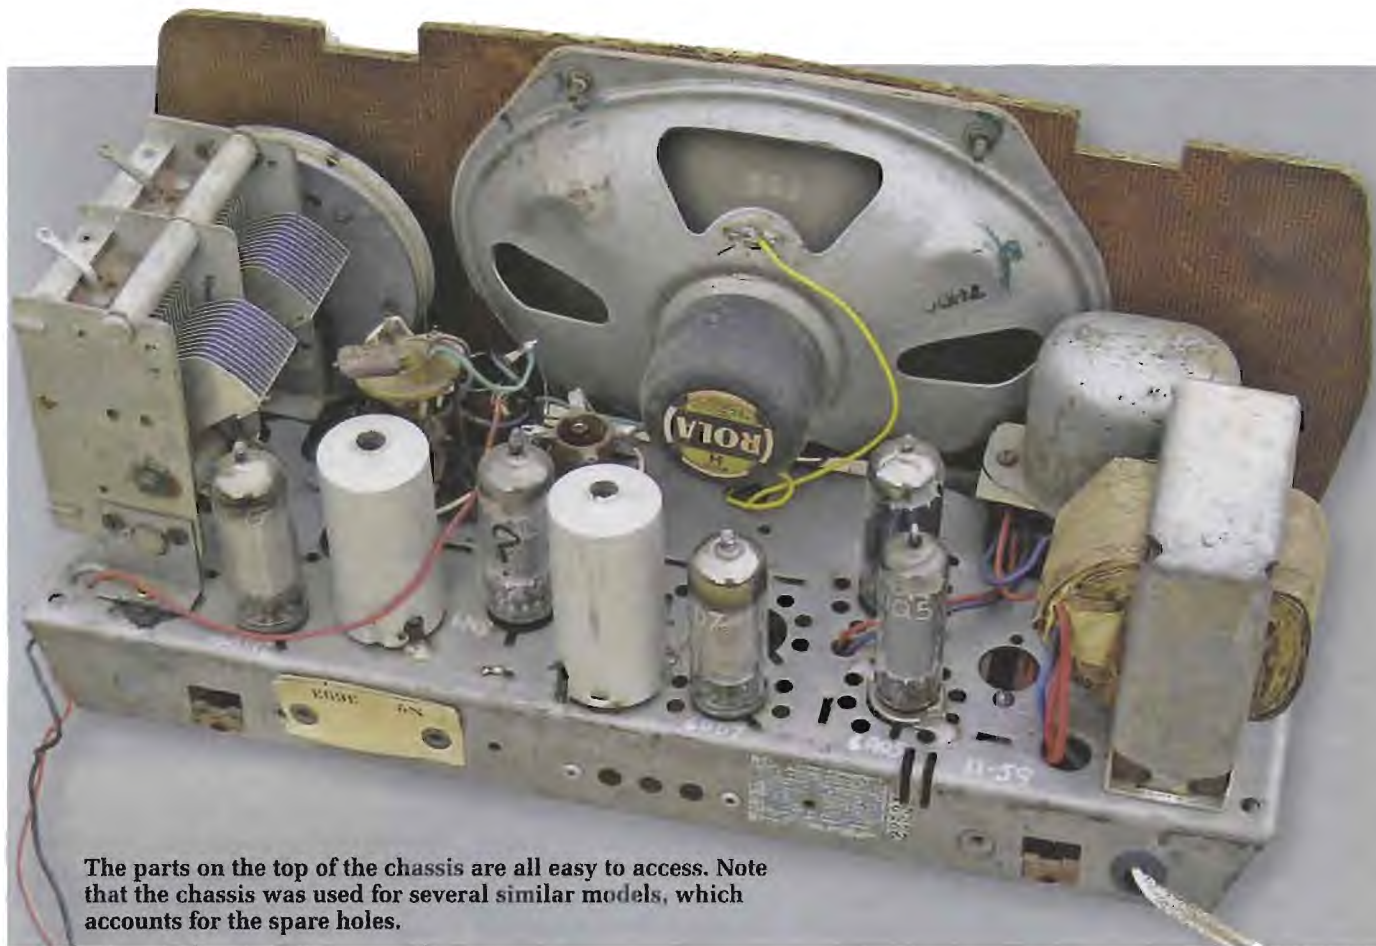
The parts on the top of the chassis are all easy to access. Note that the chassis was used for several similar models, which accounts for the spare holes.

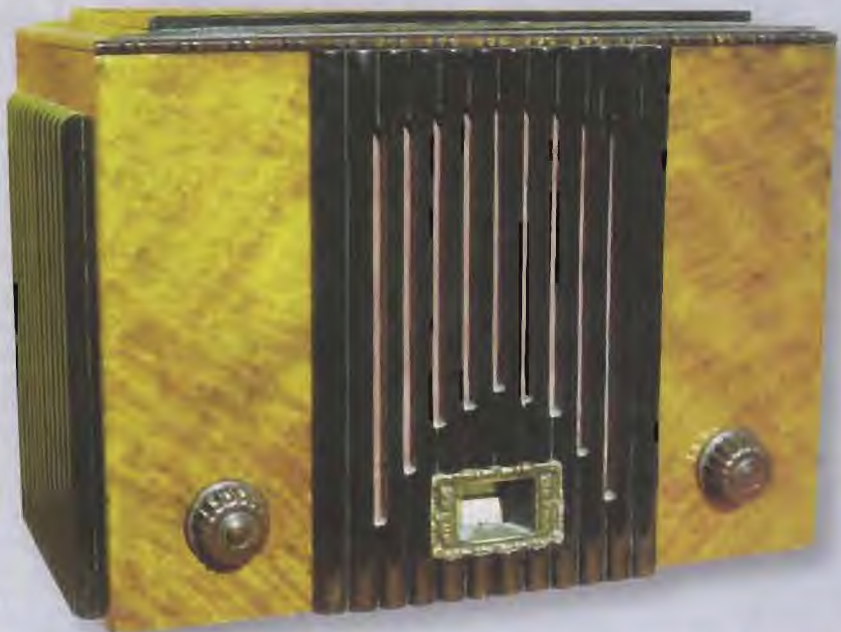
## Photo Gallery: 1934 Emmco "Little Jewel"

PRODUCED BY THE ELECTRICITY METER MANUFACTURING CO., Waterloo, NSW, the "Little Jewel" was another example of a small wooden mantel set in a style that was popular at the time. The set is a 5-valve autodyne superhet and was manufactured in 1934.

The valve line-up was as follows: 57 autodyne mixer; 58 IF amplifier; 57 anode bend detector; 2A5 audio output and 80 rectifier. Photo: Historical Radio Society of Australia, Inc.
