Vintage Radio

More DC-to-AC Inverters From The Valve Era

DC-to-AC inverters were essential in many rural areas for powering mains equipment from 32V DC lighting plants. Here we take a look at the AWA VB-32 transistorised inverter and the Ferris vibrator inverter, the latter often used to power car radios.

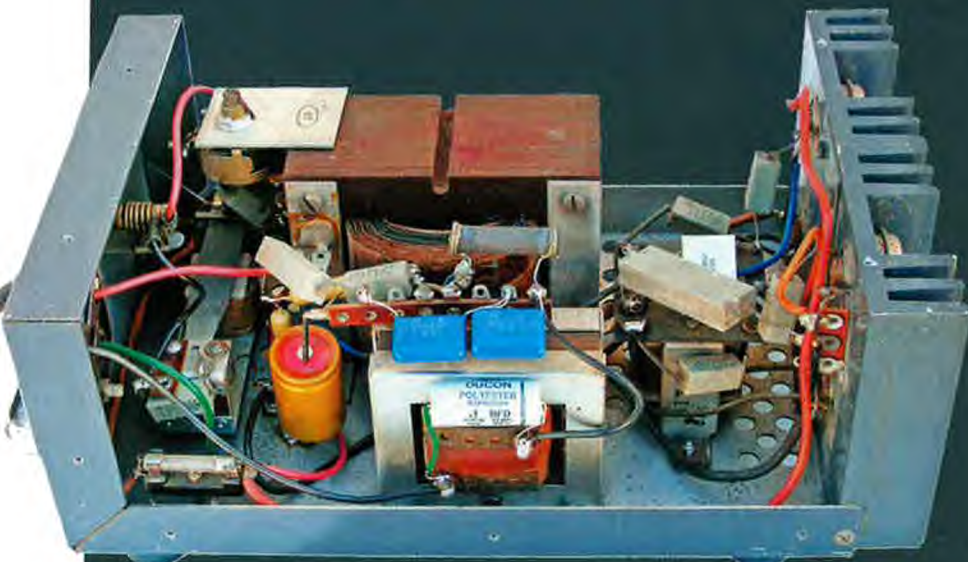
These two views show the internal construction of the AWA VB-32 inverter (photos taken after restoration). The germanium power transistors were mounted on the finned heatsink.

Two iron-cored transformers and a choke are the most noticeable components, along with several wirewound resistors and capacitors (including some paper types). No horrible smells greeted me and nothing looked the worse for wear. The plastic insulation around the two electrolytic capacitors had shrunk but they subsequently proved to be in good working order.

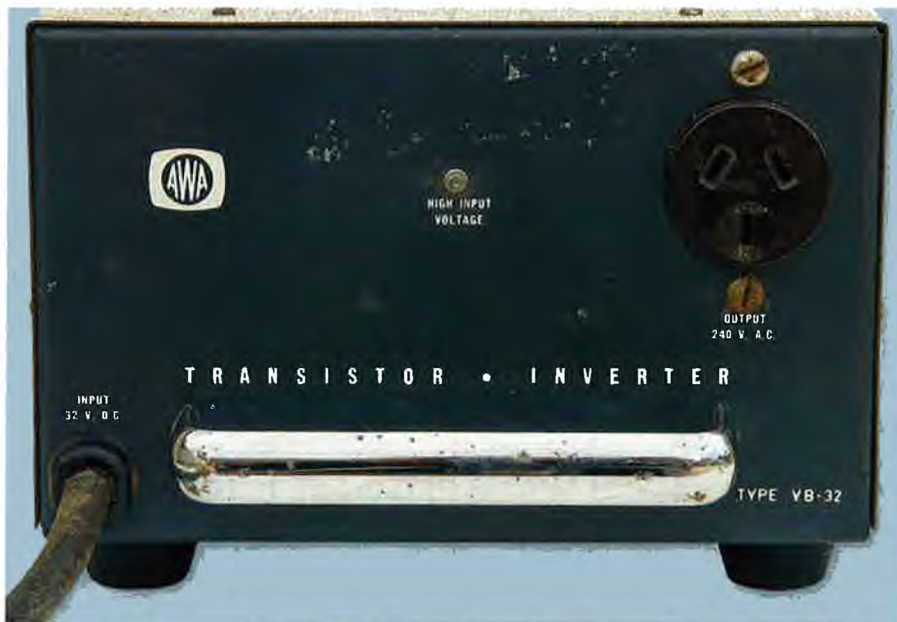
This is the AWA VB-32 inverter following restoration. It produced nominally 60-65Hz 240V AC at up to 180W from a supply of 32V DC.

Having fixed the relay, I then dusted out the cabinet with a small paintbrush, after which I cleaned all the surfaces using household kerosene on a rag. This works well and leaves the metalwork with a slightly bright appearance, although there are a few obvious "wear and tear" marks in various places.

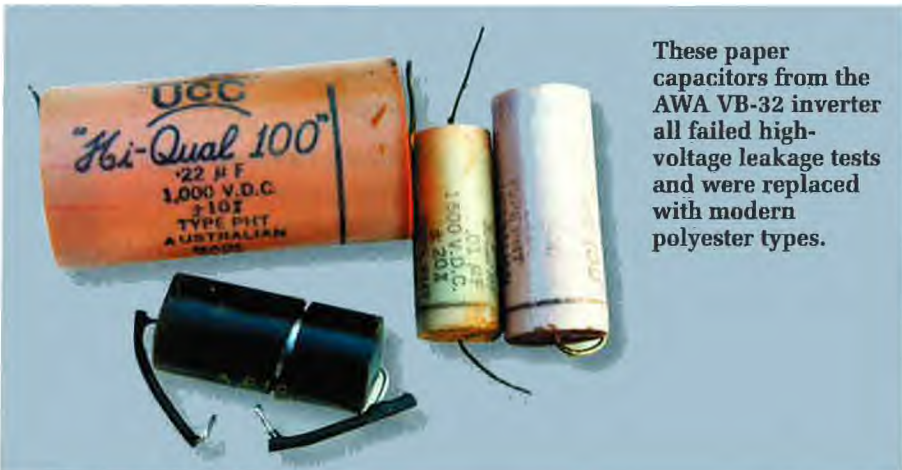
Anyway, I tested them all on my high-voltage leakage meter and none of them passed the test. It’s interesting to note that one of these capacitors was rated at 1600V and another at 1000V. I would have thought that these two at least wouldn’t have had much leakage but they did.

These paper capacitors from the AWA VB-32 inverter all failed high-voltage leakage tests and were replaced with modern polyester types.

In the end, the low-voltage units were replaced with polyester types with the same ratings. However, I couldn’t do this with the two high-voltage types, so I used two capacitors

in series in each case (both double the original value) to obtain the required voltage rating.

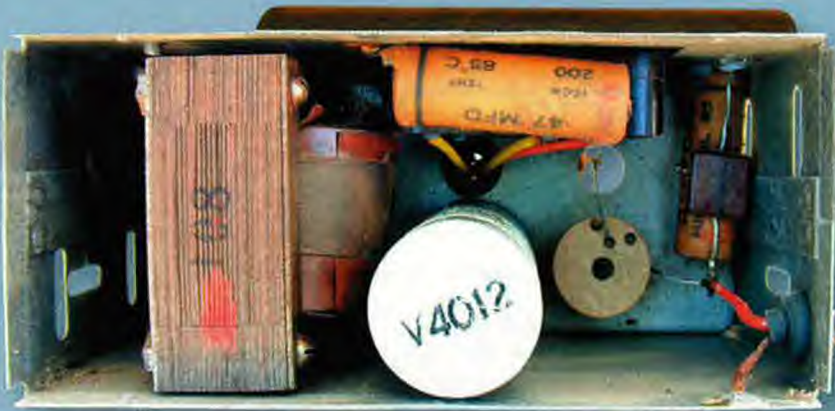
This is the view inside the Ferris inverter, from the top. The vibrator unit is located at bottom centre, immediately to the right of the transformer.

Because the resistors were faulty, it was also quite possible that the vibrator itself had been damaged. To check this, I dismantled the vibrator and this revealed that there had been severe sparking at the points.

were OK but were not making electrical contact where they were attached to the vibrating assembly. In the end, I gave up trying to get the original vibrator to work and substituted a new one from my parts collection.

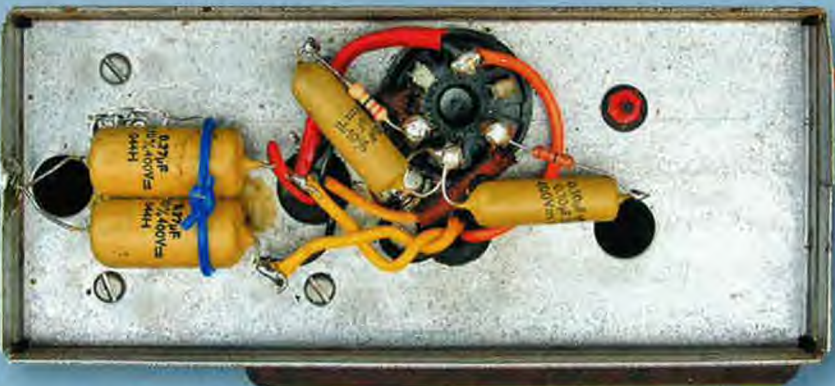
This view shows underside of the Ferris inverter after restoration. The paper capacitors were replaced with polyester units.

Once again, after my experience with the Van Ruyten inverter, I looked closely at the buffer capacitors. I tested C4, C5, C6 & C7 and found that they were all leaky so they were replaced with new polyester capacitors.

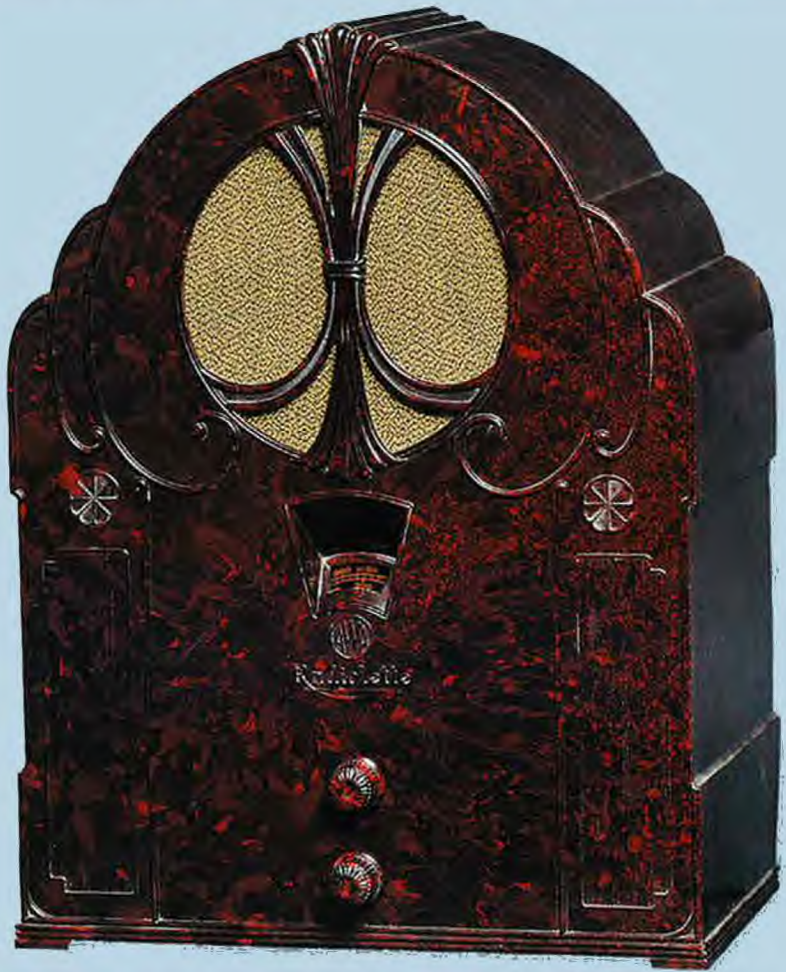
Photo Gallery: 1949 Astor Model GJ

THE FIRST AUSTRALIAN RADIO IN A BAKELITE case was the AWA C87, launched in 1932. It was a 3-valve set and the valve line-up was as follows: 35 RF amplifier, regenerative 24 detector and 47 audio amplifier. This set is now one of the most sought-after by vintage radio collectors. Photo: Kevin Poulter, for the Historical Radio Society of Australia.
