Vintage Radio

The Astor Football GR/GRP 3-Valve TRF Mantel Receiver

Manufactured around 1948, the Astor GR/GRP receiver was nicknamed “Football” because of its cabinet shape. It’s a low-cost 3-valve TRF set designed for tough times.

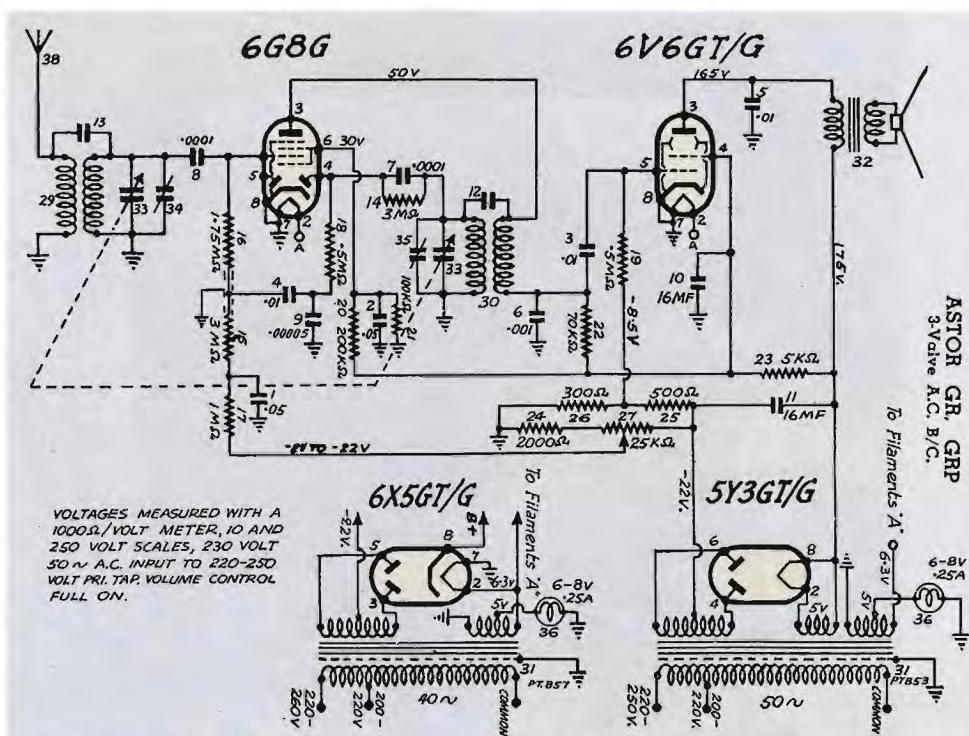
Fig.1: a 3-valve TRF circuit is used in the Astor GR/GRP receiver, with the 6G8G valve functioning as a reflexed RF and audio stage.

Because it is a TRF set, the Astor Football’s circuit is quite simple. However, in order to obtain reasonable performance, reflexing is used to gain extra sensitivity. Fig.1 shows the circuit details.

The input tuned circuit (29, 13, 33, 34) is quite conventional, with no automatic gain control (AGC) voltage applied to a 6G86 RF valve. As shown,

the input signal from the antenna is amplified by the 6G8G and passed on to another tuned circuit (30, 12, 33 & 35). It then goes via an RC network to a detector diode in the 6G8G. The end of the untuned winding not connected to the 6G8G's plate is bypassed to earth via capacitor 6.

The detected audio signal is fed through resistor 18, capacitor 4 and resistor 16 to the grid of the 6G8G. The residual RF from the detector is largely filtered out by capacitor 9. Capacitor 8 prevents the audio and bias signals from being shunted to earth by the tuned circuit.

The 6G8G amplifies the audio as well as the RF signal. In the plate circuit, the untuned winding of the tuned circuit does not impede the audio signal. As far as the audio signal is concerned, there is only the plate load resistor (22) in circuit. The audio is developed across this resistor and applied via capacitor 3 to the grid of a 6V6GT audio output valve.

The 6V6GT amplifies this audio signal and applies it to a speaker transformer which in turn drives a 5-inch (125mm) loudspeaker. Note that there is no negative feedback in the audio circuitry, in keep with the Astor's role as an economy receiver.

The power supply is quite conventional, with either a 6X5GT or a 5Y3GT acting as a full-wave rectifier. The 6X5GT appears only to have been used in the units supplied with a power transformer intended for 40Hz operation. At the time this set was produced, Perth (WA) apparently had 40Hz mains while most of the rest of Australia had 50Hz mains.

Note that the 6.3V dial lamp is run from a 5V tapping on the heater winding in order to extend its life. Another point of interest is that the receiver's power consumption is around 35W, which is almost the same as most 5-valve sets of the era.

There is no conventional volume control. Instead, the volume is controlled by the back-bias system. This can be varied anywhere between -2V and -22V and is applied to the variable-mu 6G8G valve. The more bias, the less amplification.

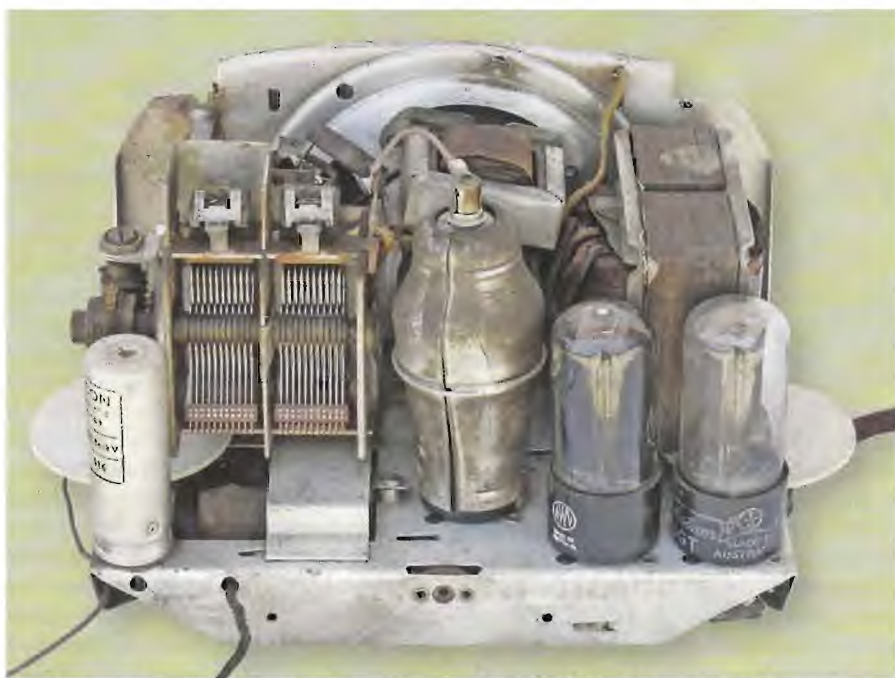
The above-chassis parts are close together but can be easily accessed once the valves have been removed. Note the metal shield on the 6G8G RF valve.

Above the chassis, things are rather different and there is little spare space. However, with the valves removed, all parts can be easily accessed for service.

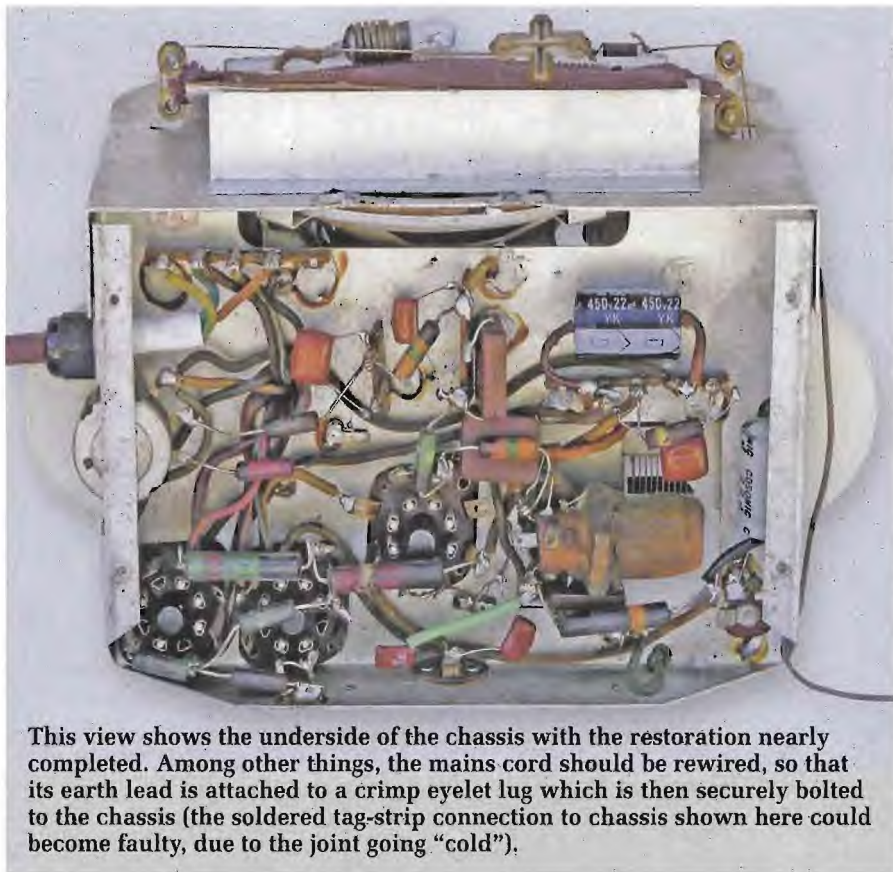
This view shows the underside of the chassis with the restoration nearly completed. Among other things, the mains cord should be rewired, so that its earth lead is attached to a crimp eyelet lug which is then securely bolted to the chassis (the soldered tag-strip connection to chassis shown here could become faulty, due to the joint going "cold").

The parts under the chassis are all quite accessible, so the set is easy to service. The layout however, is something of a dog's breakfast. Because the set has relatively low gain, parts placement is not overly critical, although personally I like to see all components related to the operation of a particular section grouped together.

First, I connected an electrolytic capacitor across each of the electros in the power supply in turn, to determine if one of these was faulty. This quickly showed that capacitor 10 was indeed faulty and this was confirmed when I checked it on my capacitance meter.

I replaced it with a 22 μ F 350V electrolytic capacitor, which I hid under the chassis. The old capacitor was simply disconnected but left in place to keep the set looking as authentic as possible.

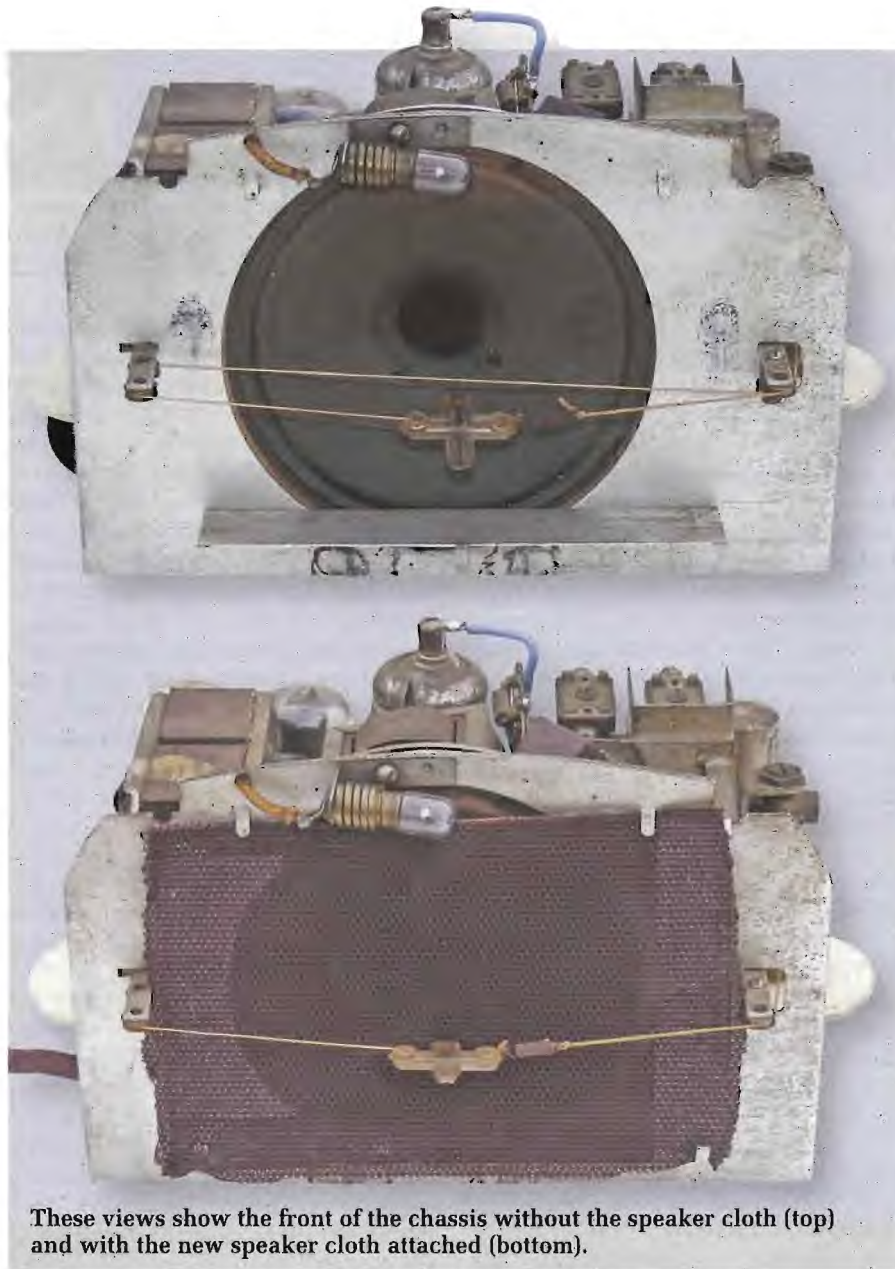
These views show the front of the chassis without the speaker cloth (top) and with the new speaker cloth attached (bottom).

Next, the light-coloured speaker cloth had rotted so I replaced it with some new material. This was glued in place using Tarzan's Grip. Unfortunately, I only had dark-brown cloth, so I also had to change the colour of the dial pointer so that it could be seen. This was changed to white using a white-out correction pen and does not look out of place.
