# Vintage Radio

## The Lyric 8-Valve Console From The 1920s

**Featuring no less than eight valves, the Lyric Model 70 broadcast-band receiver is an upmarket American-made set from the late 1920s. It's a tuned RF design with single-knob tuning and a number of interesting design techniques.**

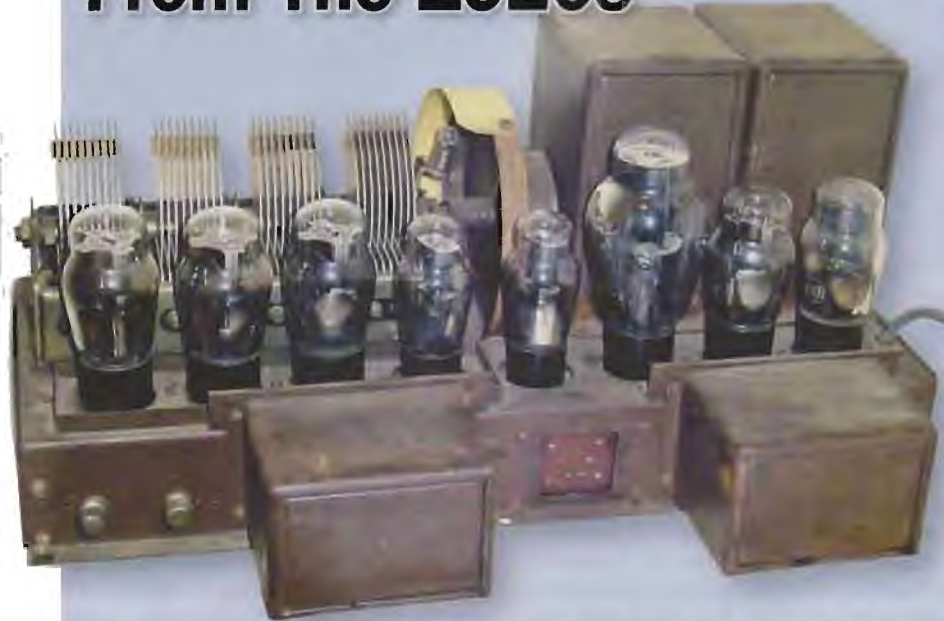
This view shows the rear of the chassis, with the valve cover for the RF stages removed. All the valves were still in working order.

Next, the valves were removed and tested and all were found to be in good working order. That was fortunate as replacements would not be cheap and in any case, would be difficult to source. The only electrolytic capacitor in the set, which proved to be a ring-in, had dried out and was replaced.

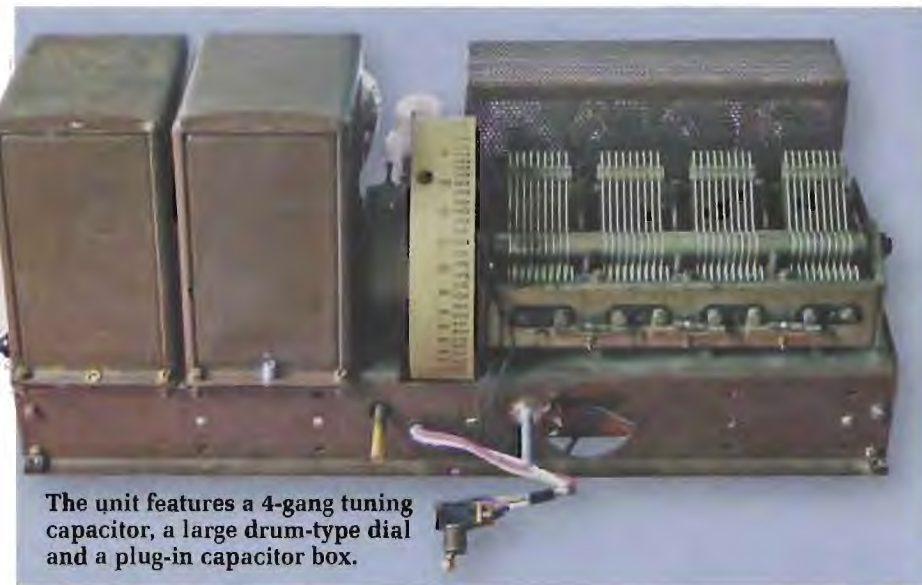
The unit features a 4-gang tuning capacitor, a large drum-type dial and a plug-in capacitor box.

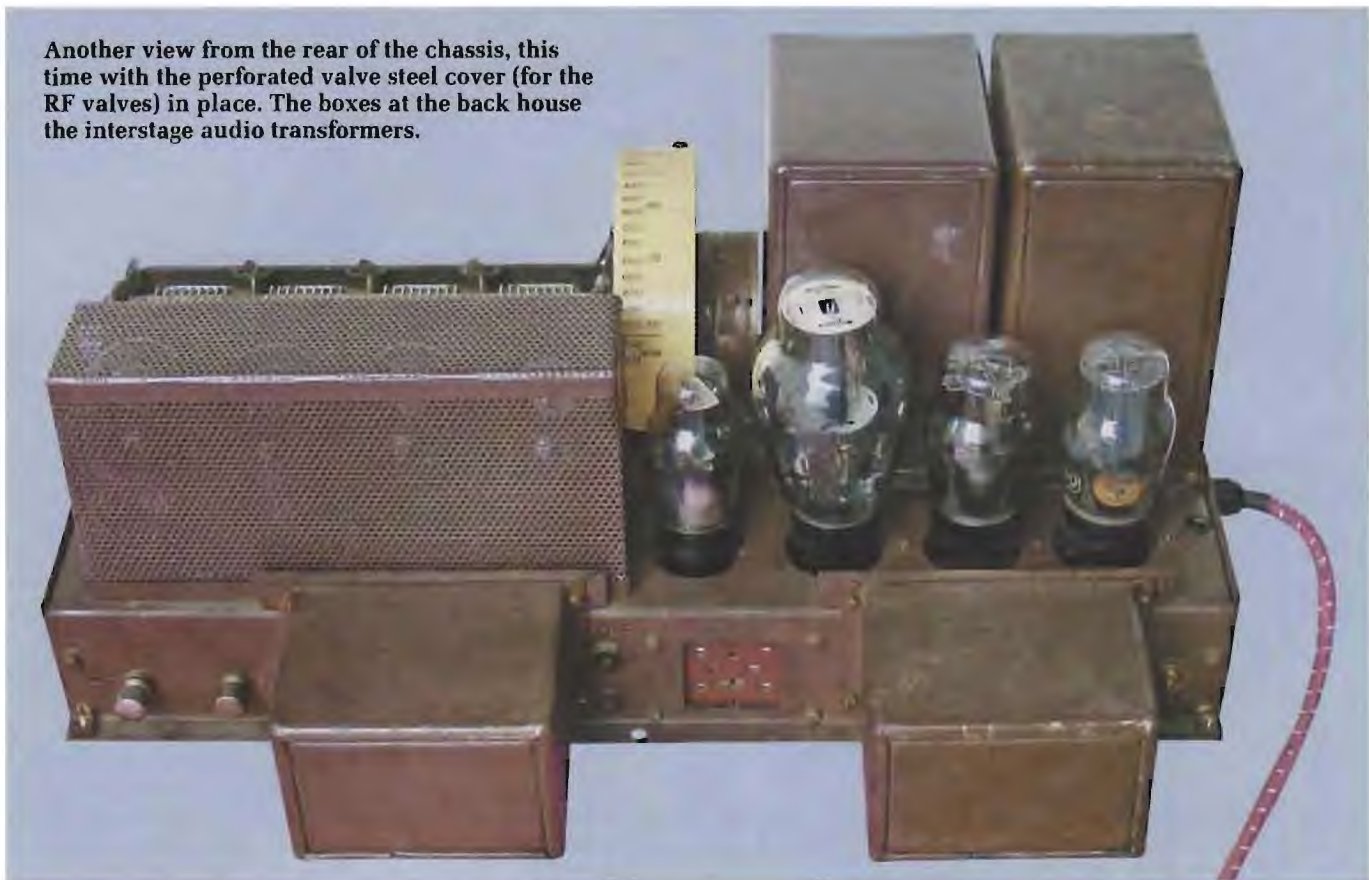
Another view from the rear of the chassis, this time with the perforated valve steel cover (for the RF valves) in place. The boxes at the back house the interstage audio transformers.

A Faraday shield had originally been fitted over the RF valves but this was now missing. As a result, a perforated metal shield was made up and painted the same colour as the chassis before fitting it into place.

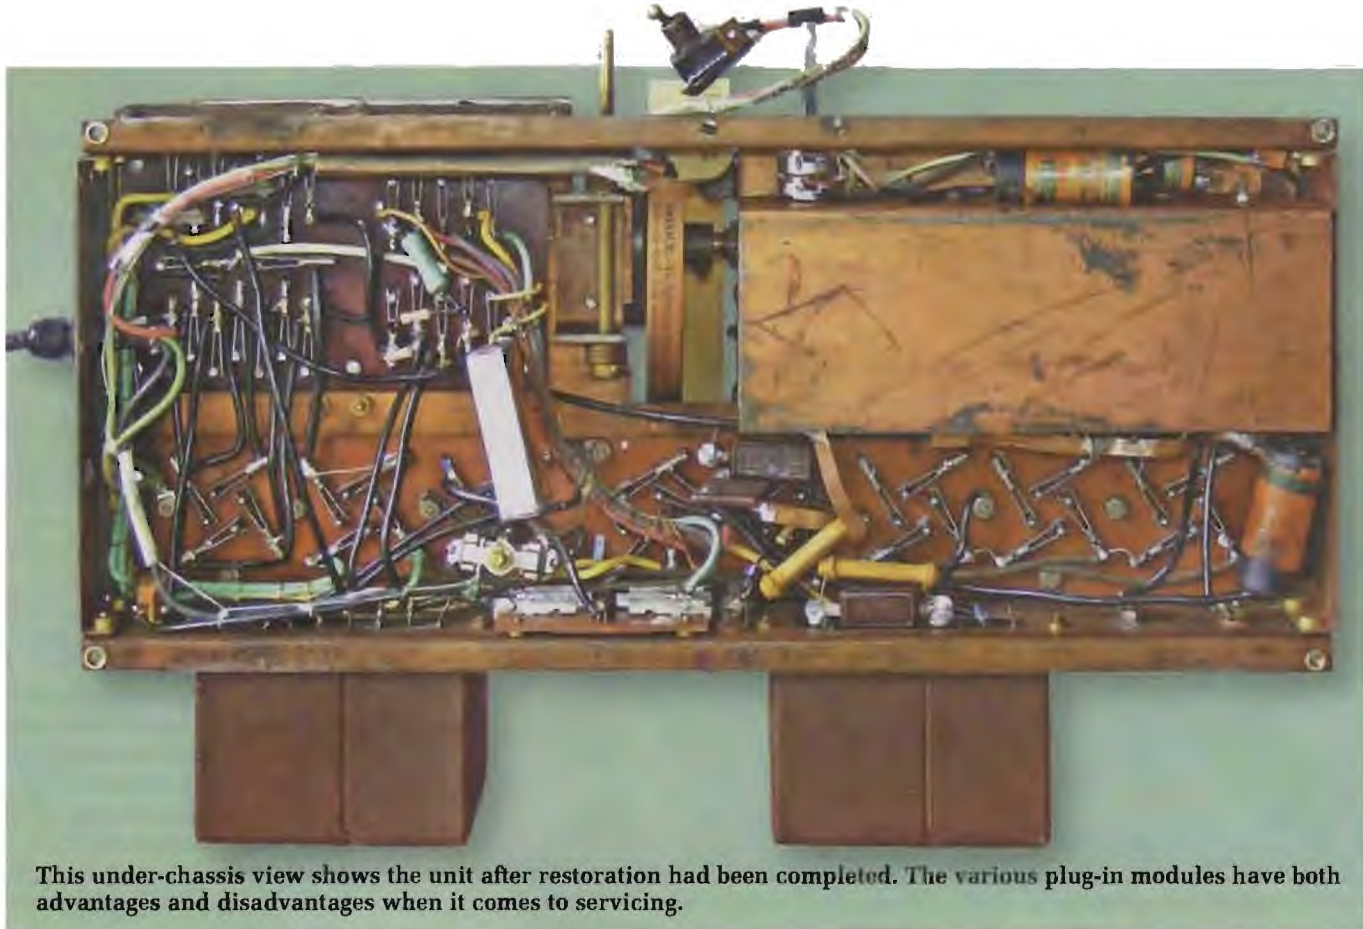
**This under-chassis view shows the unit after restoration had been completed. The various plug-in modules have both advantages and disadvantages when it comes to servicing.**

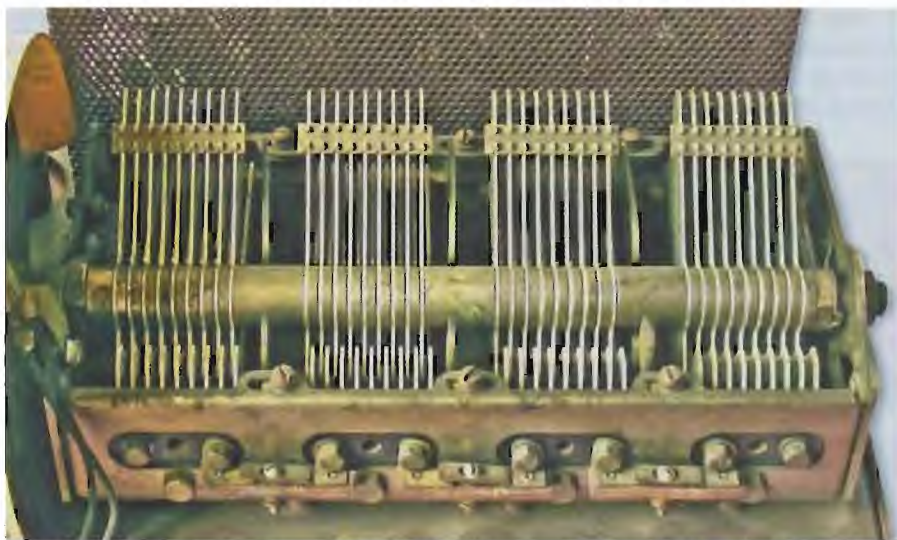
There are a number of interesting features in the RF amplifier stages. First, each RF triode stage is neutralised using neutralisation capacitors that are mounted on the 4-gang tuning capacitor – see photo. These are adjusted during manufacture (via three screws along the bottom edge) so that the receiver is stable under all conditions with the volume control set at maximum.

broadcast band. As shown in the photo, there are another six adjustment screws positioned on the edge of the frame, three between the four gangs at the front and three more at the back. These screws are adjusted

to shift a plate between each gang section, to alter the capacitance between the fixed plates and earth so that the tuned circuits could be adjusted to track correctly. There are no cores in any of the RF coils, so getting the cir-

**The 4-way tuning gang carries three variable capacitors along the bottom edge and these are used to neutralise each of the RF stages. In addition, there are six adjustment screws between the four gangs (three at the front and three at the back) and these are adjusted to ensure correct tracking across the band.**

It was now time to see what the receiver was capable of. There was no apparent instability in the RF sections so the neutralisation adjustments were left alone. The tuning coils and tracking adjustments were also left as they were, as the performance was very good and no adjustments were deemed necessary. The bias on the 250 audio output triode was checked and found to be in the design range of -52-56V.

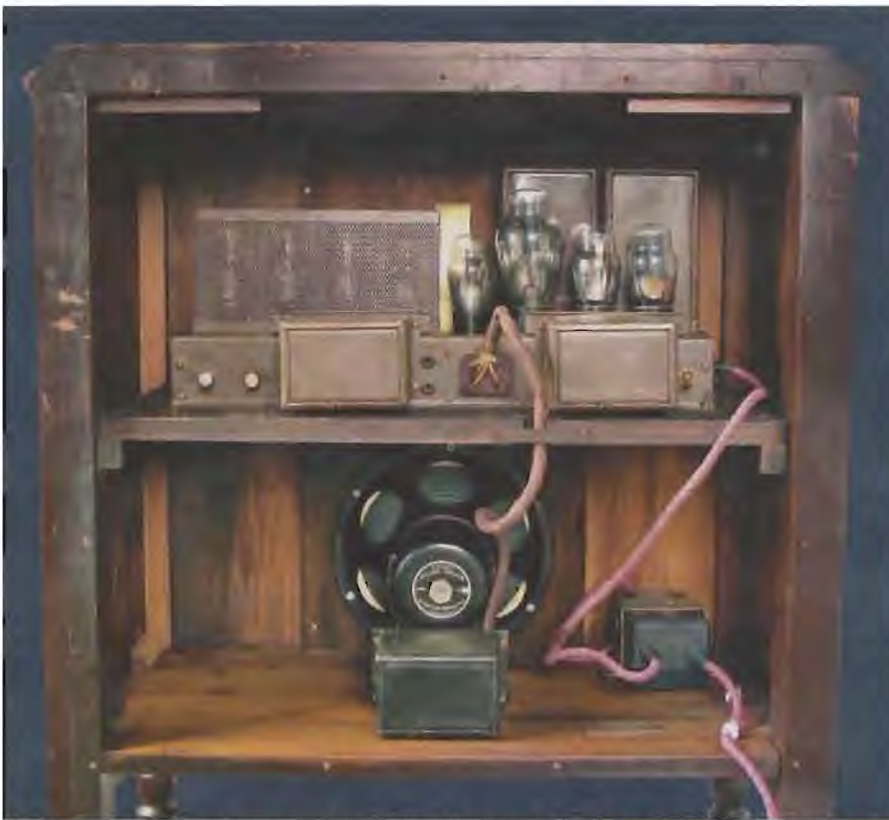
The chassis sits on a horizontal shelf in the top half of the cabinet, while the loudspeaker assembly is mounted in the bottom half and is connected via a cable and plug. Note the 240V to 110V step-down transformer at bottom right.

As mentioned previously, because it was designed for 110VAC, the set was powered via a 240V to 110V isolation

transformer (not an autotransformer). In the interests of safety, the original mains wiring was replaced to Australian standards.

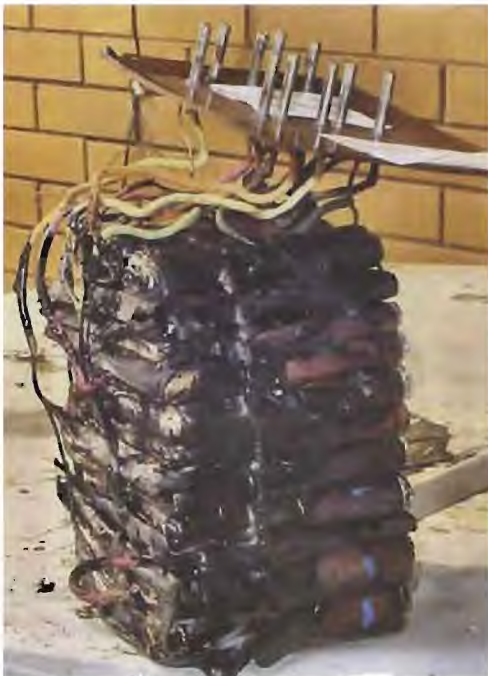
The next plug-in module is the capacitor bank, consisting of 10 capacitors housed in a metal box (see photo). This was designed to be replaced as a single unit, meaning that if one became faulty the whole lot had to be replaced. This would have been expensive and

The plug-in capacitor box contained a large number of faulty paper capacitors, which meant that a complete new assembly had to be made up.

Removing the capacitors from this box was a difficult job as they had been set in pitch. In the end, a heat gun was used to soften the pitch, after which a carving knife was used to separate the capacitor assembly from the case. In short, it was a time-consuming and messy job.

As expected, the 10 paper capacitors were all leaky and so had to be replaced. This was done by mounting much smaller replacement capacitors on two pieces of fibreboard (see photo). In particular, the 2 $\mu$ F and 3 $\mu$ F capacitors were replaced with mains-rated motor-start capacitors and the rest

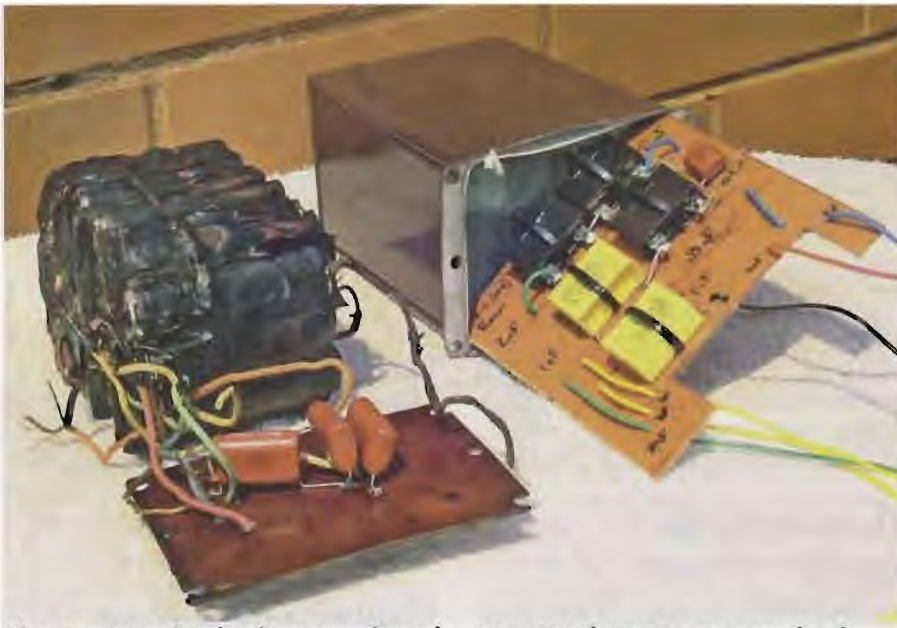
The new capacitor bank was made up by mounting the parts on a couple of pieces of fibreboard and connecting them via flying leads. This assembly was then housed in the original box. The original capacitor bank is visible at top left.

with mains-rated MKT and polyester types. The value of each capacitor was marked next to it on the fibreboard, to aid future servicing.

As shown in the photo, the various leads were then soldered to the appropriate pins on the capacitor box plug, after which the box was plugged back into the set.
