Vintage Radio

The Airzone 612 6-valve battery-powered console

Designed in 1938, the Airzone 612 was a 6-valve battery-operated receiver specifically designed for use in remote areas. It's an excellent performer and even after 70 years, the alignment of the set featured here was almost spot on.

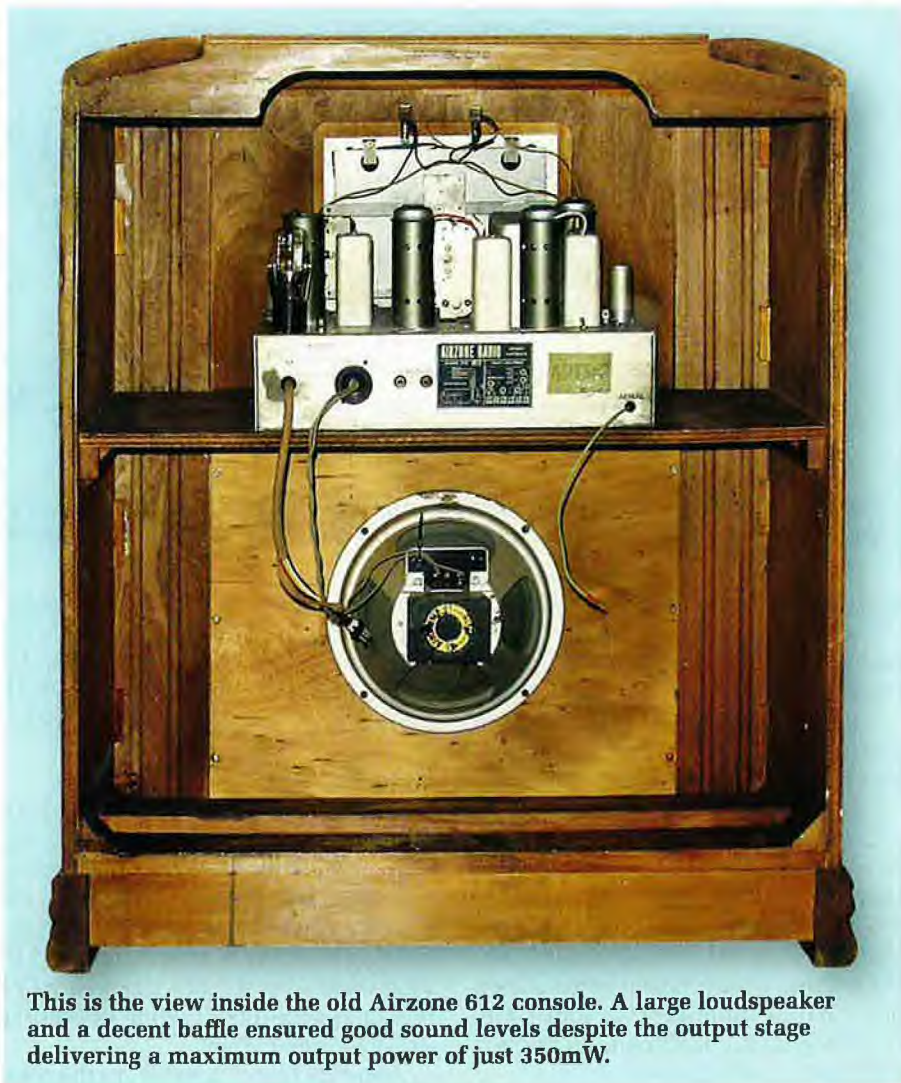
This is the view inside the old Airzone 612 console. A large loudspeaker and a decent baffle ensured good sound levels despite the output stage delivering a maximum output power of just 350mW.

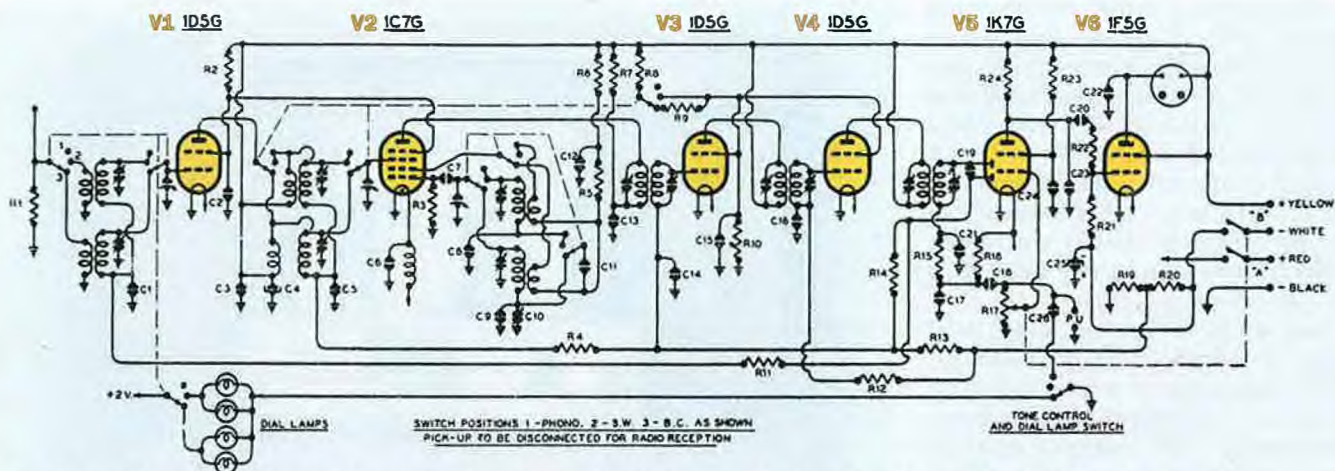
Refer now to Fig.1 for the circuit details of the Airzone 612. The receiver is quite conventional with a 1D5G (V1) as a tuned RF (radio frequency) amplifier. The output from this stage is coupled via another tuned circuit to the signal grid of a 1C7G (V2) which

functions as the frequency converter. This stage generates an IF signal that's 456kHz higher than the tuned RF signal.

This IF signal is coupled via a double-tuned IF transformer to a 1D5G (V3) which functions as the first IF amplifier. The resulting signal is then fed via another double-tuned IF transformer to the second IF amplifier (V4). It then goes through another double-tuned IF transformer to the detection and AGC diodes in a 1K7G valve (V5).

Finally, the detected audio signal is fed to the pentode section of a 1F5G (V6) which in turn drives a large (and efficient) loudspeaker via an output transformer.

Fig.1: the Airzone 612 is a fairly conventional superhet design employing six valves. It's a dual-band set and was powered from a 2V lead-acid cell (for the valve filaments) and three 45V batteries (to derive a 135V HT supply).

The detector diode in V5 has no bias applied to it and commences working as soon as a signal is received. By contrast, the AGC diode is biased to -2V which means that it doesn't start conducting until the IF signal exceeds 2V. This means the set has delayed AGC which is very useful when operating in weak signal areas.

Standing bias is applied to the four RF and IF valves and this is derived from the voltage developed across R19 in the HT-line. In addition, the AGC line applies various amounts of bias to valves V1-V3, depending on the signal strength. The RF valve (V1) receives the full AGC voltage (via R11), while V2 & V3 receive just half the AGC voltage (derived from the junction of resistors R13 and R14). V4 (the 2nd IF amplifier) has no AGC applied to it.

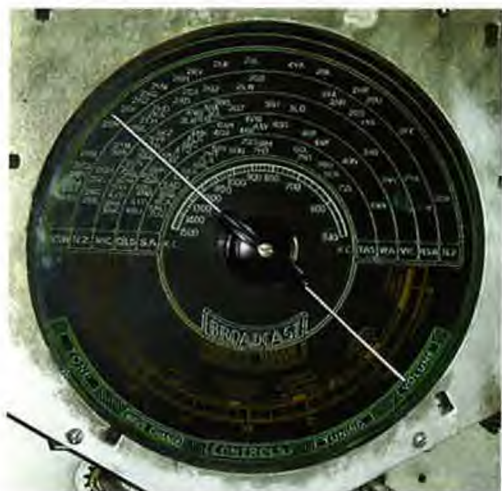
The clear dial cover in the escutcheon

is now showing its age, having yellowed somewhat. However, because it's curved, a replacement is difficult to source.

A close-up view of the dial scale. The dial lamps are switched so that only the broadcast or shortwave markings are illuminated.

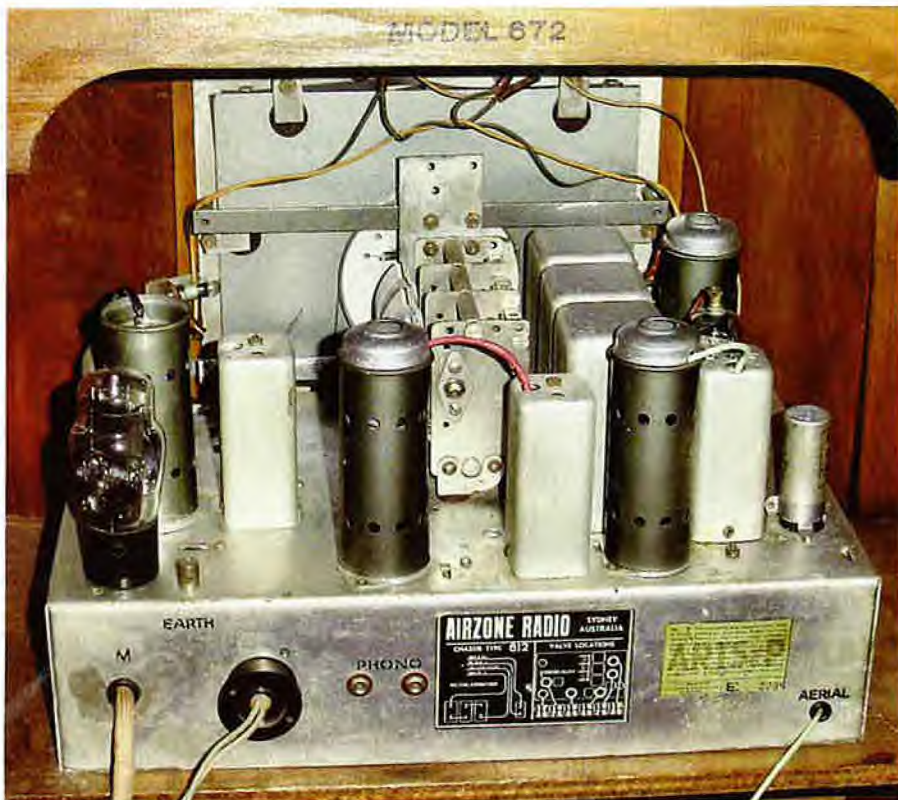
Considering its age, the chassis was really in quite good condition although there were inevitably a few problems. First, when it was removed from the cabinet, it was found that the volume control had been replaced at some time in the past and its shaft had been cut quite short. As a result, it was missing its control knob.

An under-chassis inspection also revealed a degree of tampering by someone who clearly didn't know what they were doing. This is a common problem with many vintage radios – the "hero" who is going to restore it attacks it with great gusto, in the process removing many parts which are earmarked for later replacement. Unfortunately, he subsequently cannot remember where everything goes and so parts finish up where they don't belong and the set doesn't work properly.

During this process, Marcus discovered that the 1K7G's plate resistor (R24) had been changed from 250kΩ to 20kΩ. The original 250kΩ resistor had been wired to the grid instead of the plate, so it was no wonder the valve was faulty. Valves do not take kindly to significant positive voltages on their control grids.

Another problem concerned back-bias resistors R19 & R20. These are actually part of a single tapped wire-wound resistor which is bolted to the chassis. This was faulty, again due to the previous restorer, and was replaced with two separate resistors.

The old Airzone's chassis was in remarkably good condition for its age, with all the labelling still intact. Unfortunately, someone had tampered with the circuitry, although the problems were soon sorted out.

(Marcus) who is capable of restoring old radios. His practice is to replace all the paper and electrolytic capacitors when restoring a receiver and so this was one of his first jobs. Marcus also tested all the valves and found that the 1K7G was faulty. This was replaced, after which further checks were made on component values.

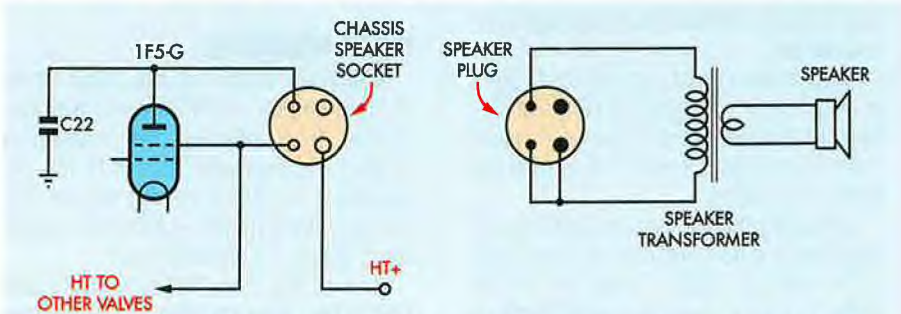
Marcus was not happy about the speaker transformer being mounted directly on the speaker, however. The reason for this was simple – if anyone was to remove the speaker plug on the back of the chassis while the receiver was operating, the 1F5G output valve would have no voltage on its plate but full voltage on its screen.

Fig.2: this circuit shows how the unit could have been wired so that the HT to the valves was removed if the speaker assembly was unplugged.

It would not survive this sort of treatment for long and so, despite detracting from originality, Marcus decided to mount the transformer on the chassis, with only the voice-coil

leads going to the speaker via the plug.

In fact, it would not have been difficult for Airzone to have corrected this problem. They could have easily wired the receiver so that the HT to the entire circuit was removed if the speaker was unplugged, thus saving the 1F5G from destruction. As shown in Fig.2, the modification is so simple that it makes one wonder why Airzone didn't do this.

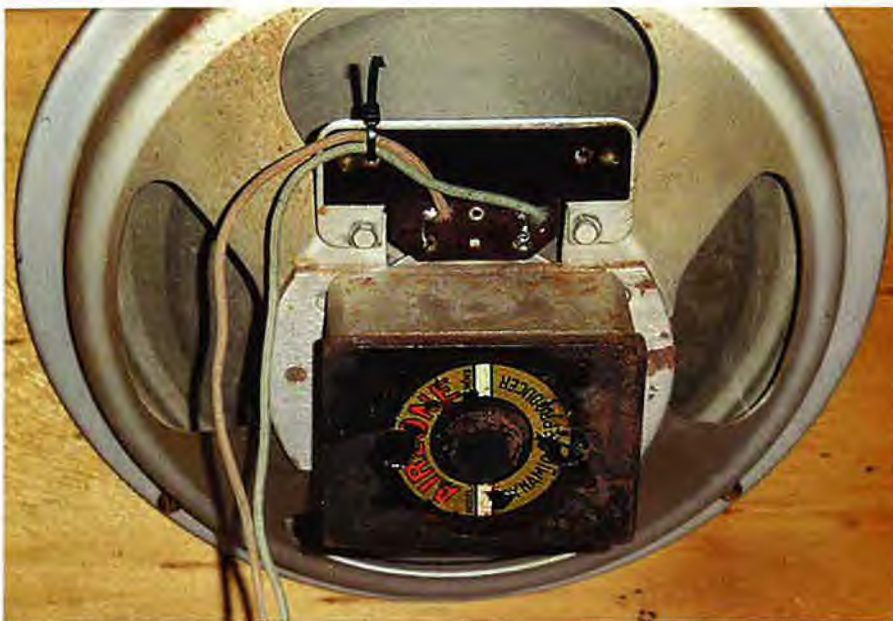
It didn't take long to track down the problem. A close inspection soon revealed that the speaker transformer had been replaced at some stage and the speaker cone had also been damaged. Unfortunately though, the flexible wires that connect the voice coil to the speaker transformer had been broken.

The original loudspeaker required some work to get it going again, including a patch on the paper cone. The flexible wires that connect the voice coil to the speaker transformer had also been damaged and required replacement.

This fault was quickly repaired using some flexible wire from a defunct loudspeaker, while the hole in the

speaker cone was repaired by gluing a thick paper covering in place. This was the original speaker, so it was worth spending the time to repair it.
