Vintage Radio

The STC 504: a 5-valve table radio from 1939

Manufactured just before World War 2, the STC 504 is a 5-valve table receiver housed in a very attractive timber cabinet. It's an interesting circuit that performs well, especially after a few minor tweaks to its AGC system.

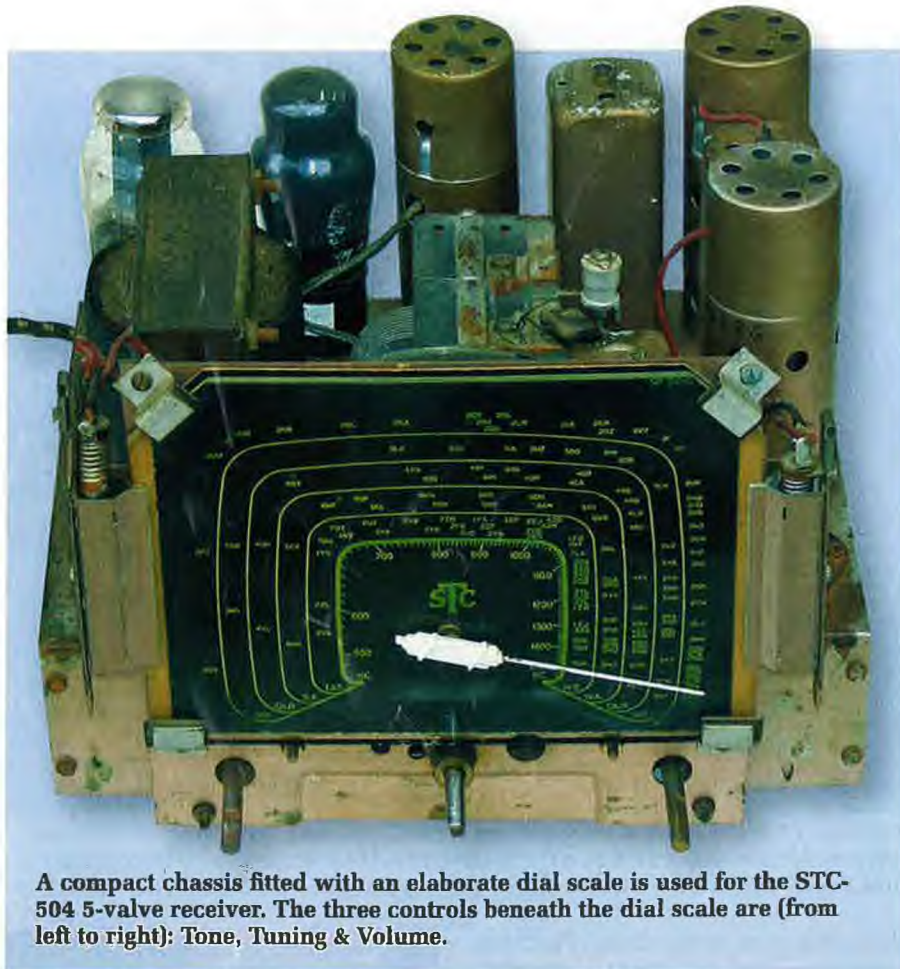
A compact chassis fitted with an elaborate dial scale is used for the STC-504 5-valve receiver. The three controls beneath the dial scale are (from left to right): Tone, Tuning & Volume.

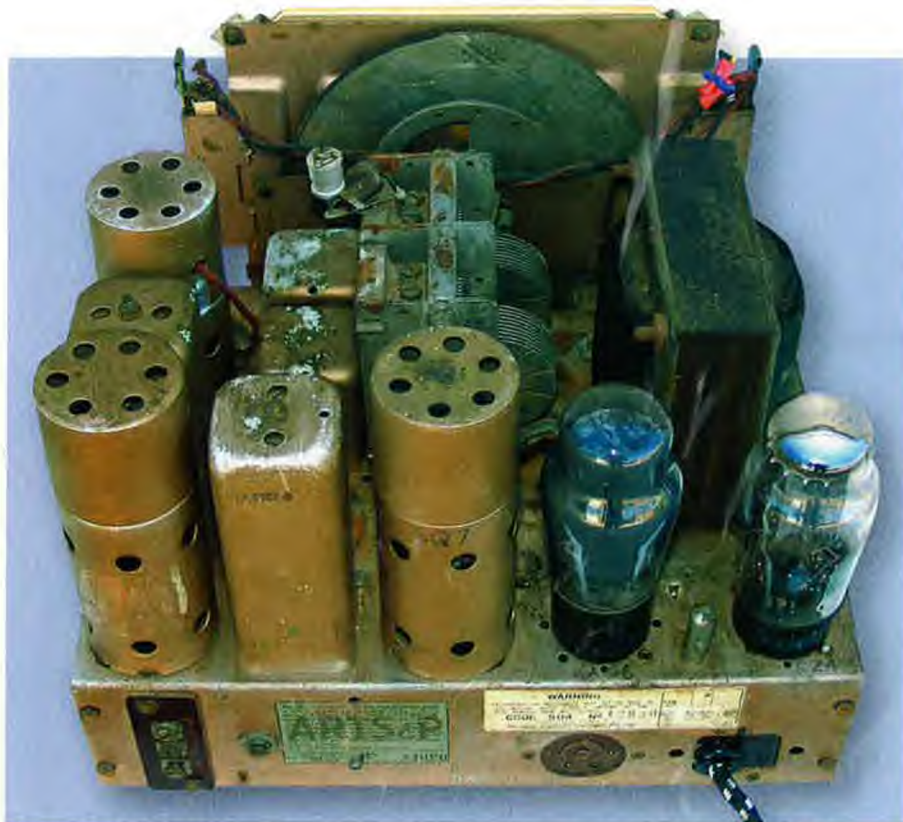
The top of the chassis is tightly packed with the major parts. Metal shields are fitted to the converter, IF and detector/triode valves, while the mains cord is now firmly anchored with a cordgrip grommet in place of the original knot.

The power cord was also a problem, being retained only by a knot in the lead just inside the chassis. That may have been acceptable back in 1939 but it's certainly not acceptable today. This primitive anchoring scheme has now been replaced with an approved cable clamping system.

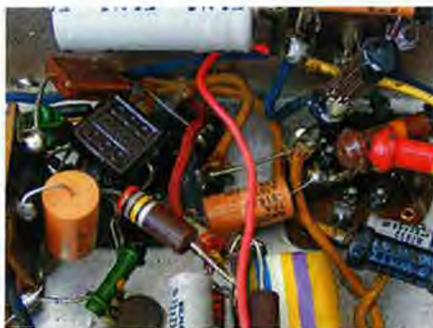
The parts around the detector/first audio amplifier socket are somewhat crowded together.

Finally, close inspection of the wiring around the 6Q7G revealed a lump

of solder between a couple of the valve pins. It was removed and fortunately hadn't caused any problems.
