# Vintage Radio

## AWA R7077 Beat Frequency Oscillator

**It was 1939 and Australia was at war. Its future seemed far from secure and every industry in the country was geared to support the military effort. Amalgamated Wireless Australasia (AWA) played a key role by designing and producing vital communication equipment.**

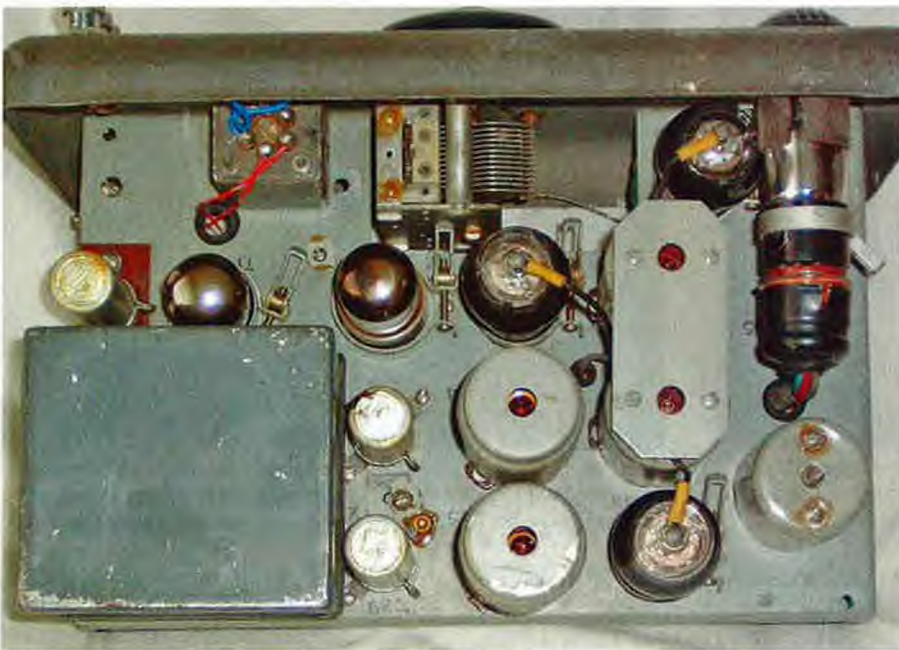
This top view of the chassis shows the robust construction techniques used in the R7077. The valves are all held in place by clamps, so that they cannot come loose as the unit is moved about.

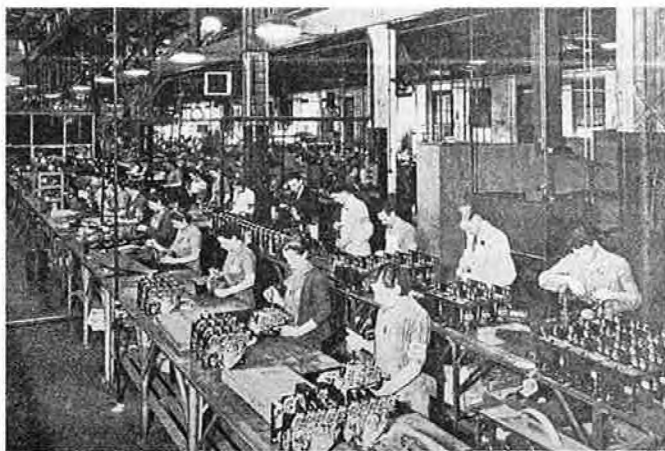
A general view of one of the assembly lines in the Radio Electric Works, at AWA's Ashfield factory. Many types of transmitters and receivers were built here during the war.
