Vintage Radio

Breville 730 Dual-Wave 5-Valve Receiver

Manufactured in 1948, the Breville 730 table-top receiver was housed in an attractive timber cabinet and covered both the broadcast and shortwave bands. It featured a wide audio response and this, coupled with a large loudspeaker, gave very good performance.

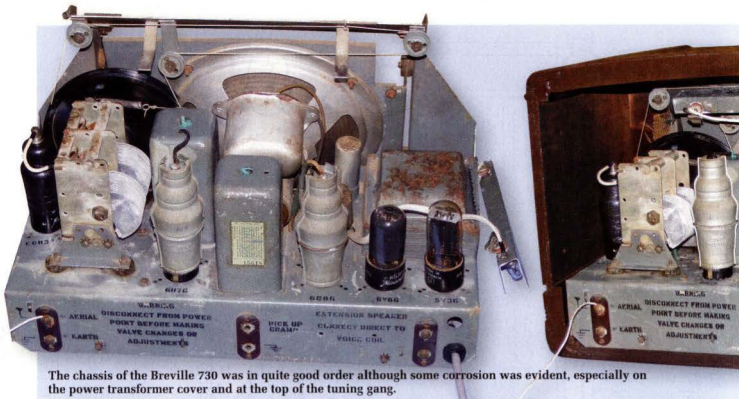
The chassis of the Breville 730 was in quite good order although some corrosion was evident, especially on the power transformer cover and at the top of the tuning gang.

The tuning gang was also a little worse for wear so it was the next job on the list. First, a small hand blower was used to remove the dust that had accumulated between the plates. This revealed that some of the plates had corrosion on them, so these were carefully cleaned by pushing some fine emery paper between them.

The chassis itself was in quite good order and was simply cleaned using the blower and a small brush.
