Vintage Radio

A rare 1929 AWA C54 Radiola set rescued from oblivion

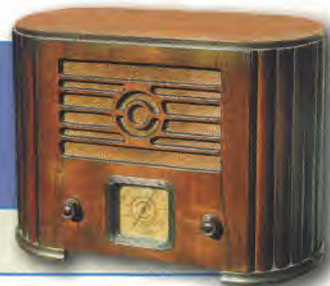
Some vintage radios are in such a dilapidated state when discovered that you wonder why anyone would even attempt to restore them. Such was the case with this rare AWA C54 – its cabinet was badly water-damaged and the chassis was dirty, dusty and rusting.

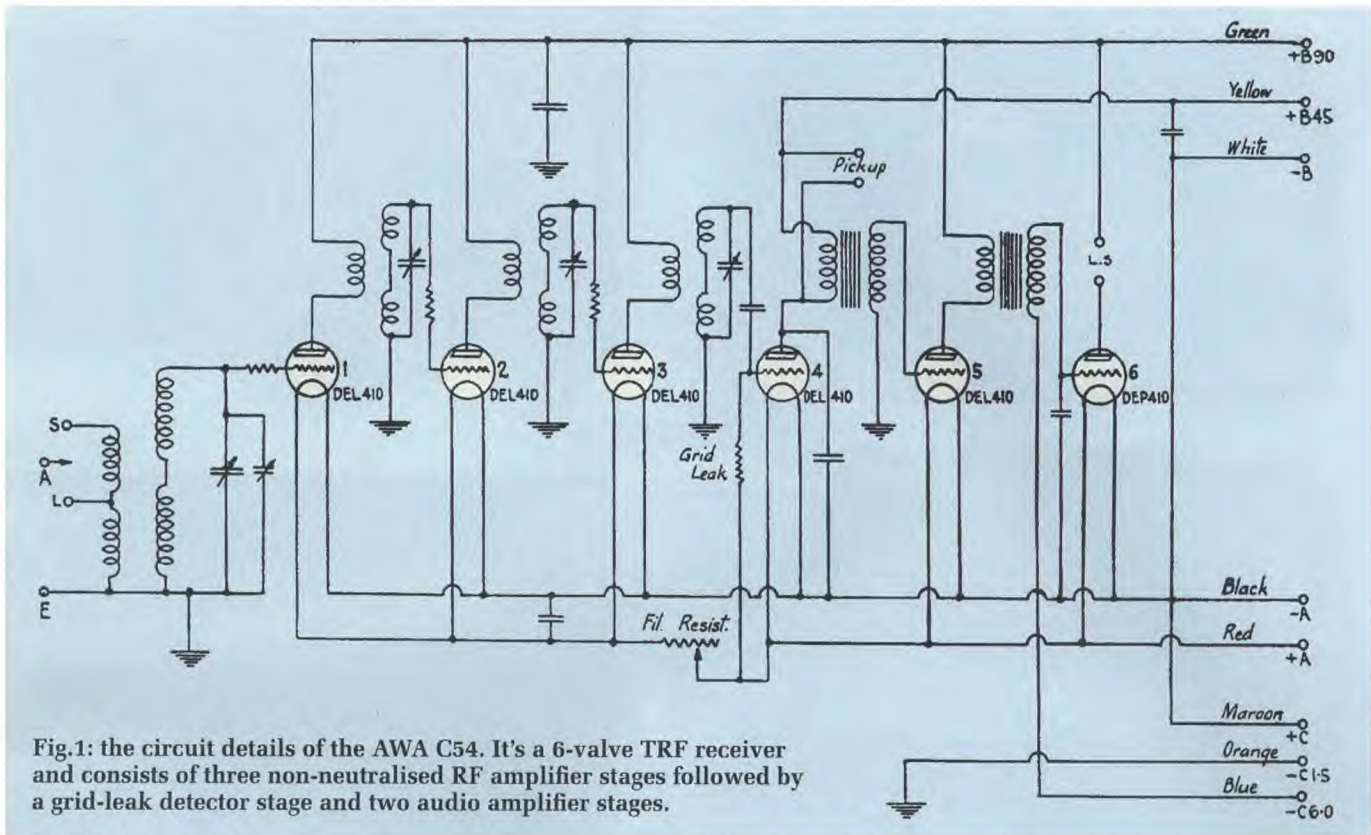
Fig.1: the circuit details of the AWA C54. It's a 6-valve TRF receiver and consists of three non-neutralised RF amplifier stages followed by a grid-leak detector stage and two audio amplifier stages.

Fig.1 shows the circuit details of the C54. It's a 6-valve TRF receiver and is similar to the 1928 C50 model, except that "losser" (or stopper) resistors are used whereas in the C50, the RF stages were neutralised using capacitors. A likely reason for this is that AWA was unwilling to pay the necessary licence fee to Hazeltine to use their neutralisation patent.

In summary, stages 1-3 are non-neutralised RF amplifier stages with series resistors between the tuned circuit and the grid of each valve to ensure stability. This, combined with a fairly small number of turns on the primary of each coupling transformer, resulted in adequate gain without instability.

Stage 4 is a grid-leak detector with no regeneration, while stage 5 is the first audio stage. This is then followed by the audio output stage (stage 6).

It's interesting to note that the chassis is connected to the -1.5V tap of the bias (C) battery, resulting in the negative side of the filament (A) battery being 1.5V above the chassis. This was done so that the three RF stages could be biased with the bottom ends of their

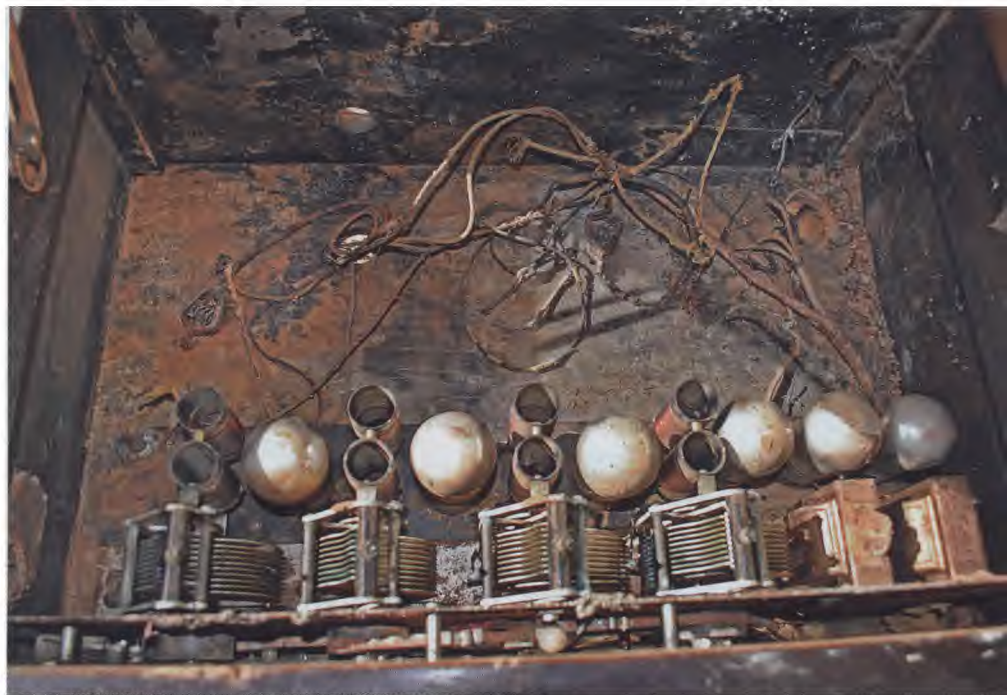
The 84-year-old AWA C54 was obtained by the author in very poor condition, with a badly water-damaged cabinet and a dirty, rusting chassis. Restoring it to full working condition was a monumental task.

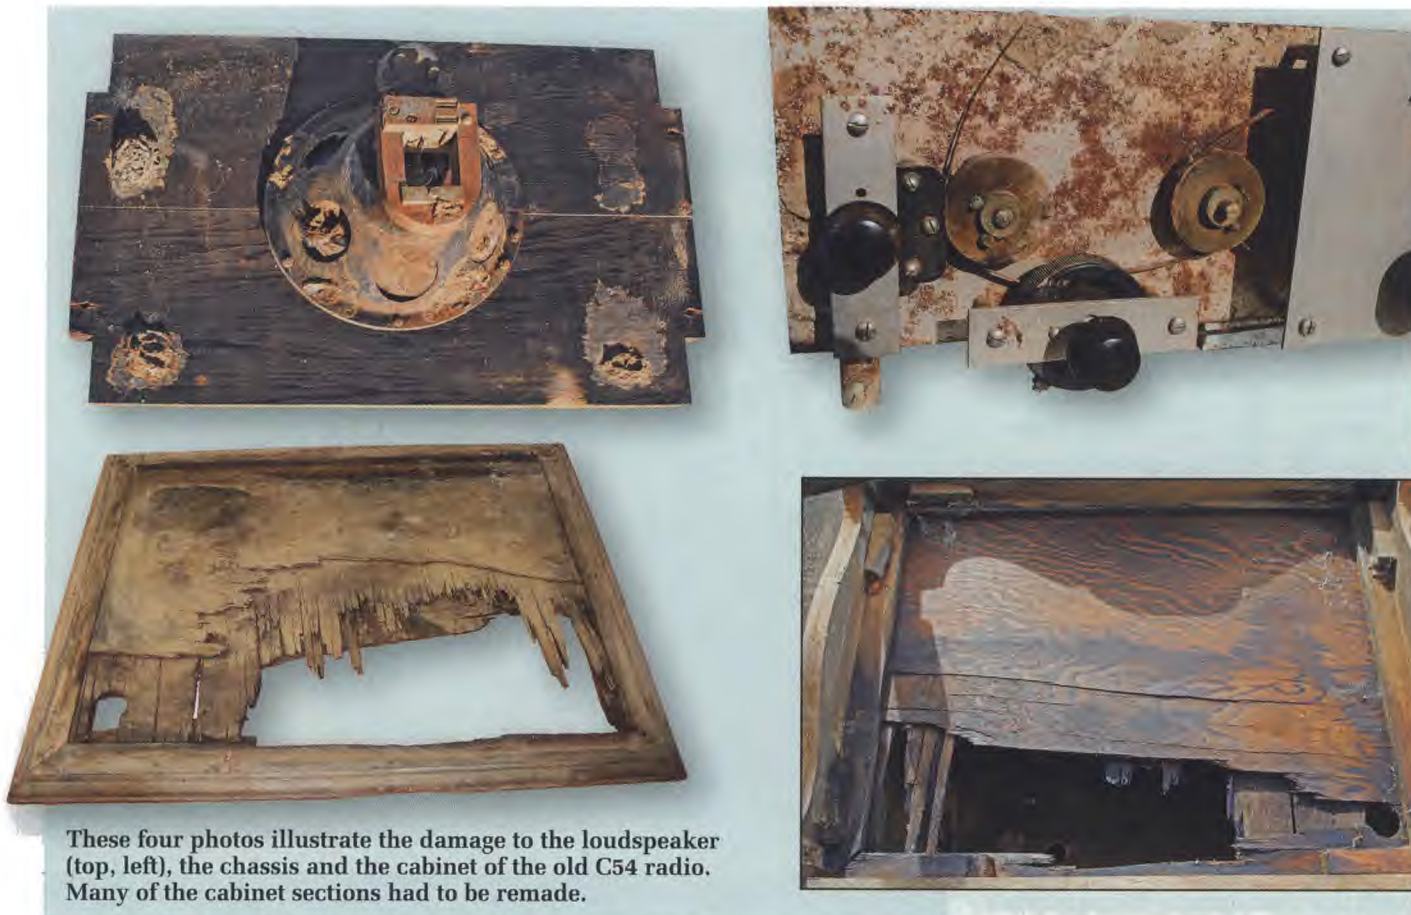
These four photos illustrate the damage to the loudspeaker (top, left), the chassis and the cabinet of the old C54 radio. Many of the cabinet sections had to be remade.

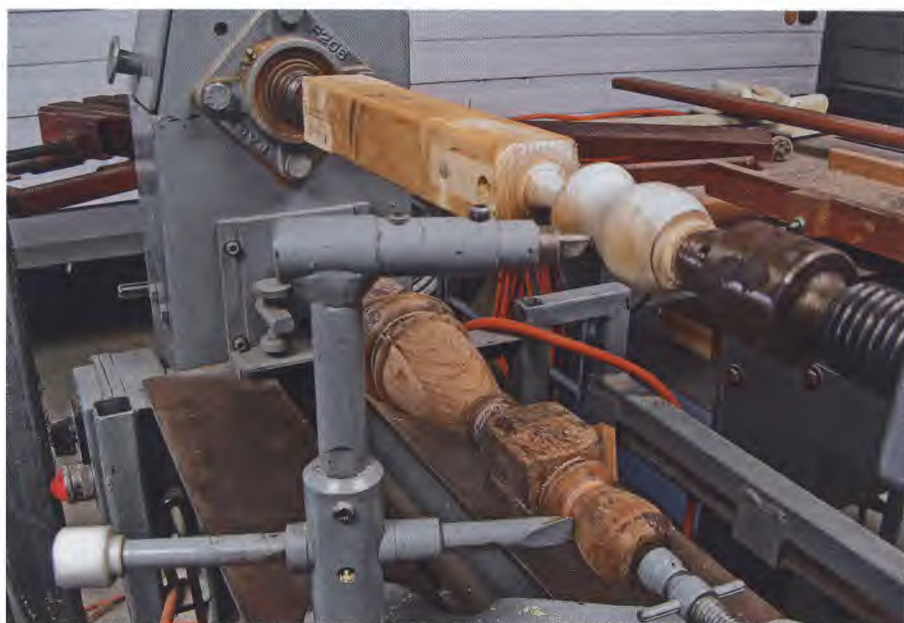
The author's home-made copy wood lathe came in handy when it came to making new sections for the turned legs that are fitted to the cabinet.

sections were manufactured, using a copy wood lathe I made several years ago. This lathe not only made it much easier to make the parts but also enabled them to be virtually exact.

The upper sections of the turned legs were fabricated from four separate pieces, each glued to a central leg component. This made it possible to turn such a large section without using a single piece of solid timber, thereby conserving material.

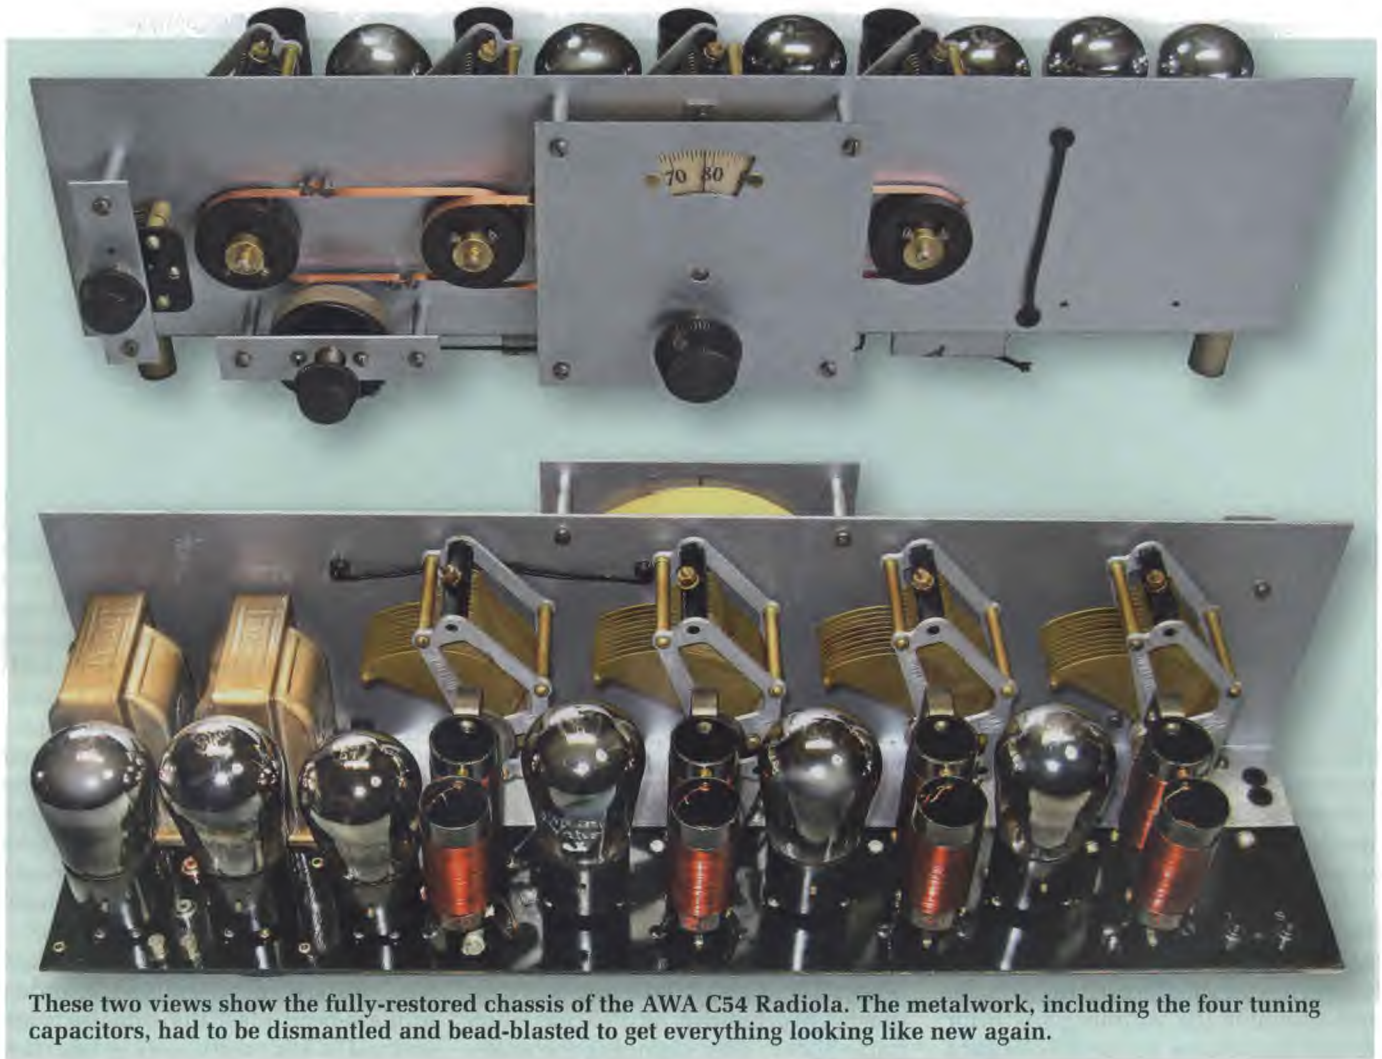
These two views show the fully-restored chassis of the AWA C54 Radiola. The metalwork, including the four tuning capacitors, had to be dismantled and bead-blasted to get everything looking like new again.

the chassis restoration by first taking a series of photos before removing all the parts. I then glass-bead blasted all the metalwork, including the tuning capacitors and the speaker components. Surprisingly, the speaker had no obvious damage whatsoever to the cone! There was not one hole to be seen, which is quite incredible considering the age of radio, although the back protection cloth was almost non-existent.

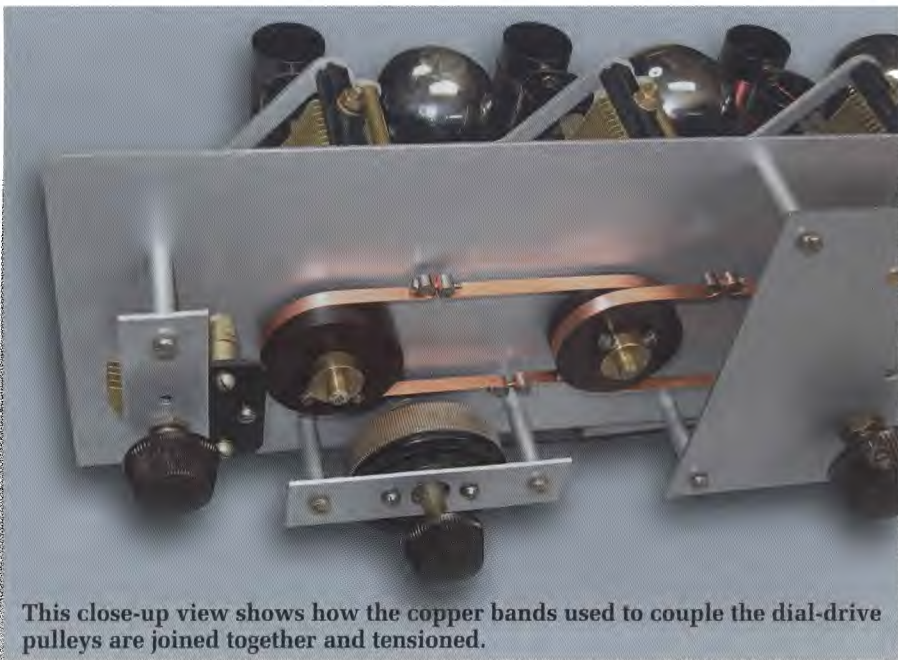
This close-up view shows how the copper bands used to couple the dial-drive pulleys are joined together and tensioned.

Copper bands are used as belts to couple the drive pulleys. Each pulley has a hole in its centre for a location pin, thereby eliminating any slippage once the belt is tightened by small cylindrical clamps.

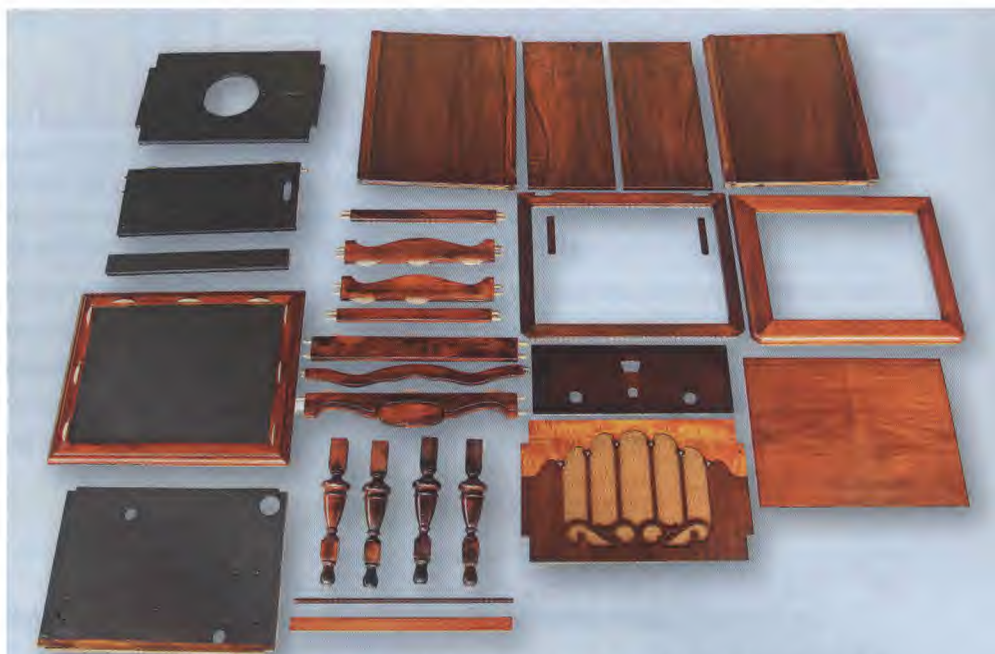
A major part of the restoration involved rebuilding the cabinet. This view shows the various pieces, many of them completely re-made, before the final assembly.

pletely re-manufactured. First, a timber frame was fabricated using a router, then reassembled using the more modern biscuit-jointing method. This then became the base onto which the veneer panels were glued, with the frame edge around the panel enabling better machining, rather than trying to machine across the ply panel's grain when finishing off the edge.
