# Vintage Radio

## STC's Type 500A 5-Valve Mantel Radio

STC's 1938 Type 500A is a well-made 5-valve mantel radio which was housed in a handsome timber cabinet. The unit featured here was obtained in quite good condition and required relatively little work to restore it to full operation.

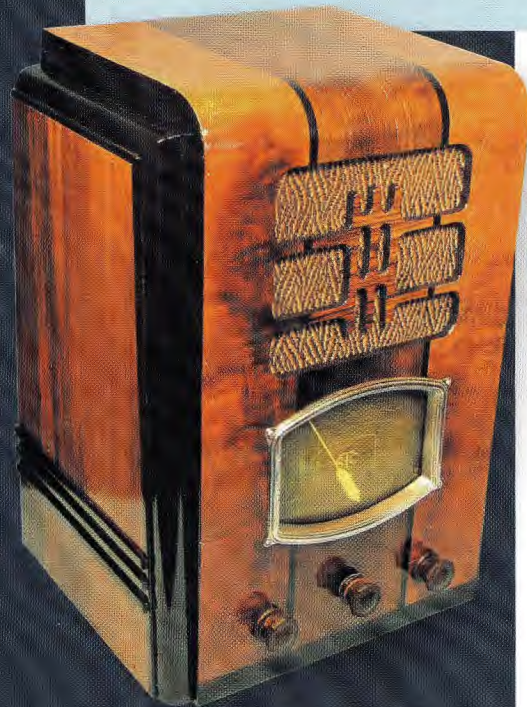
This STC 1938 500B tombstone model still has its original speaker grille and knobs. Exactly the same grill and knobs would have been installed on the model 500A pictured above but these parts have been changed at some stage during the set's life.

The grille fabric and knobs originally used on the 500A were also used on the 1938 STC tombstone model 500B. This set is shown in one of the accompanying photos and is another of the author's prized radios. It's displayed next to the 500A and clearly demonstrates what the 500A's original grille fabric and knobs look like.

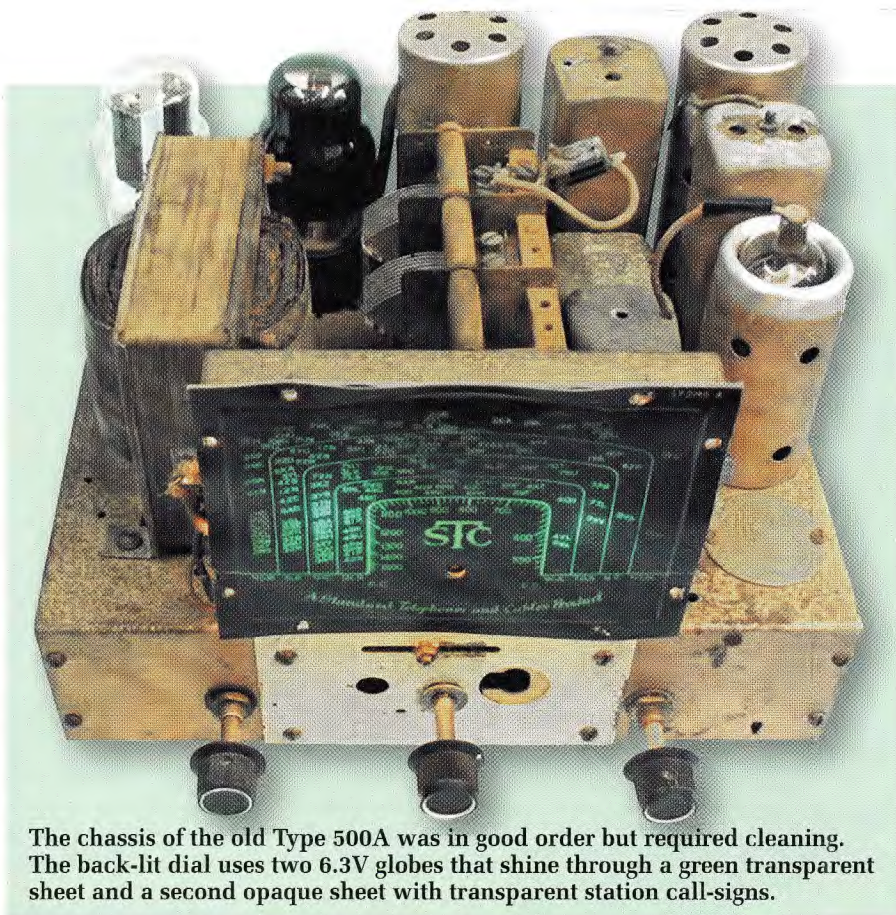
The chassis of the old Type 500A was in good order but required cleaning. The back-lit dial uses two 6.3V globes that shine through a green transparent sheet and a second opaque sheet with transparent station call-signs.

dial back-lighting is achieved using incandescent dial globes which shine through a layer of green backing positioned behind an opaque dial-plate with transparent call-signs.

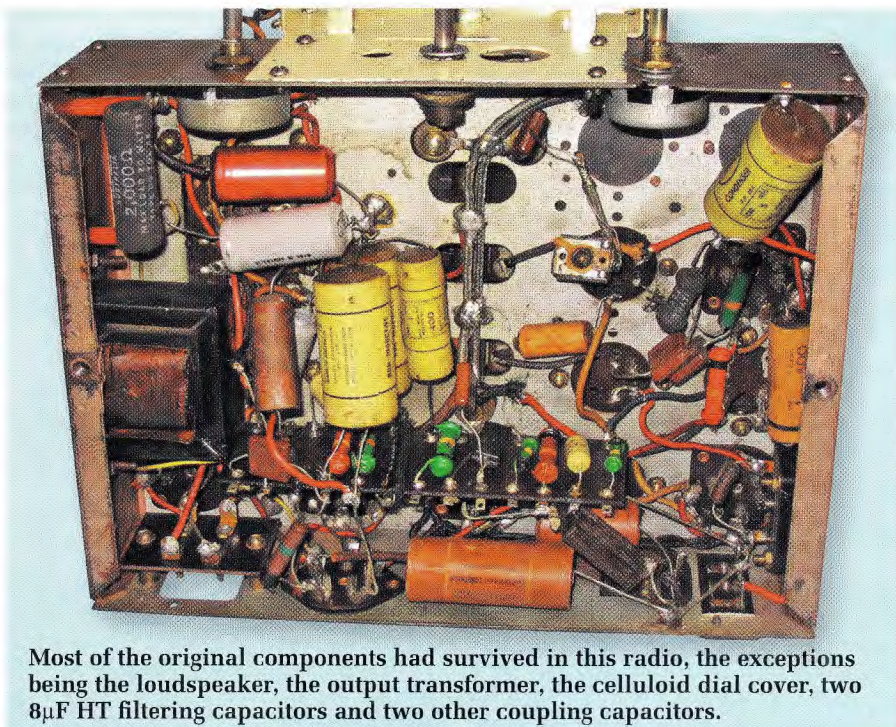
Most of the original components had survived in this radio, the exceptions being the loudspeaker, the output transformer, the celluloid dial cover, two 8μF HT filtering capacitors and two other coupling capacitors.

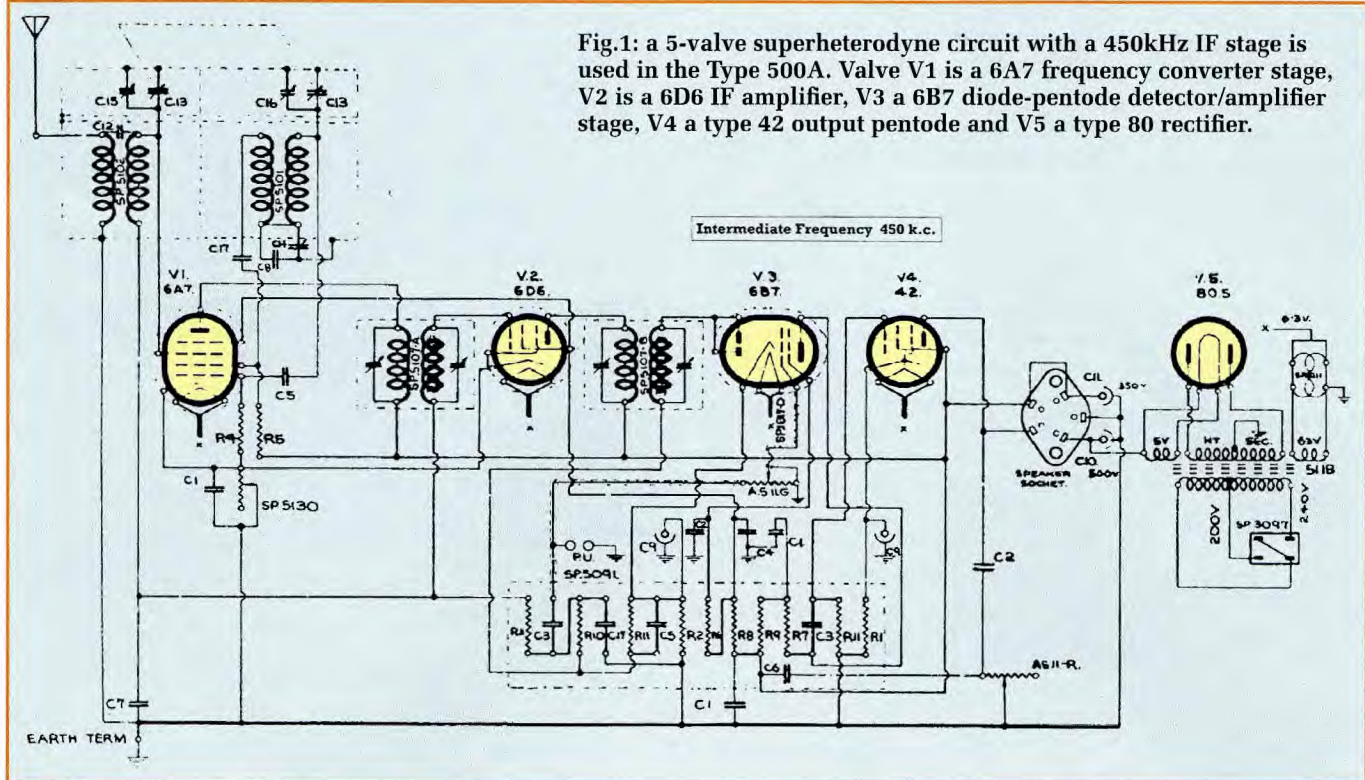
Fig.1: a 5-valve superheterodyne circuit with a 450kHz IF stage is used in the Type 500A. Valve V1 is a 6A7 frequency converter stage, V2 is a 6D6 IF amplifier, V3 a 6B7 diode-pentode detector/amplifier stage, V4 a type 42 output pentode and V5 a type 80 rectifier.

The circuit itself is a 5-valve superheterodyne type using a 450kHz IF stage. It includes a 6A7 frequency converter (V1), a 6D6 IF amplifier stage (V2), a 6B7 diode-pentode detector/amplifier stage (V3) and a type 42 pentode (V4) for the audio output. The 450kHz IF stage employs two metal dust core transformers and STC state that resistance coupling is used between the detector/amplifier (V3) and output stage (V4).

The last claim is a bit odd though, because C3 provides conventional capacitive coupling to the type 42 output pentode.

Potentiometer AS11-R (50kΩ) acts as a top-cut tone control in conjunc-

tion with C2. The volume control pot (500kΩ) is labelled AS11-G and this alters the gain of the 6B7. The top of the volume pot also accepts signals from a gramophone pick-up, with the signal fed in via terminals on the rear of the chassis (see photo).

The threshold sensitivity is adjusted by a trimpot marked as SP5130 on the circuit diagram and located at the lefthand rear of the chassis. This trimpot alters the RF gain of the 6A7 converter valve.

The final valve in the line-up is a type 80 rectifier. This provides full-wave rectification of the high-voltage secondary output of a conventional mains transformer to provide the HT line. This HT line is filtered by capacitors C10 & C11 (both 8μF) and the

HT coil in the electrodynamic loudspeaker. As previously mentioned, in this particular set, the latter had been replaced by a 2kΩ 20W resistor.

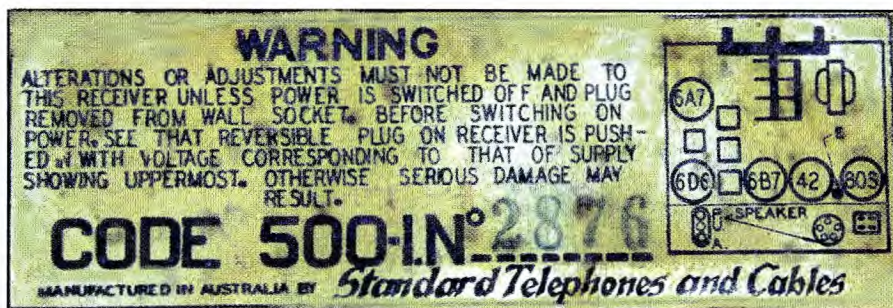
The original twin-flex mains cord ran to a plug to the right of the speaker socket and this plug was used to select between a line voltage of 200VAC or 240VAC (see Fig.1). This warning label on the rear panel advises the user to check that the plug position correctly corresponds with the supply voltage .

The original 2-core mains lead installed in the 1960s is now illegal in this type of equipment. In addition, this cord was terminated in a loose socket that made poor contact and this socket had to be orientated to match the mains voltage. This meant that the 200VAC tap on the power transformer could be incorrectly selected.

As a result, the 2-core mains lead was replaced with a modern 3-core lead which was directly connected to the 240VAC tap on the power transformer. This cord will be substituted with a cloth-covered cord in the near future, so that it is more in keeping with the set's age.

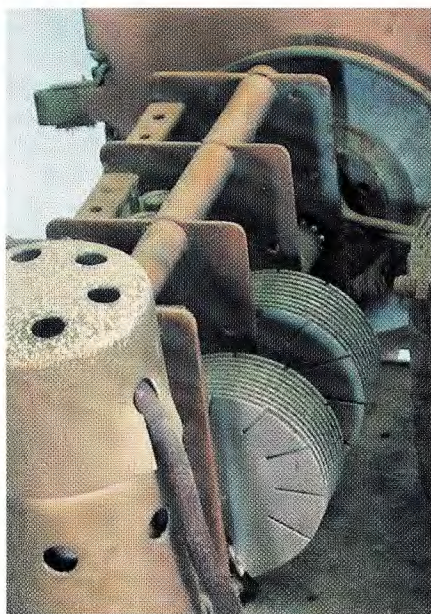
The same punched chassis was used by STC for a range of radios and this explains the rather unusual use of a 3-gang tuning capacitor frame with one section missing. A 3-gang tuner would have been necessary in models with an additional tuned RF stage.

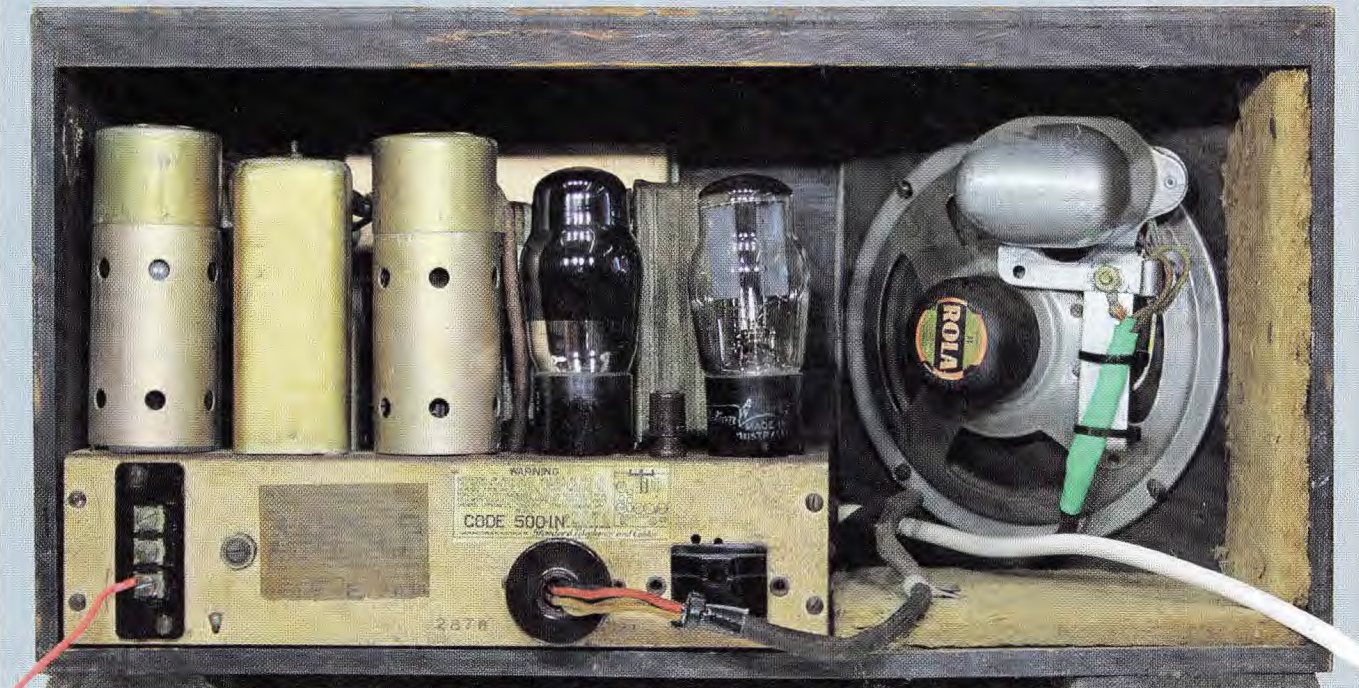
This view shows the Type 500A after restoration. The new 3-core mains cord bypasses the voltage selection plug (to the right of the loudspeaker socket) and is wired directly to the transformer. It also allowed the chassis to be safely earthed.

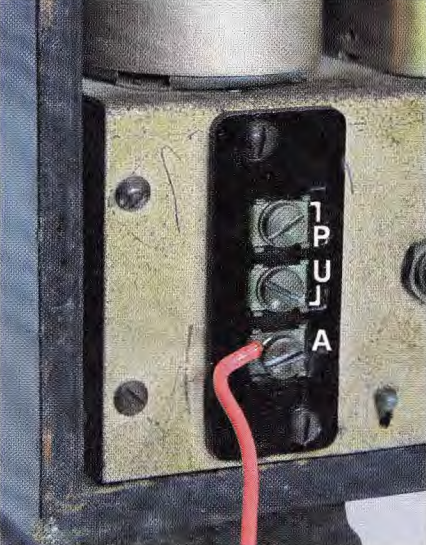
The 500A's back panel features two screw terminals to accept the output from an external turntable pick-up (see the advertisement from Levenson's Radio). These two terminals connect to the volume control (AS11-G) in the first audio stage but note that there's no switch to switch the RF front-end out of circuit. Instead, the radio was tuned to a quiet part of the dial when the record player was being used.

The pick-up terminals are on the rear of the chassis, directly above the antenna terminal. There's no provision to switch out the RF section when using the record player; instead, the user has to tune to a quiet spot on the dial, to avoid interference.
