# Vintage Radio

## The Stromberg-Carlson 1946 model 5A26 radio

Released in 1946, the Stromberg-Carlson model 5A26 was a good-performing 5-valve superhet radio in an attractive Bakelite cabinet. The set featured here was acquired in relatively good condition and was easy to restore.

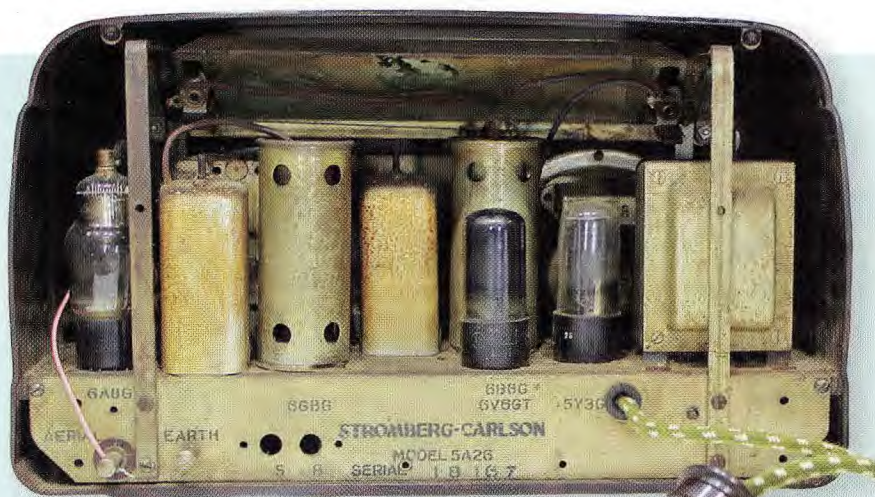
Above: the inside of the old radio looked like it had been splattered with fat but this "grease" probably came from the wax impregnation used in the power transformer and other components.

All components on the top of the chassis looked like they had spent years next to a fry pan in a kitchen and had been splattered with fat. However, there are two pieces of evidence against this explanation: (1) the soiling was not spread across the components in a pattern consistent with splatter; and (2) another 5A26 showed identical soiling, indicating a characteristic inherent to these Stromberg-Carlson radios.

The chassis was given a thorough clean up with mineral turpentine to remove the wax and dust, while abrasive paper was used to restore the appearance of the aluminium IF-coil cans and the transformer covers.

A thorough clean-up of the chassis with mineral turpentine removed the grease and dust. Some 180 grit abrasive paper was then used to shine the aluminium IF-coil cans and clean the steel chassis. Note that although steel wool does a good job when it comes to bringing back a shining metal sur-

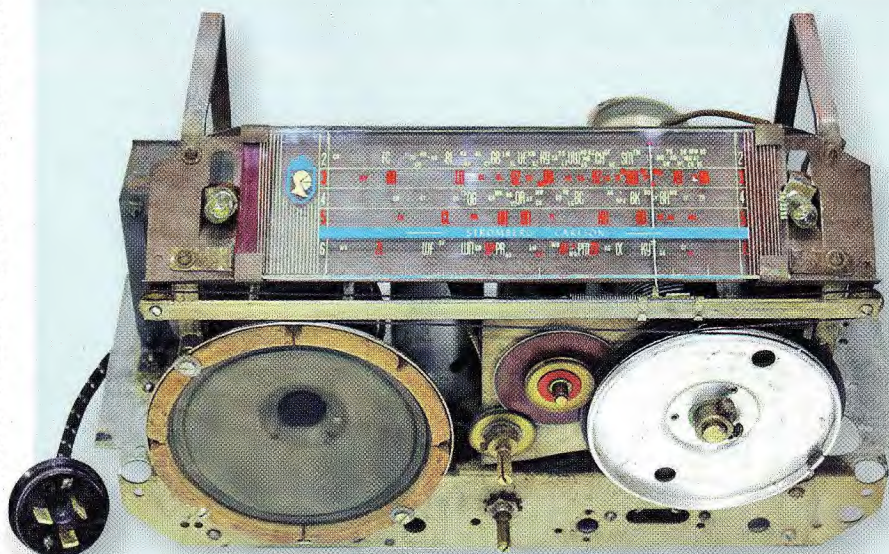
This view shows the chassis of the Stromberg-Carlson 5A26 after restoration. The dial cord had come away from its track and figuring out the correct path in order to restring it was one of the challenges faced in restoring this radio.

The dial cord hadn't broken but had come away from its track, so I had to figure out the correct path in order to rethread it. This was more challenging than on most radios I've tackled but I eventually got it working. The trick is to make two loops around a string-clamp to get just the right amount of spring tension.

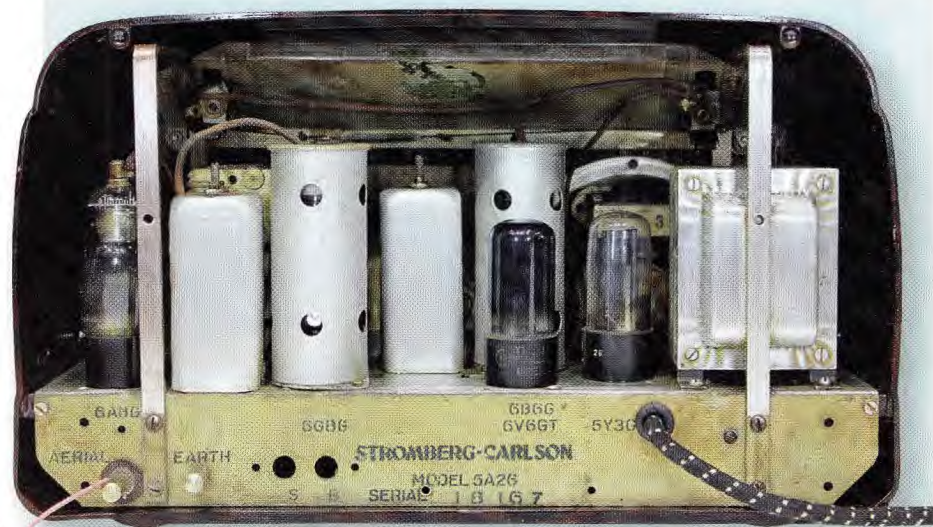
A new fabric-covered mains cord was fitted to the restored chassis. This was anchored using a cable clamp and its Earth wire secured to the chassis.

Finally, a replacement 3-core mains lead had been installed by the previous restorer but the earth had been left floating. The olive-green colour of that replacement cable didn't suit the set, so I substituted a black-flecked cloth-covered cable and connected the Earth lead securely to the chassis. This new cable was also clamped to the chassis, rather than using a knot inside the chassis (now illegal, as used to "restrain" the old cable.

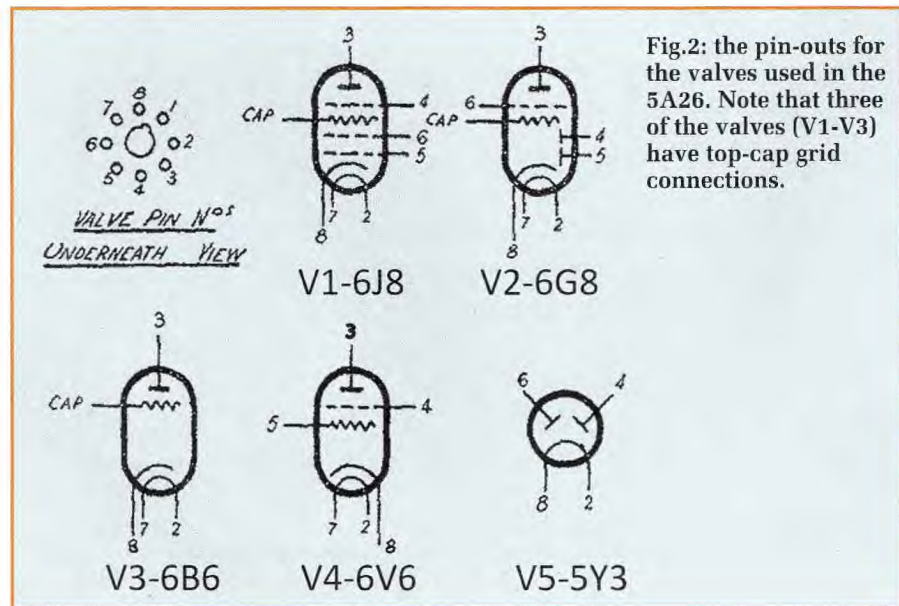
Fig.2: the pin-outs for the valves used in the 5A26. Note that three of the valves (V1-V3) have top-cap grid connections.

Note that three of the valves (V1, V2 & V3) have top-cap grid terminations, as indicated by the pin-out diagrams in Fig.2 (reproduced from the data published in the Australian Official Radio Service Manual, 1946). The loudspeaker is a Rola 5-inch permanent magnet type, so filter inductor L6A is a discrete component rather than a field coil.

As stated above, three of the valves have top-cap grid connections. In the case of V1 & V2, these go to the tuning gang and the secondary winding of the first IF coil respectively, while V3's grid connects to the wiper of the volume control via a capacitor. These top-cap connections allow the leads to be kept short, to minimise stray capacitance.

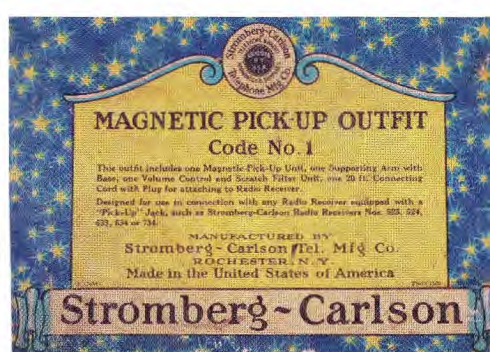
Stromberg-Carlson pioneered gramophone playback via a radio's audio amplifier stage. This photo shows the box-top of a 1928 add-on "Magnetic Pick-Up Outfit".
