# Vintage Radio

## Tela-Verta 1948 Musiclock Model 204C Mantel Radio

Designated the model 204C, this classic art-deco mantel radio incorporated a 5-valve superhet chassis and a Smith's Selectric clock movement with alarm & sleep functions.

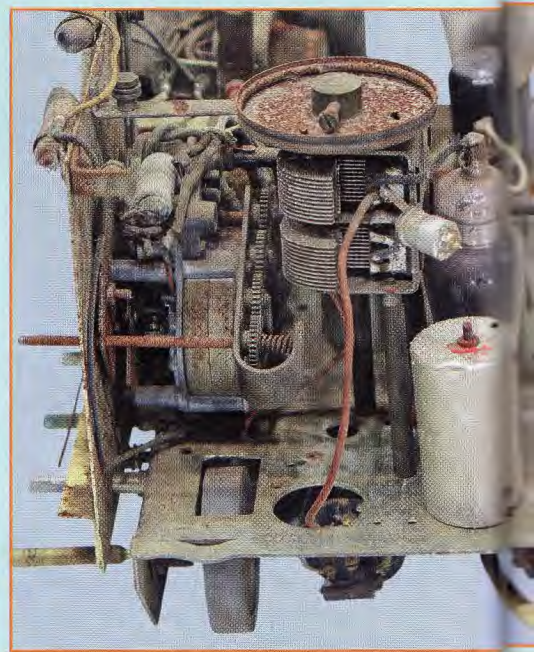
The 204C model incorporated a Smith's Selectric clock movement with alarm, wake-to-music and sleep functions. The photo immediately above shows the synchronous motor and gears used in this clock. It also clearly illustrates the poor state this example was in before work began.

Unfortunately, the clock's hands were missing and the rest of the mechanism was deemed to be beyond repair. As a result, all the electric clock parts were removed during the restoration and a modern quartz alarm clock movement substituted.

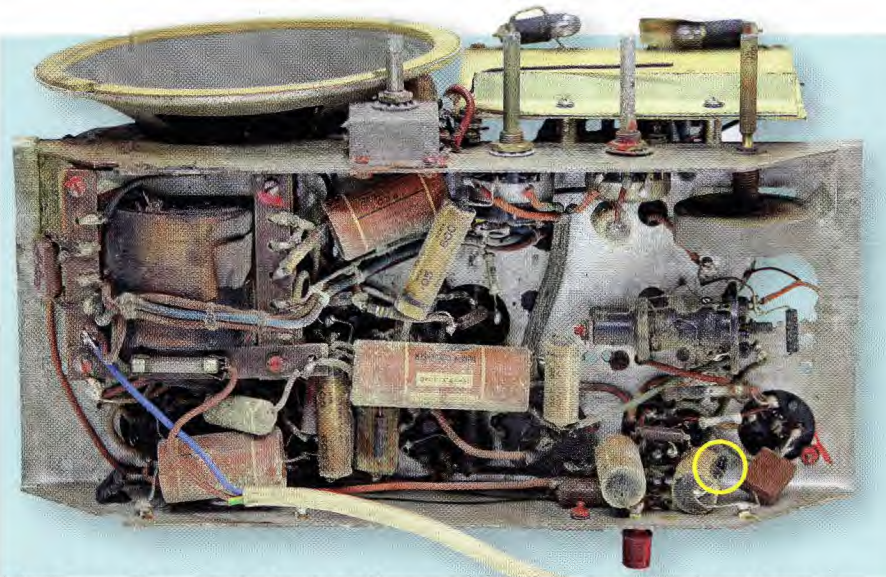
Fig.1 shows the circuit details of the model 204C. It's a conventional

The reason the radio had originally stopped working was simple – the 450Ω resistor (circled) in the 6A8's cathode circuit had gone open circuit. This left the cathode floating so that the valve could no longer function as a mixer-oscillator.

Fortunately, measuring the voltages around the 6A8 mixer-oscillator quickly revealed the problem. The cathode was at 118V (circuit indicates 3V) and all other voltages were way out. This indicated that the 450Ω 6A8 cathode resistor was open circuit and that indeed proved to be the case. As a result, the cathode resistor was replaced along with its parallel 0.05μF bypass capacitor.

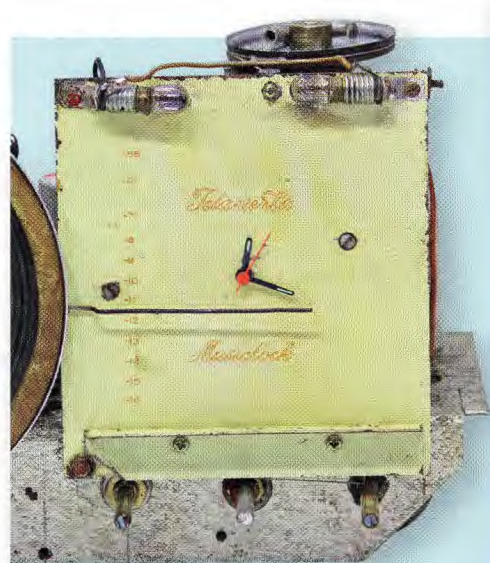
The clock face is positioned directly behind the dial which carries the hours and minutes markings.

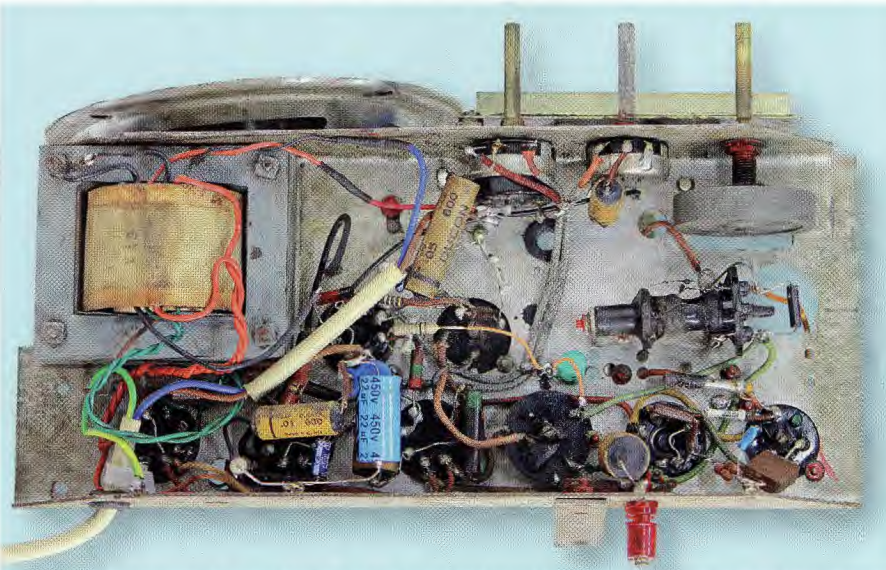
This photo shows the restored chassis with its replacement transformer & various other parts. The mains cord was later securely anchored using a clamp.

In this case, a Philips chassis on my parts shelf had a transformer that could be adapted, even though it was about 10mm longer and needed some creative metal work in order to slip it into place. The replacement transformer produced HT voltages that were spot-on to the circuit diagram values for the Tela-Verta and it had the necessary 5V and 6.3V heater windings.

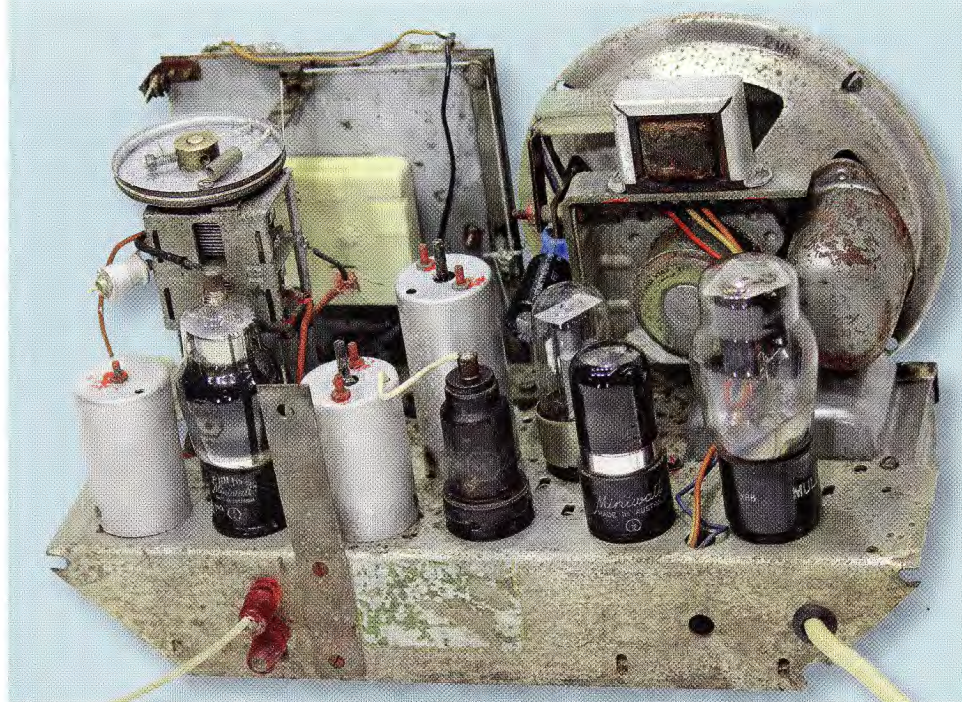
This rear view shows the replacement clock movement on the back of the dial plate (ie, immediately in front of the tuning gang).

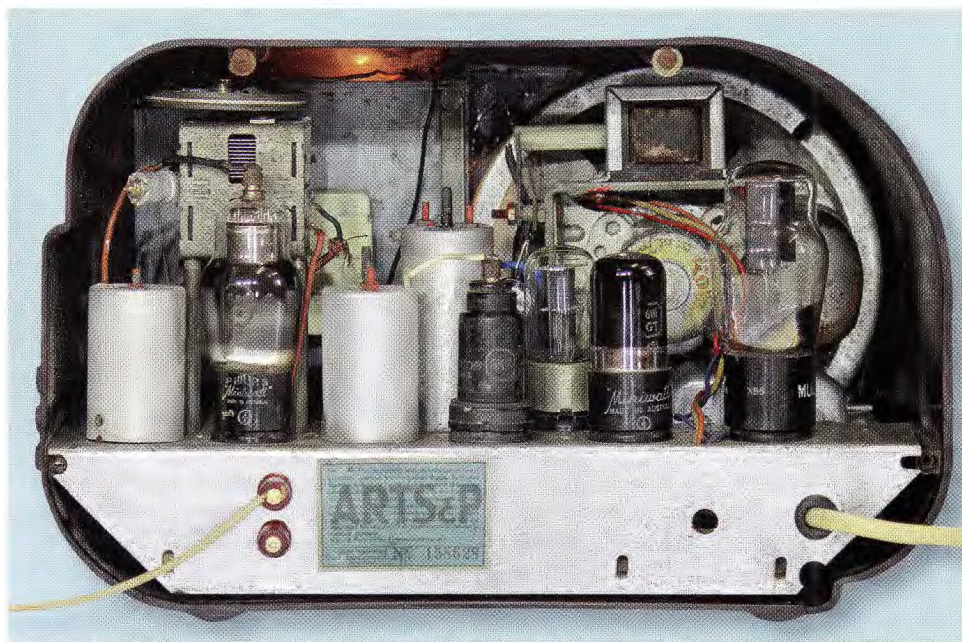
The restored chassis is a neat fit inside the Bakelite case and has been fitted with a new dial cord and a new ARTS&P sticker.

The last remaining repair job involved restringing the dial cord. The thick, green string that someone had previously used was laughably inadequate for the job and had to be removed. Unlike ordinary string, proper dial cord will follow the rotation of the tuning shaft without binding on itself or slipping.

There was one more heart-sinking moment left. As shown in one of the photos, the ends of the chassis are acutely angled in order to clear the case. However, when I attempted to push the restored chassis back in, the mounting screws used for the replacement transformer fouled the edges. The solution proved to be quite simple – it was just a matter of cutting 3mm off the ends of the screw threads that secured the transformer, after which the case and the chassis married up.
