Vintage Radio

The 1955 Fleetwood 4-Valve Model 1003

The Fleetwood Model 1003 is a 4-valve set that was manufactured at Philips' Hendon plant in South Australia during the 1950s. It's a relatively simple design based on 9-pin valves and has quite good performance.

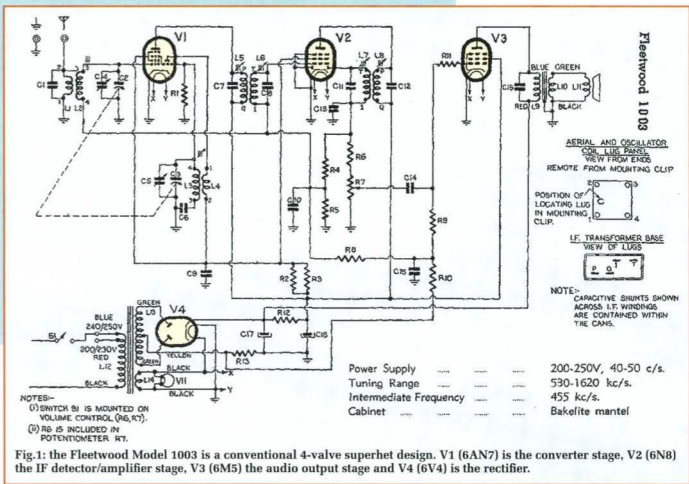
Fig.1: the Fleetwood Model 1003 is a conventional 4-valve superhet design. V1 (6AN7) is the converter stage, V2 (6N8) the IF detector/amplifier stage, V3 (6M5) the audio output stage and V4 (6V4) is the rectifier.

Fig.1 shows the circuit details of the Fleetwood Model 1003. It's a conventional superhet design with V1 (6AN7) operating as the converter, V2 (6N8)

as an IF detector/amplifier stage, V3 (6M5) as the audio output stage and V4 (6V4) as the rectifier.

Unlike the Fleetwood set, the Philips 5-valve model 165 uses two valves to achieve IF amplification, detection and AGC - see Fig.2. In this circuit, V2 is a 6BH5, while V3 is a 6BD7 which subsequently drives a Philips Miniwatt 6M5 output pentode. By contrast, in the Fleetwood circuit (Fig.1), a single 6N8 (V2) performs IF amplification, detection and AGC.

The 9-pin 6M5 power pentode (V3 in the Fleetwood) has a gain of 22 in typical use and this is adequate to avoid the need for extra preamplification after the IF stage. In fact, R6 is a 400kΩ series resistor that's actually built into the 100kΩ volume pot (R7) to reduce the signal that's fed from the 6N8 to the 6M5 audio output valve. The 6M5 can easily deliver 3W of audio, which is more than enough to

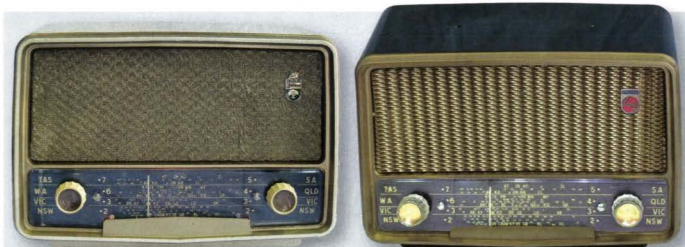
In addition to its distinctive logo, the Fleetwood Model 1003 (left) is easily distinguished from the electrically-identical Philips Model 164 (right) because it uses a cloth speaker grille rather than a metal mesh grille.

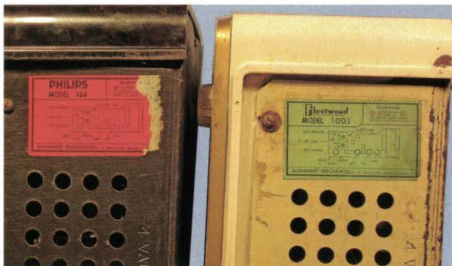
The Philips Model 164 and Fleetwood Model 1003 are virtually identical. Even the labels on the back are the same, except that one is red and the other is green.

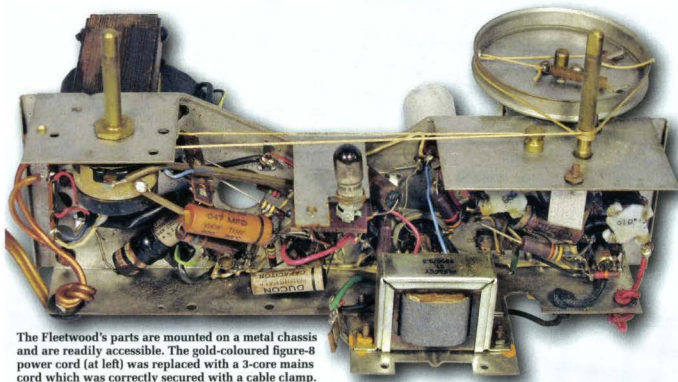
The Fleetwood's parts are mounted on a metal chassis and are readily accessible. The gold-coloured figure-8 power cord (at left) was replaced with a 3-core mains cord which was correctly secured with a cable clamp.

My Fleetwood 1003 radio was received in working order and all the parts under the chassis appeared to be in good condition. That meant that there was little to do other than tidy up the rather messy layout. Indeed, one essential chore was to replace the rather stylish gold figure-8 2-core flex with a 3-core mains power cord and to properly secure this with cable clamps.

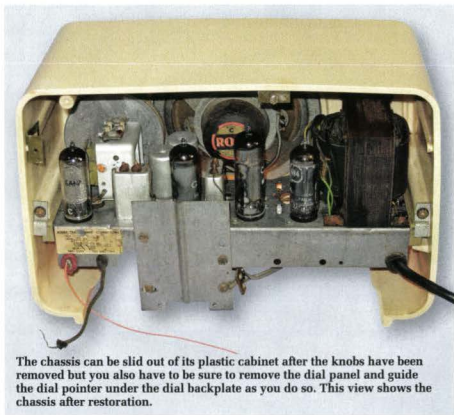
The chassis can be slid out of its plastic cabinet after the knobs have been removed but you also have to be sure to remove the dial panel and guide the dial pointer under the dial backplate as you do so. This view shows the chassis after restoration.

In these sets, the dial pointer is awkwardly poked up from under the back plate behind the dial assembly and if you simply tug on the chassis, the dial cord breaks. The correct procedure is to first remove the plastic calibrated

dial panel at the front (two screws) and then guide the dial pointer under the backplate that is part of the cabinet moulding as the chassis is withdrawn.

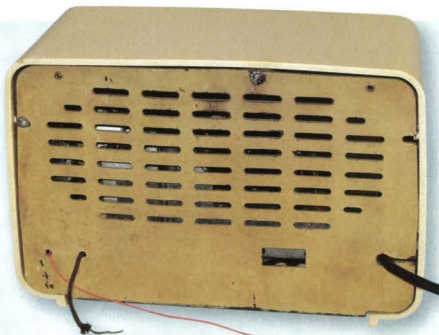
This rear view shows the Fleetwood 1003 fitted with its punched fibre-board cover. The two leads at lower left are for the antenna and earth connections.

other parts on the top of the chassis – this despite the back of the set being protected by a punched fibre-board cover. This dust and any associated grime were removed by brushing the parts with mineral turpentine and then air-blowing the chassis dry.

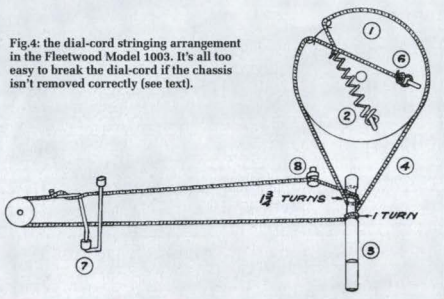
Fig.4: the dial-cord stringing arrangement in the Fleetwood Model 1003. It's all too easy to break the dial-cord if the chassis isn't removed correctly (see text).

In my radio, the dial had already been restrung but with ordinary string rather than dial cord. This suggests that someone else had previously fallen into that beginner's trap. Despite using ordinary string, the restrung dial worked quite well, so I left it as it was.
