Vintage Radio

AWA 1946 Fisk Radiola Model 92 Egg Crate

Despite having modest performance and cut-price circuitry, many vintage radios have become collectors' items due to their distinctive cabinet styles. The AWA Fisk Radiola Model 92 "egg crate" radio from 1946 is one such set.

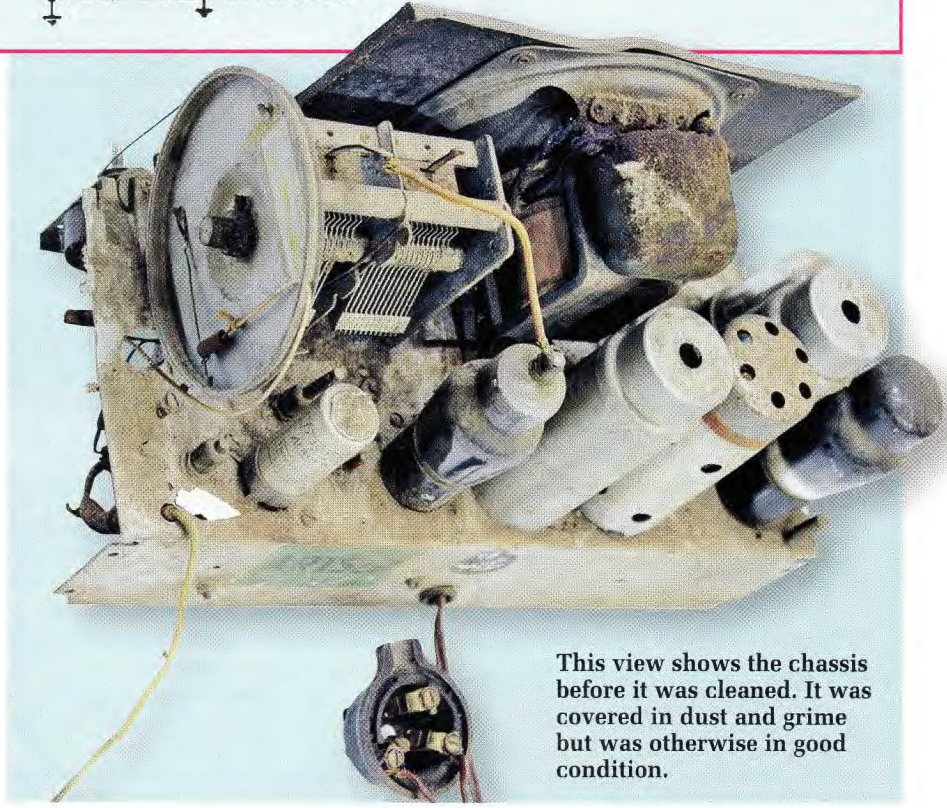
Internally, the radio was covered in grime and that meant that the chassis

This view shows the chassis before it was cleaned. It was covered in dust and grime but was otherwise in good condition.

Once the outside was looking good, the chassis was brushed out to remove any fluff and then liberated from its grime using a turpentine wash. It was then blown out with compressed air to thoroughly dry it.

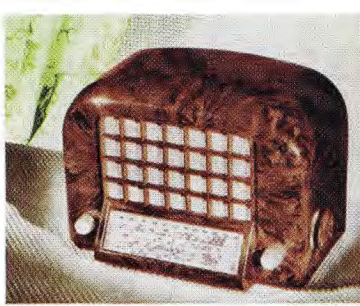
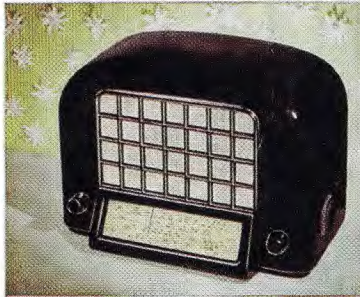
The cabinet came up looking like new but the torn speaker cloth had yet to be replaced when this photo was taken. It was later swapped out for a similar coarse-weave fabric that had been sprayed with ivory-coloured paint to match the original colour.

I tackled the cabinet first. The original speaker grille fabric was beyond repair and that presented a problem because its coarse pattern is part of the character of this radio. Fortunately, I soon discovered that I had some similar fabric on hand, the only problem

being that it was pale blue. That problem was quickly solved by spraying the fabric with ivory-coloured paint, a technique that works quite well.

Next, the knobs were removed and cleaned using a brush and warm, soapy water. I then cleaned the cabinet and wiped it over with "Armor All" and it came up looking almost like new.

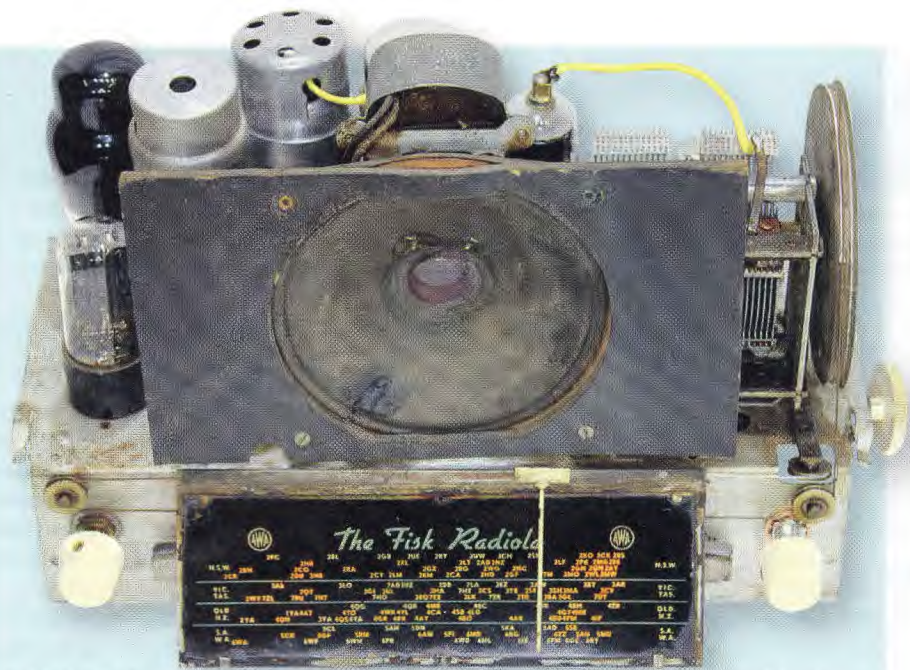
This is the fully restored chassis, ready for re-installation into its cabinet. In addition to the electrical repairs, the dial cord required restringing and a small tear in the speaker cone was repaired with PVA glue.

That done, the broken dial cord was removed and replaced. I also discovered that the 5-inch speaker cone had a small tear and this was repaired using PVA glue.

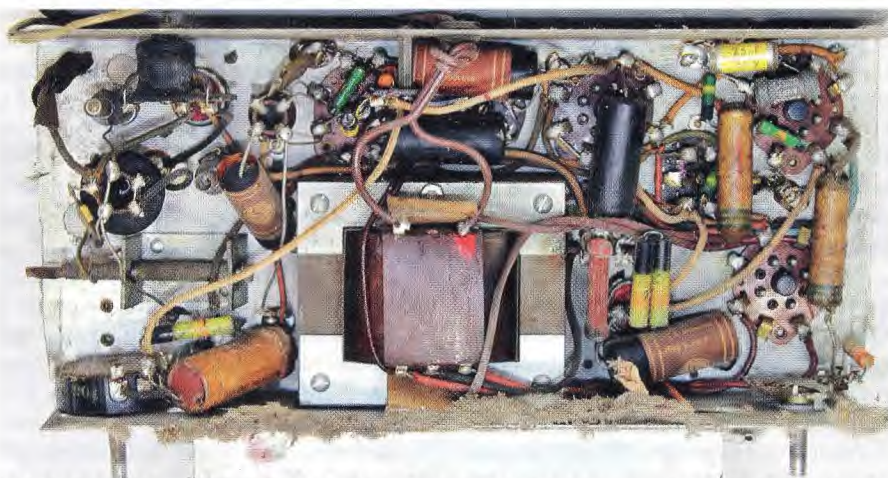
This view shows the underside of the chassis prior to restoration. Note the knot (now illegal) tied in the twin-flex mains cord that was originally fitted to the set. The volume control and several faulty electrolytic and paper capacitors had to be replaced to restore the set to operation, along with various other repairs.

two chassis-mounted HT filter electrolytics (C25 & C26) had dried out, with perished red rubber at the base of the cans. Rather than remove them, these capacitors were left in place on the chassis in order to maintain the original appearance. It was just a matter of cutting the appropriate leads to disconnect them and then installing two 33 μ F 450V electrolytics under the chassis to serve as the HT filters.

In addition, paper capacitor C22 (0.05 μ F), which couples the detected signal from the 6G8 to the 6V6 audio output stage, was replaced with a 0.047 μ F 630V Mylar unit. Based on long experience, I always replace this usually leaky capacitor as a matter of routine. This prevents leaked HT from overloading the output pentode with positive grid bias, which can quickly destroy both the output valve and the output transformer.

The last modification before switch-on was to remove the old 2-core mains flex and install a 3-core cable. This allowed the chassis to be securely earthed, making the unit much safer to work on. In addition, the new cable was securely clamped into position. The original cable had been secured by tying a knot in the lead just inside the chassis (see photo), which is illegal these days. It was common practice back then, though.

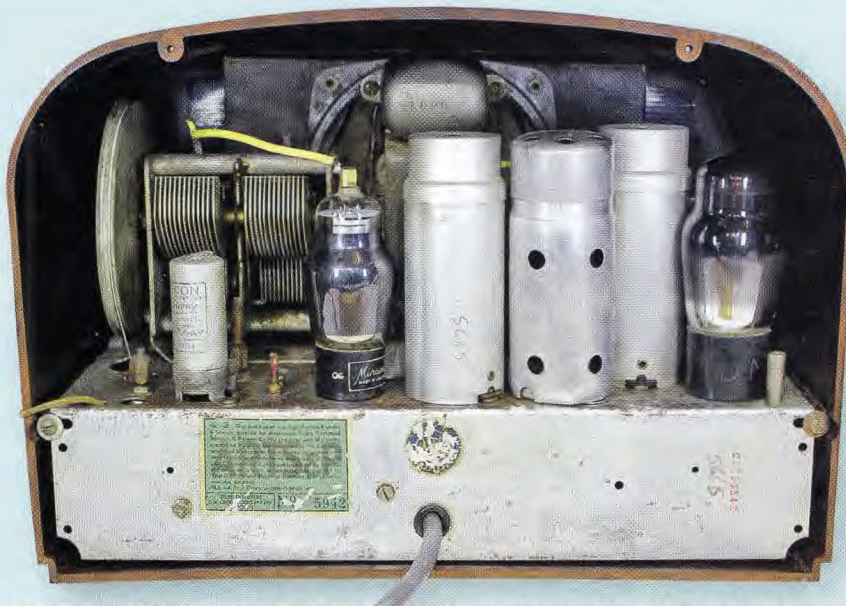
The ARTS&P label on the back of the chassis indicates that this Model 92 set was manufactured in 1946. It's in quite good condition considering its age.
