Vintage Radio

Pye 1951 5-Valve Model APJ-Modified

Pye's 1951 Model APJ-Modified is a conventional post-war receiver featuring three shortwave bands, a 5-valve superhet circuit and a cut-price timber cabinet. It also has a trap for the unwary – an output transformer frame that's connected directly to the HT from the rectifier!

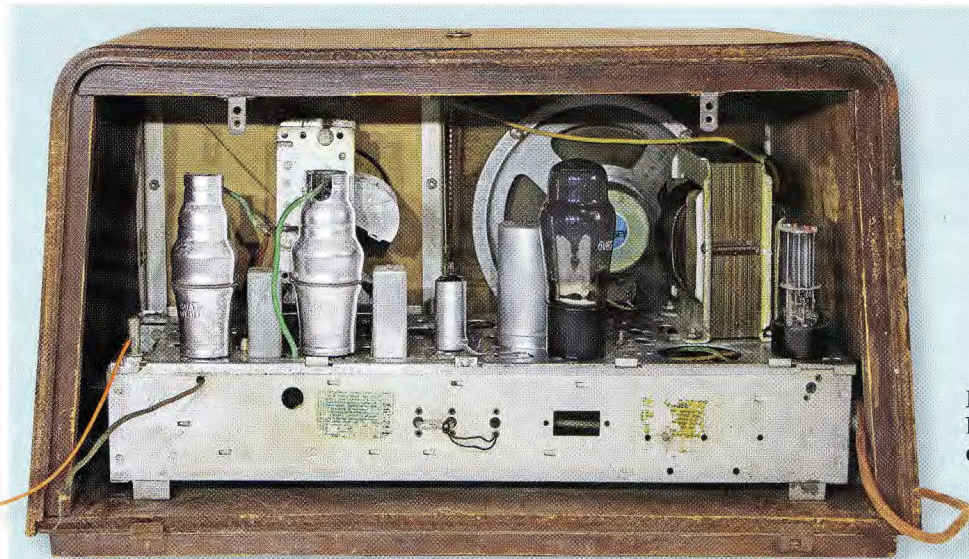
Rear view of the Model APJ-Modified set and the base of an octal 6U7G IF amplifier.

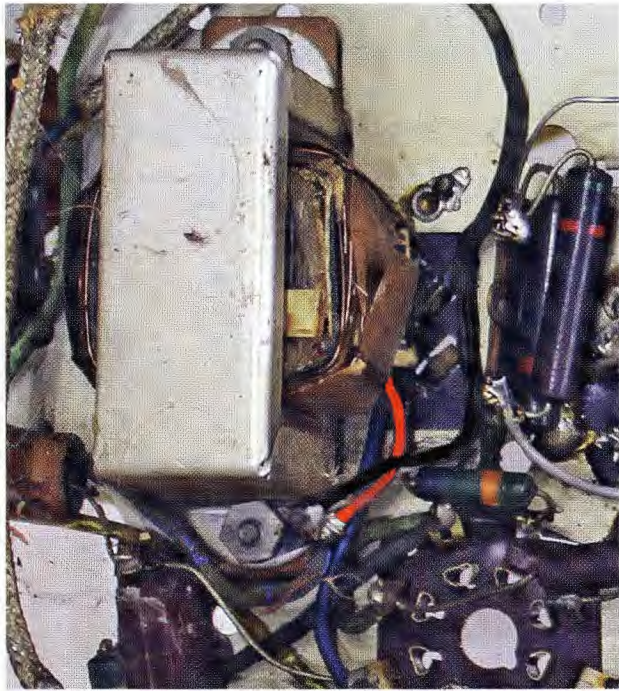
The unmodified front-end circuit is shown in Fig.2 and this features a miniature 6AN7 valve as the converter. The Pye service notes state that "it was intended to use a converter valve type 6AN7 in the model APJ receiver. As supplies of this valve were not available at the time of production, a type

A particular problem in this set is that the HT from the rectifier and the secondary of the output transformer were connected to its frame, which was insulated from the chassis. This particular set also had excessive HT of 329V which caused occasional arcing between the output transformer primary and the earthed secondary.

Fig.2: a 6AN7 converter valve was originally meant to be used, but due to a shortage of this type of valve during production, a 6J8 or 6J8A converter valve was used instead.

This also eliminated occasional arcing (induced by the overvoltage) that could be seen as flashes between the output transformer primary (at full HT) and the earthed secondary.

And here a word of warning! If you come across one of these radios, note that the output transformer is mounted on an insulated stand-off from the chassis and its exposed metal frame is connected to the full HT (see Fig.1). The manufacturer provides no specific warning of the extreme danger, although a decal on the chassis does give a general warning as to the presence of high voltages.

So why was the output transformer's frame connected to the HT? The reason is that connecting the transformer's frame to its primary (and thus to the HT from the rectifier) helps prevent electrolytic spot corrosion of the fine wire used in the winding.

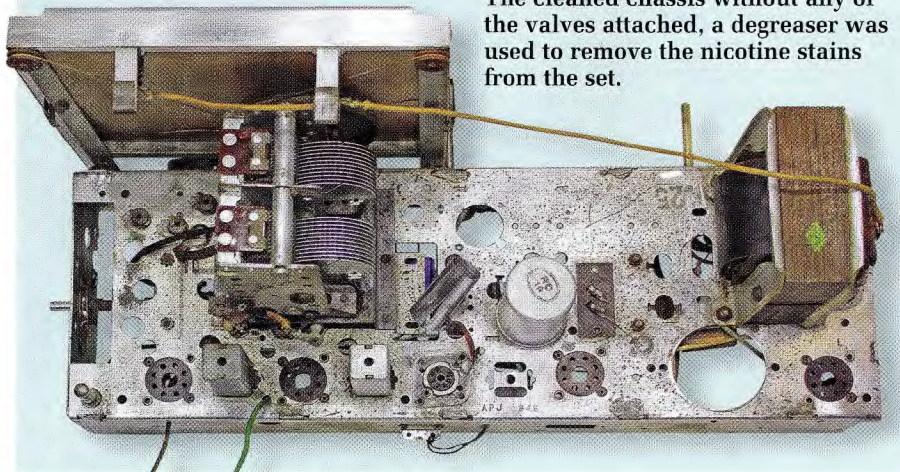
Removing the chassis exposed further problems. The first thing I noticed was that it was covered in a uniform brown staining that was particularly evident on the plates of the tuning gang. This radio had obviously spent quite some time absorbing nicotine in a household of smokers.

The cleaned chassis without any of the valves attached, a degreaser was used to remove the nicotine stains from the set.

The nicotine staining was so pervasive and intractable to mild cleaning that it was a job for degreaser. First, the valves were removed, the loudspeaker detached and the mains transformer water-protected by covering it with plastic wrap. The chassis was then judiciously sprayed with degreaser, brushed clean with water and thoroughly dried with compressed air.

The plates of the tuning gang emerged from this process positively gleaming. Many corrosion spots were then removed from the steel chassis by scouring with steel wool, taking care
