# Vintage Radio

## HMV's 64-52 Little Nipper

Charles Kosina has always enjoyed reading *Vintage Radio* every month in *SILICON CHIP*. But rather than being simply nostalgic about his former job after school repairing radios, he decided to restore a valve radio that he purchased online, a 5-valve HMV Little Nipper, model 64-52.

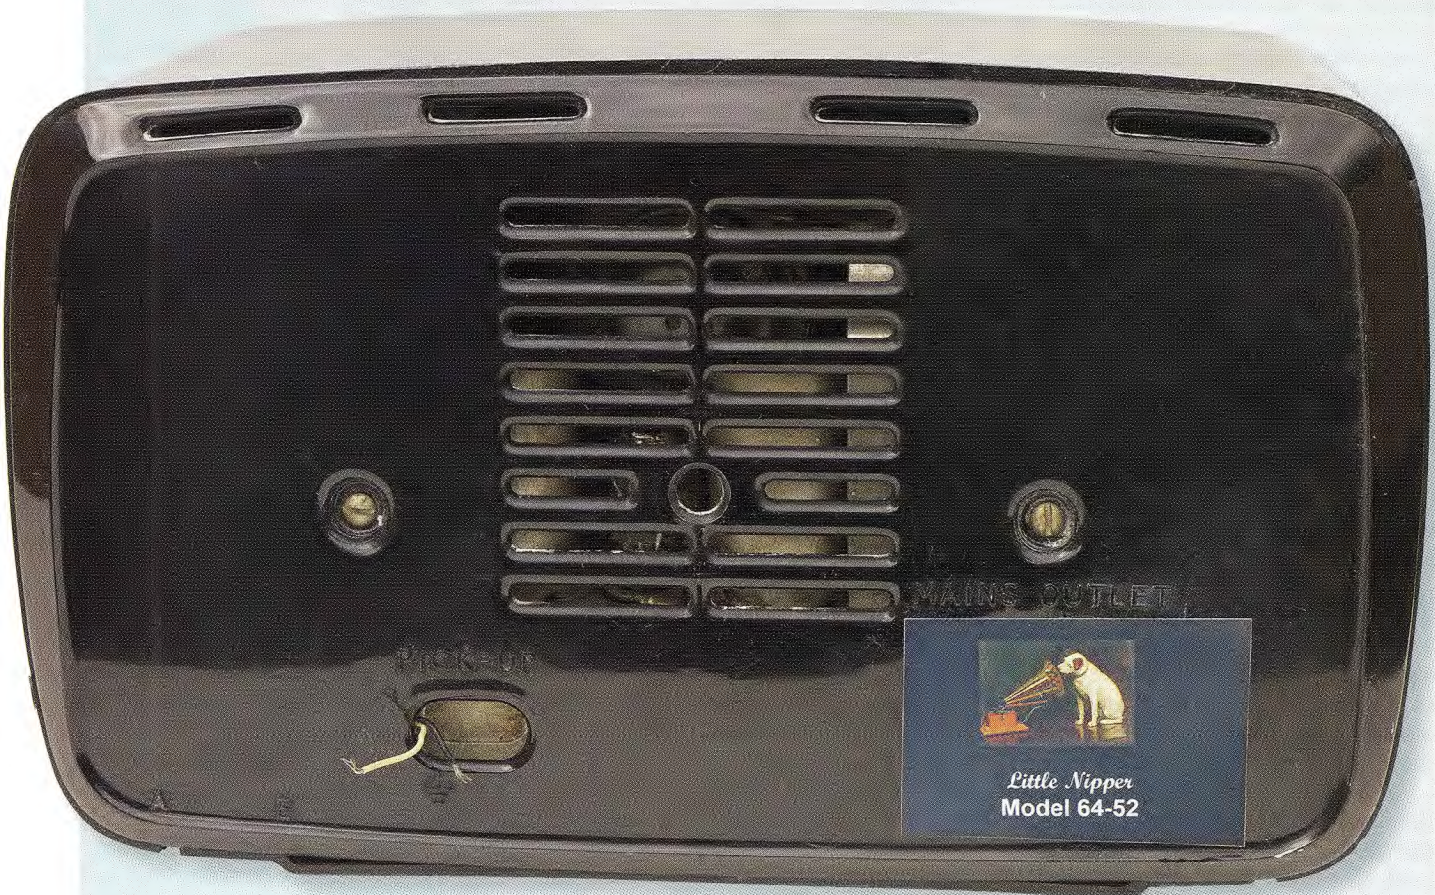
The rear cover of the set had damage around the mains outlet hole and so this was covered by the blue label, since the mains cable exits through the bottom of the set. This case cover was used in a number of Little Nipper models. The short black and white wires emerging from the back are for external antenna and earth.

glue line and reglue it was too much of a risk, so decided to leave it as is. But I did remove the excess glue very carefully. The back cover had a piece missing next to the "Mains Outlet" hole. The cover is obviously designed to fit different models as the mains cable did not come through it anyway. What to do about it?

Trying to reconstruct it was too hard and not really worth it. I opted instead to make a label cover with 300gsm photo paper to fit over the hole.

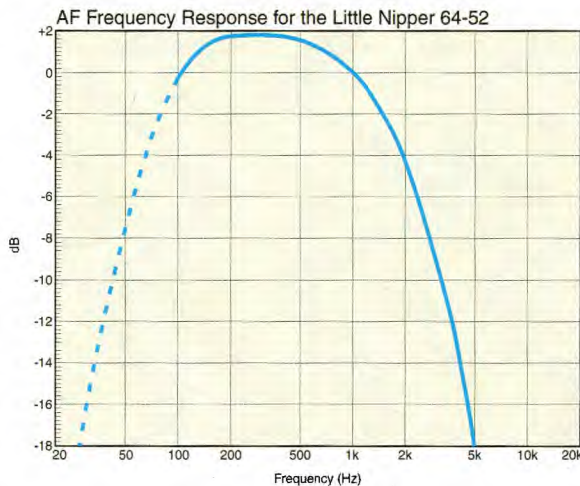
Fig.2: the Little Nipper's audio response was pretty typical for the day. It's quite far down at 5kHz and this is largely a result of the narrow IF response, which was desirable to get high sensitivity and good selectivity.

the speaker was 1.1W before there was any noticeable distortion of an input sine wave. I also did a frequency run on the set from the antenna to the speaker and this is shown in Fig.2. Using 1000Hz as the 0dB reference level, the  $-3\text{dB}$  point is about 1700Hz and at 3000Hz the audio response is 9dB down.
