Vintage Radio

HMV's 1951 Portable Model B61D

Portable radios became quite popular in the 1950s and 1960s, especially with the arrival of beach culture. And while they were quite expensive, relatively heavy and their battery life could be quite short, their cabinet designs were attractive and they are now very collectible. The HMV B61D portable is a good example.

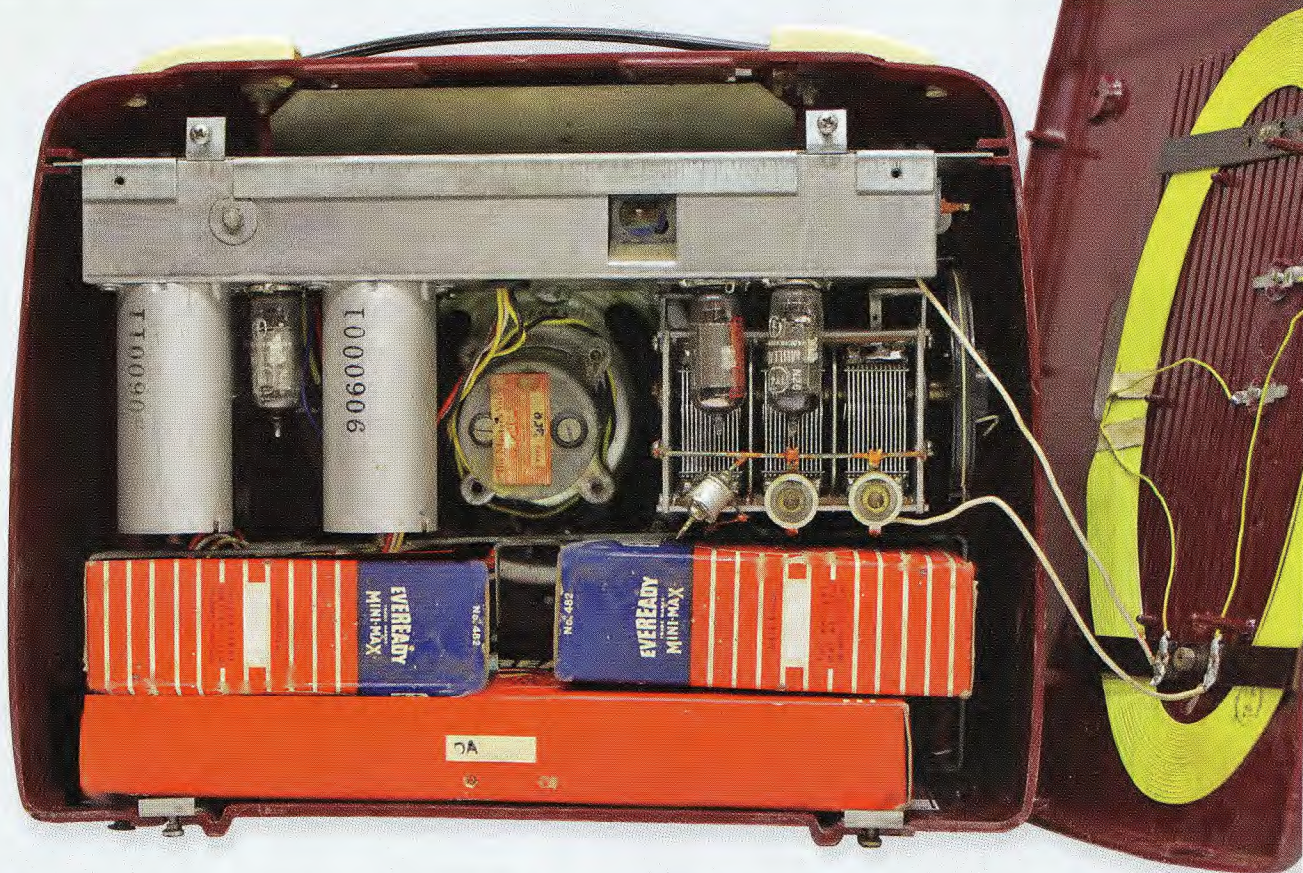
The chassis is mounted upside down in the cabinet and the central area is vacant to provide clear space around the rear of the speaker. The circuit diagram is just visible under the battery pack. The wound loop antenna is on the rear panel of the cabinet.

The chassis is mounted upside-down at the top of the radio. The

flanges on the top cover slide into moulded grooves to make installation and removal easy. The arrangement guides the control knobs to neatly line up with the access slots at the front.

The chassis is held in place by nuts tightening onto screw threads that are embedded in the case. A pair of long-nose pliers and a socket driver are needed to remove and install the nuts in the confined space at the front of the case.

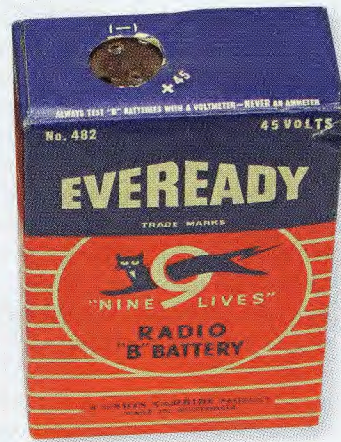
Batteries for portable radios were mated with polarised plugs (2 or more pins) to ensure correct connection to the circuit.

a year or so of typical service. Models with a mains adapter have less battery space and use a different set of batteries. The batteries connect to a wiring loom that has plugs configured so that only correct connections can be made. The sockets in the batteries can be seen in a picture of the Eveready battery.

Sockets are located at the top of the 45V type 482 and at the side of the 1.5V type 745. Eveready was the top selling brand of the time, but another of the HMV portables in my collection had a set of Diamond brand batteries installed.
