VINTAGE RADIO

AWA 1963 model B13 stereogram

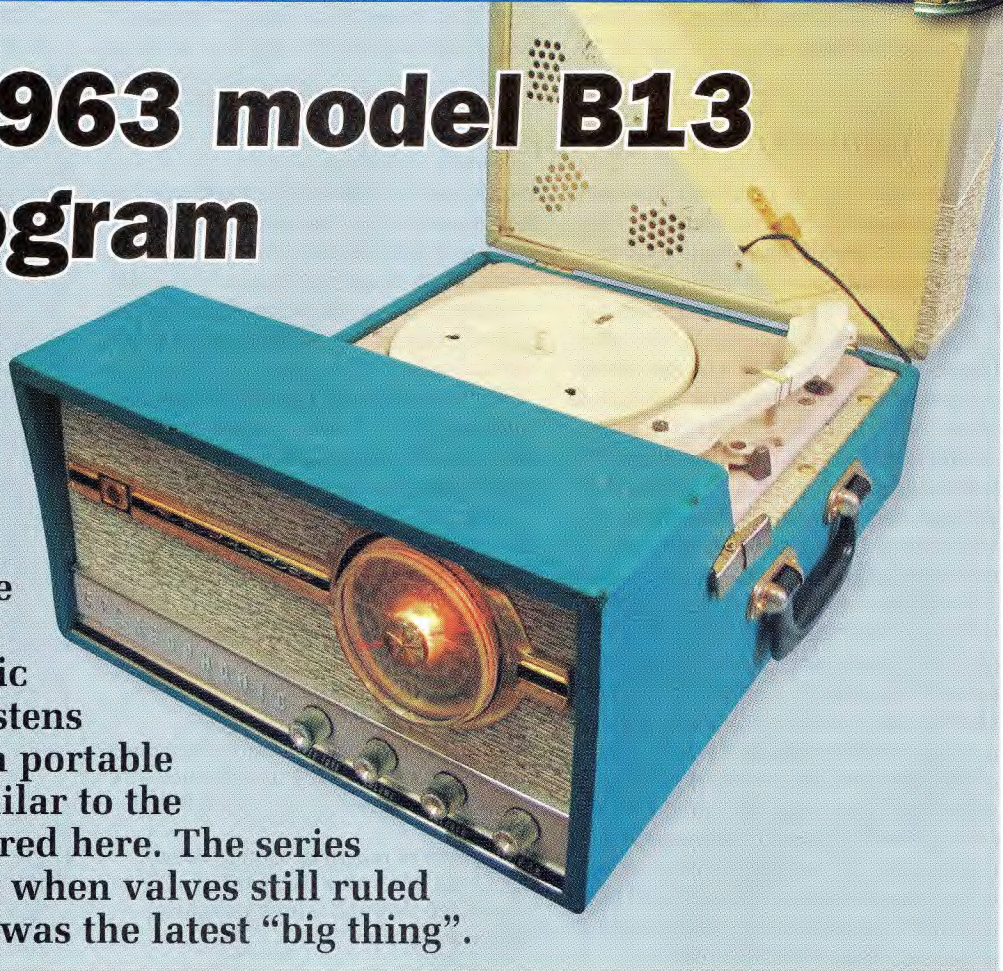
If you watch the popular “Endeavour” detective series on ABC TV, you will know that the young D.S. Morse is a classical music enthusiast who listens to LP records on a portable record player similar to the AWA model featured here. The series is set in the 1960s when valves still ruled and stereo sound was the latest “big thing”.

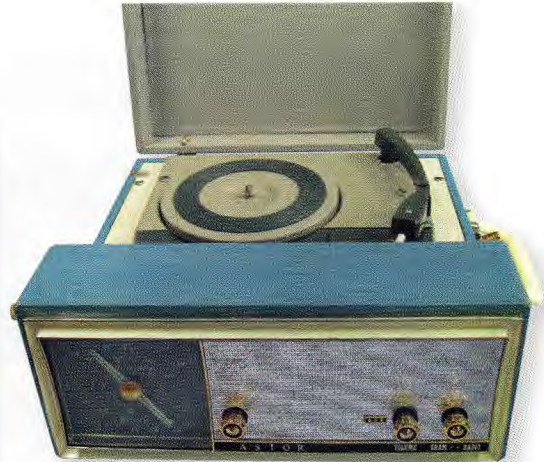
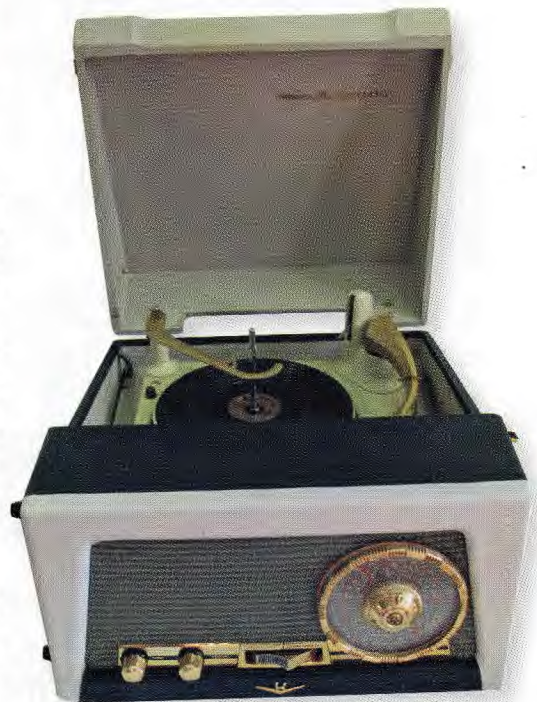
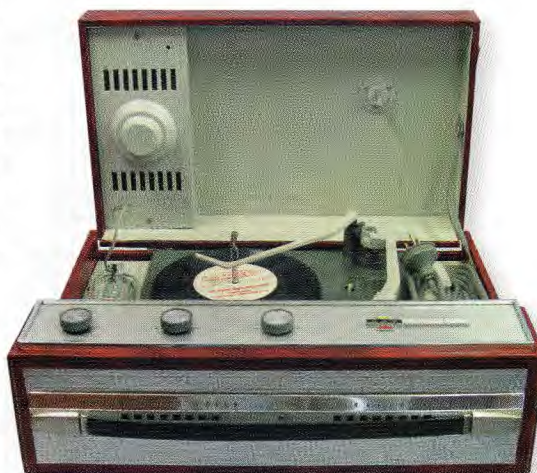
Two of these three portable radiograms of the period were stereo, both with a second channel speaker in the lid which had to be detached for listening to records. The three models shown above are a 1964 Astor G10L, 1955 Kriesler model 11-76 and 1966 HMV Bahama O3-8K.

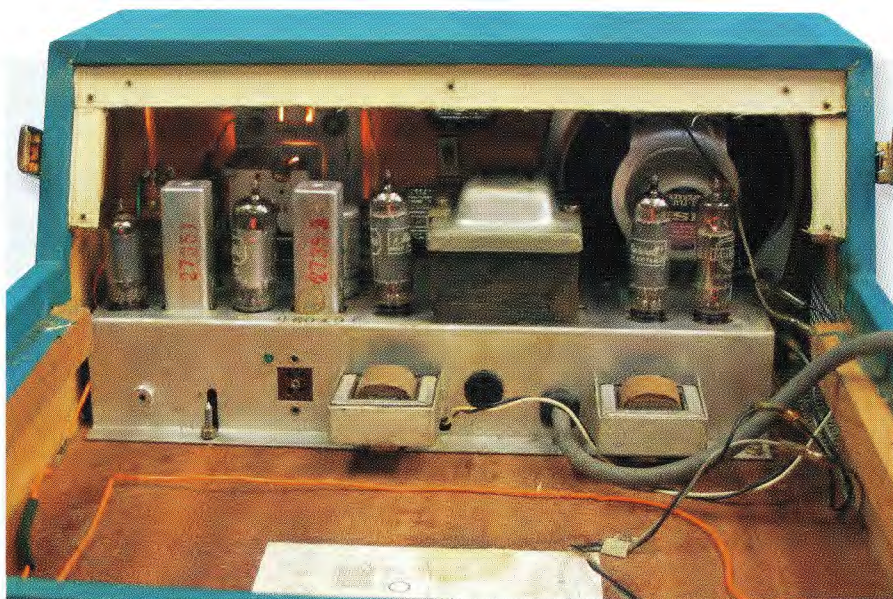
The chassis is crammed into the front of the case and the two audio out transformers hang off the rear. The orange wire is the aerial loop.

The chassis of the unit has been crammed into the front of the case as can be seen on the previous page. The orange wire used for the loop antenna can be seen connected to the aerial coil in the photograph showing the front of the chassis (right hand side in the photograph).
