# VINTAGE RADIO

## Astor HNQ Mickey 4-1/2 valve radio

**This is a plain-looking set, and as a four-valve reflex superhet, it isn't particularly good at pulling in weak stations. But it does have one interesting feature in that it uses permeability tuning, which was common in car radios but not so much in mantel sets.**

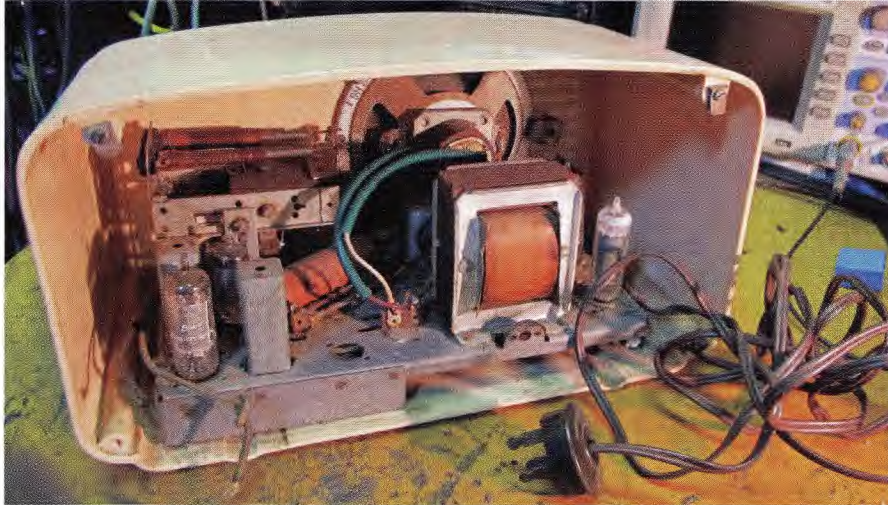
**The inside back of the Astor HNQ. The damaged 6AQ5 output audio amplifier valve is directly right of the power transformer. The visible two-core power cable was replaced with a proper three-core cable with Earth.**

insulation to Earth was intact and the windings were intact. I also fitted a three-core mains flex in place of the dodgy old two-core cable, retained with a knot.

I used a fabric-covered cable taken from an old toaster, to better suit the era of the set, and I made sure to anchor the cable properly and solder the Earth wire to the set's chassis.

At this point, I had to address the vacuum-less vacuum tube. It had a crack around the base and was undoubtedly beyond my repair abilities. Luckily, I happened to have a 6AQ5 in my spares with the box marked "brand new", so I swapped it into the set.

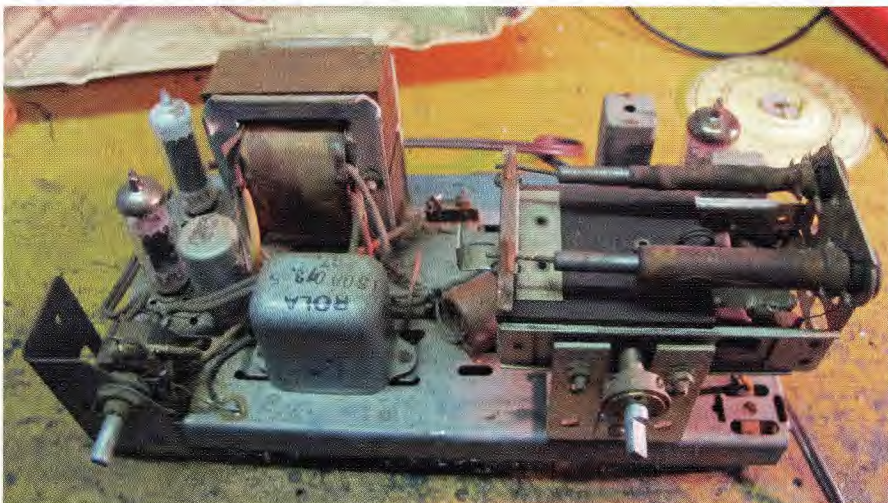
**The contacts on the power switch/volume control (bottom left) were badly corroded; a bit of cleaning brought it back into action.**

While doing this work, I discovered that the power switch was open circuit. The power switch is integrated with the volume control pot, so I removed it and pulled it apart. I found that the mechanism was working fine but the contacts were severely corroded. A shot of WD-40 and then chemical cleaner fixed that problem and it worked fine after reassembly.

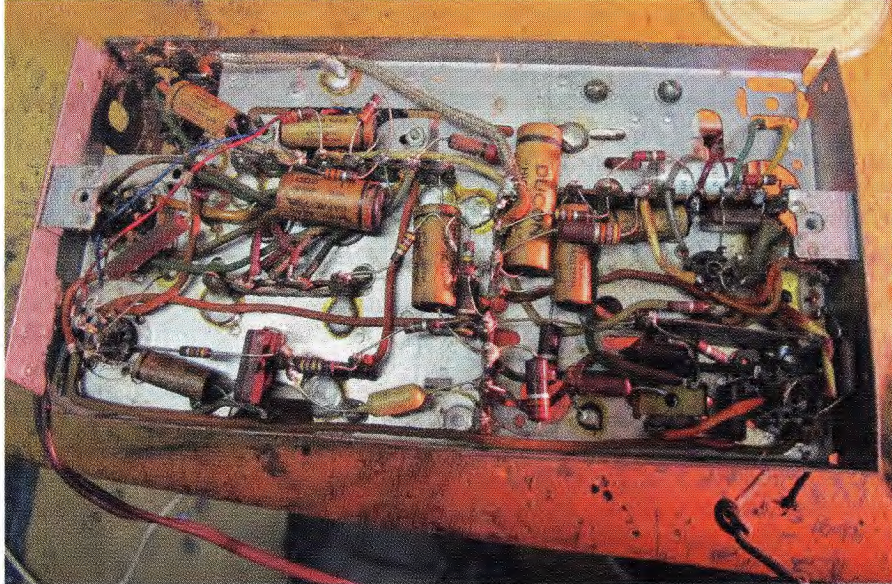
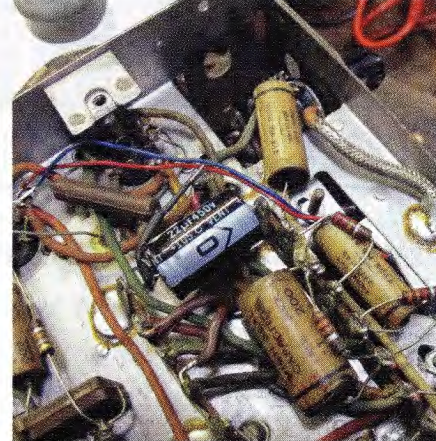
The underside of the chassis is primarily populated by resistors and capacitors. The photo on the right shows the newly fitted electrolytic capacitor which reduces audible hum.

I then checked all the DC voltages and found most to be as shown on the service manual circuit diagram, with -8V back bias indicating that the set had the expected current draw. The hum level was a bit high though, with HT ripple measuring about 0.5VAC at the HT 16 $\mu$ F capacitor (#18), increasing to about 2VAC when tuned into a strong station, with the audio modulating the rail!

So I fitted a new high-voltage electrolytic capacitor across #18, leaving the original in place. That drastically reduced the hum, both audibly and on the scope.

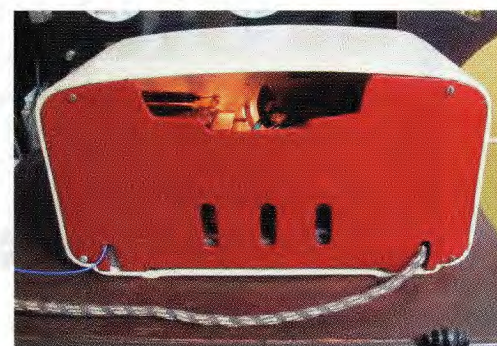
I then cut a scrap of fibreboard to the shape of the template and drilled the four securing holes. Once it fitted in OK, I cut a big chunk out of the top to form a handle which also acts as a vent for hot air to escape. I then cut a few slots toward the bottom for the cords to pass through, and others to let in some fresh, cool air.

The fibreboard tends to fluff at the edges where it was cut, so I sprayed the whole thing with a couple of thick coats of automotive filler undercoat to hold it together. Then, as I had a nearly empty can of iridescent Hot Red paint, I emptied it onto the back for a bit of contrast with the case. Whether you consider the final result good or not is a matter of taste. **SC**
