VINTAGE RADIO

1940 RME model 69 communications receiver

By Fred Lever

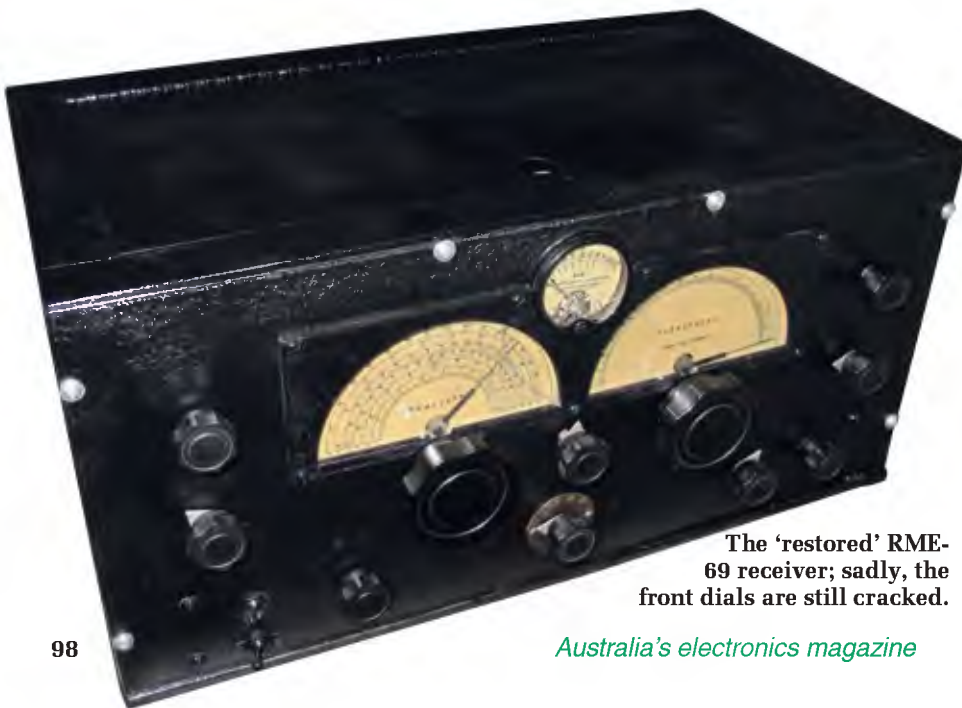
The 'restored' RME-69 receiver; sadly, the front dials are still cracked.

I achieved that by replacing obviously faulty parts and removing some strange modifications. I then carried out what I confess to being a cosmetic 'tart up' on the set and the matching pre-selector, by cleaning them and misting with a light coat of gloss black, over the faded wrinkle finish. The insides and chassis were cleaned, masked off and a light coat of silver misted over the rust and patina.

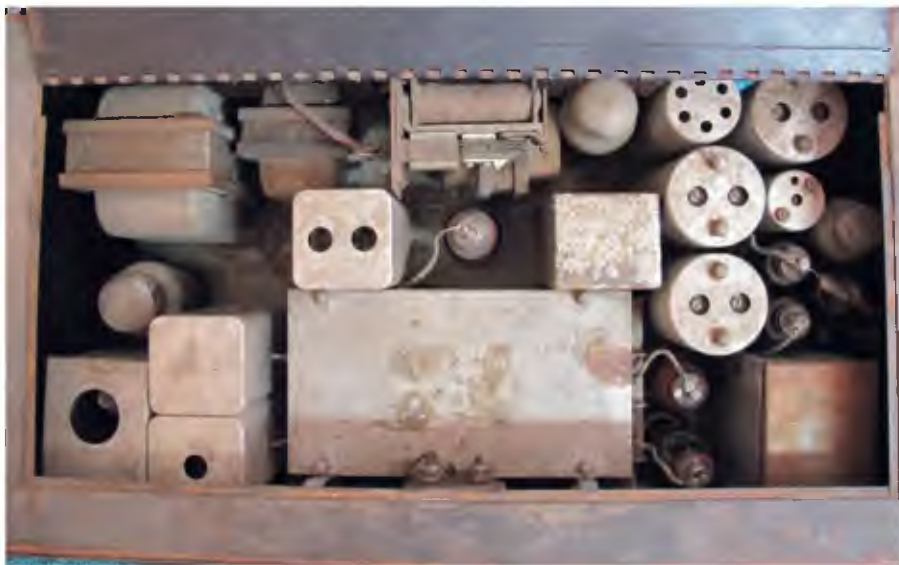
The inside of the receiver, as originally received, was full of dust and showed some surface rust.

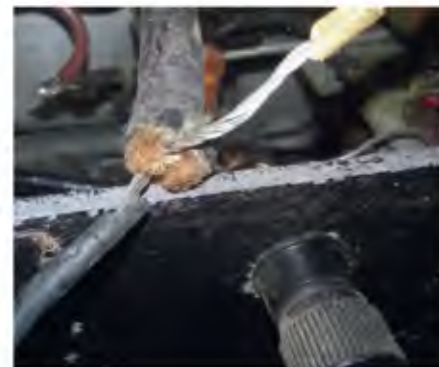
The original mains wiring in the receiver was unusable and unsafe, as shown. It was replaced with three-core cord with a chassis gland.

My first job was to remove all the existing mains wiring as it was not safe, due to rotting rubber and cracked insulation. I wired in a three-core cord with a chassis gland. After testing the insulation and Earth conductivity of the mains side of the circuit, I powered it up with low-voltage AC and

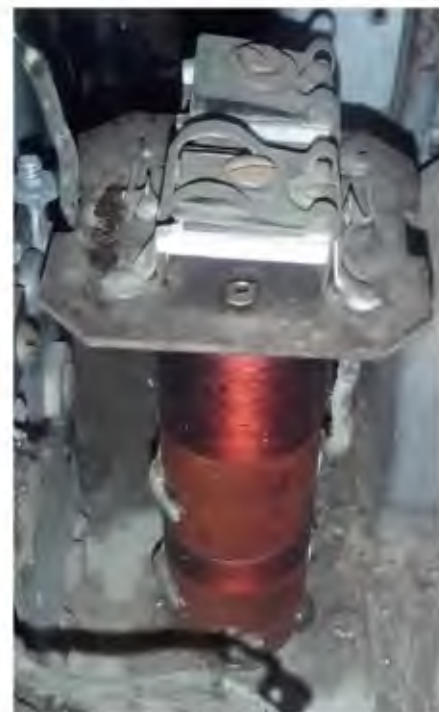
fitted inside the broadcast coil can. It was a heck of a job to get the can off, but once exposed, I found the adjusting screws on the calibration trimmers had simply unwound from vibration. You can see this clearly in the photo below.

Above: the underside of the RME chassis before any restoration work was done. Right: the calibration trimmers inside the broadcast coil had their screws unwind over time due to vibration.

Simply recalibrating the settings made the receiver work in a lively manner with gain, not loss, from the IF stages. Therefore, those two loose screws crippled the receiver on the AM band! From the corrosion on the parts, I think they had been that way for a long while. Possibly, the receiver was not used on the broadcast band in its ham duty, so this fault was never found.

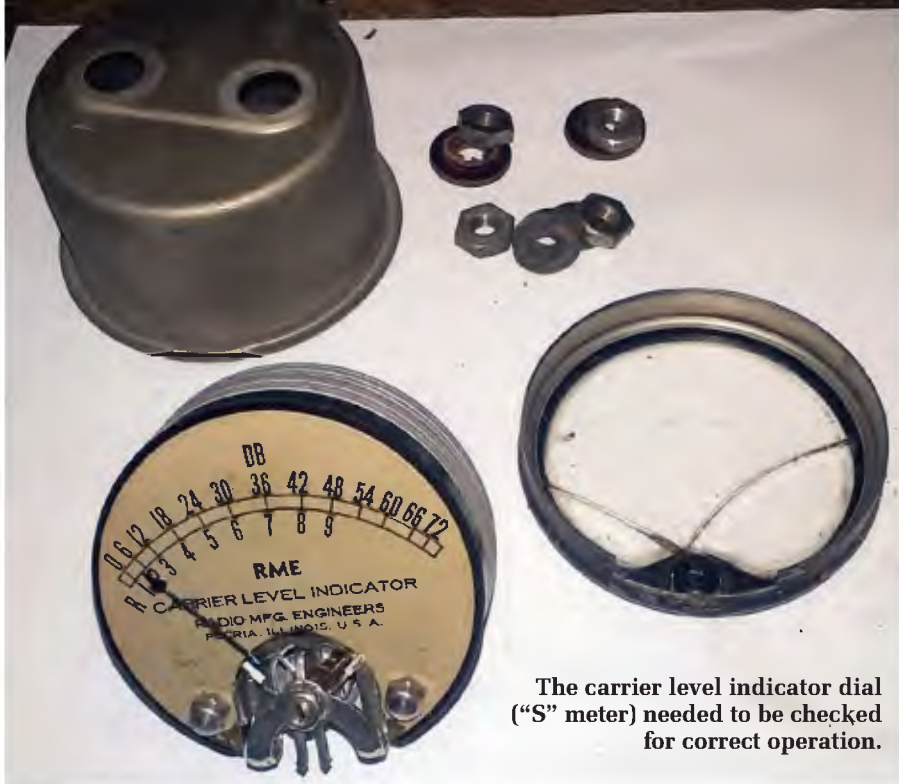
The carrier level indicator dial ("S" meter) needed to be checked for correct operation.

The meter circuit bugged me as it is not clear how it operates, and the zero adjustment (null) control did not do anything sensible. I was not sure if the meter was working, so I decided to pull it out and hook up to a bench test circuit that mimicked the set circuit. I found that the meter had an internal

The set had some prominent non-original parts fitted with strange values. I replaced them with the original values, and the S meter then worked sensibly.

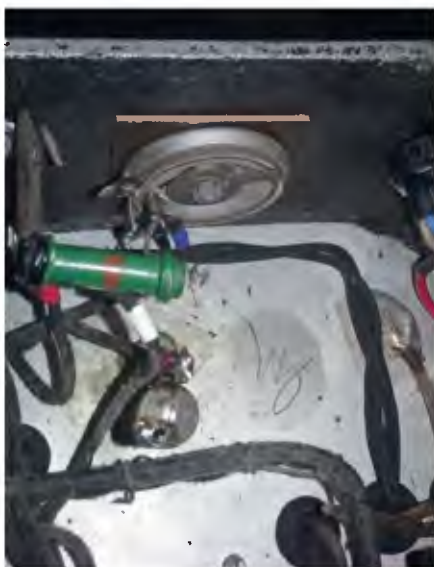
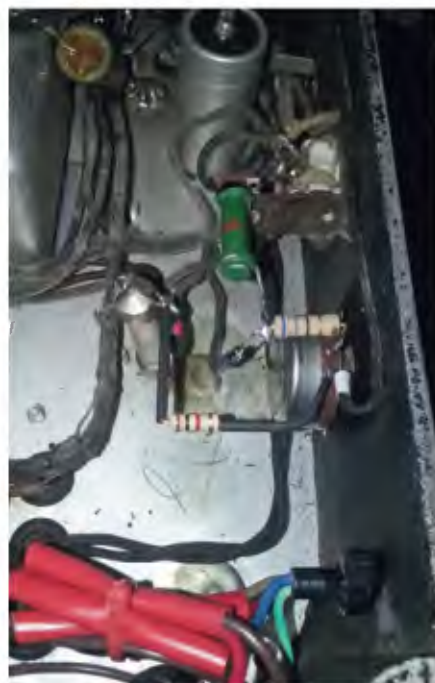
The old carrier meter zero adjustment is shown above with its replacement circuit at right (200Ω potentiometer R10).

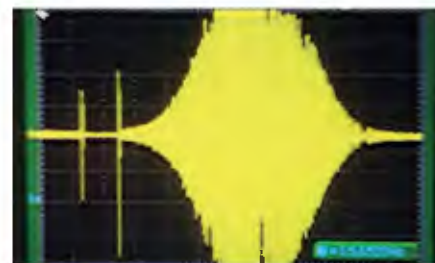
Fig.2: an IF pass response without the Bliley crystal filter

cleaned and refitted it. This produced a result where the crystal does 'something' to the response of the IF strip, but I did not believe that it was working correctly. The IF pass response with filter out is about 10kHz (Fig.2) while with the filter switched in, the response is about 5kHz (Fig.3).

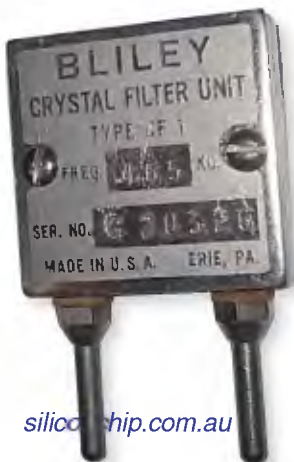
The Bliley 465kHz crystal filter is shown enlarged for clarity, with an actual size of 30 x 40mm. Serial number: G20326.

The crystal (a BLILEY type CF1 465kHz , serial no. G20326) is supposed to resonate and provide a narrower pass filter at the intermediate frequency, to sharpen the selectivity for sorting out really close stations. There are panel controls to vary the insertion effect.

The problem was that with the crystal switched in, there was no real resonant point around the nominal frequency of 465kHz , and the IF response was worsened.

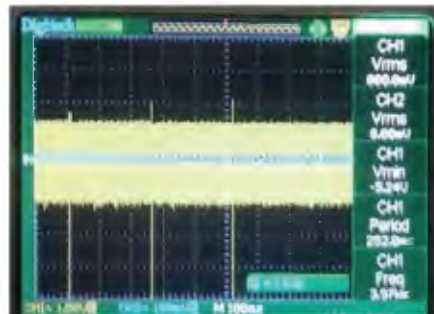
Fig.5: with the Lamb Silencer switched out, spark interference is visible in the output.

Once that lot was fixed, the threshold control now suddenly cut the IF response at too high a setting, so the circuit was clearly active. I then rigged up an "interference tester" involving a magneto air spark gap next to the set, to simulate automotive ignition interference, and was delighted to see Mr Lamb's patent theory vindicated. See the sweeps without (Fig.5) and with (Fig.6) the filter.

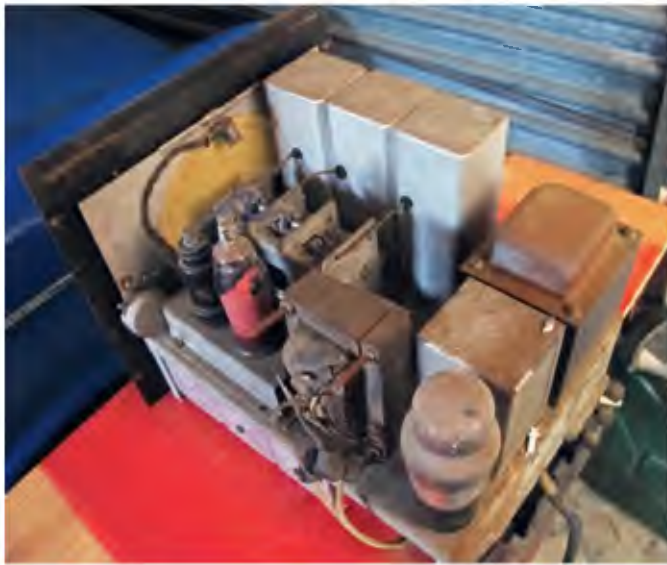
The DB-20 pre-selector had a very worn filter choke hanging off the lower left of the chassis. This choke, the power supply transformer and the type 80 rectifier valve were removed and replaced with a π filter.

The first thing I noted inside was a huge filter choke held down by gravity! I eased the chassis out of the case and found that the choke was connected with BB points through a bit of figure-8 wire. It seems that the original had failed, and anything handy had been pressed into service.

I decided to ditch the choke altogether, wire in some silicon diodes in place of the type 80 valve and mount some appropriate filters and dropping resistors on some tag strip. In place of the choke, I put a 3.3k Ω 5W resistor and a pair of 150 μ F 400V capacitors in a π filter arrangement. I left a dud type 80 bottle plugged in the rectifier socket to fill the space.

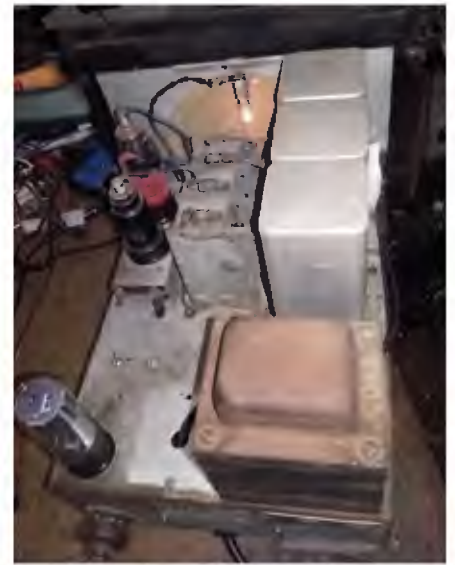
With some signal tracing and testing, I found leaky capacitors; resonant IF transformer T1 needed peaking at 465kHz; and worst of all, the 6H6 was dead.

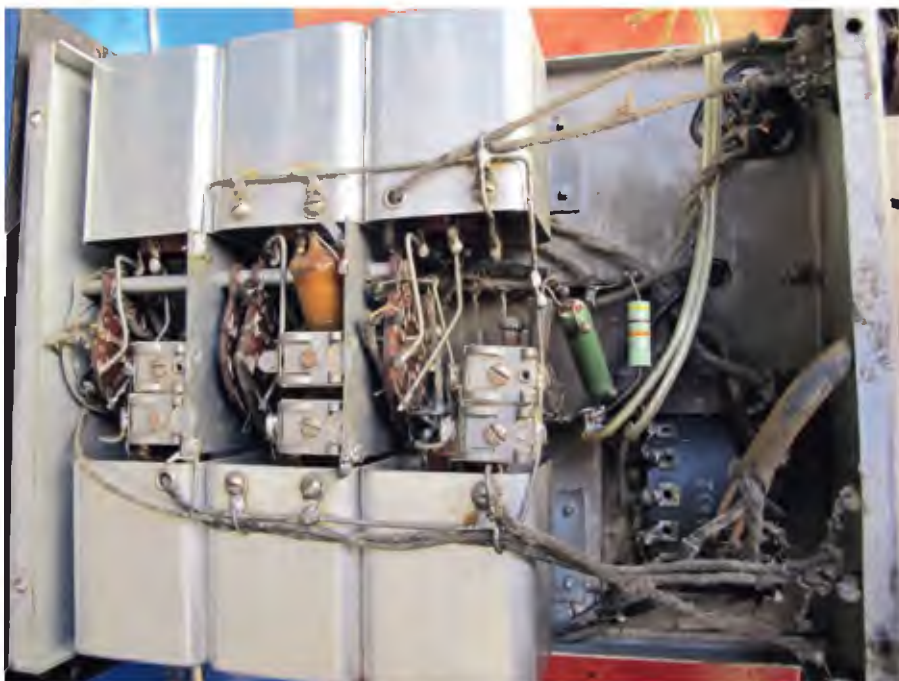
Left: the original underside of the DB-20 pre-selector. The DB-20 provides continuous coverage from 550kHz to 32MHz in six bands, and has a gain of ~20-25dB which is the basis for its name. The DB-20 was also used by the US Navy under the name CME-50063.

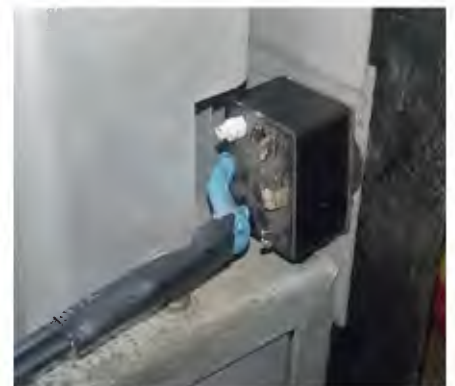
Below: a replacement switch for gain control "A" on the front panel.

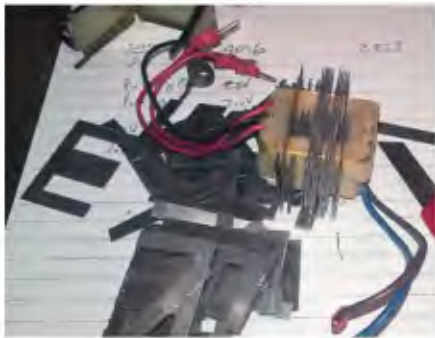
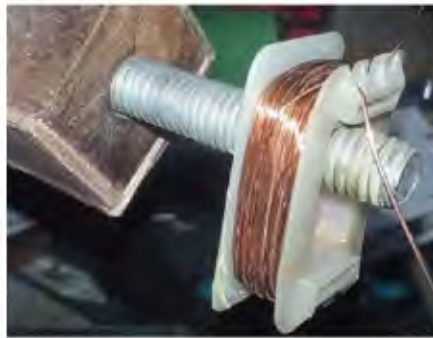
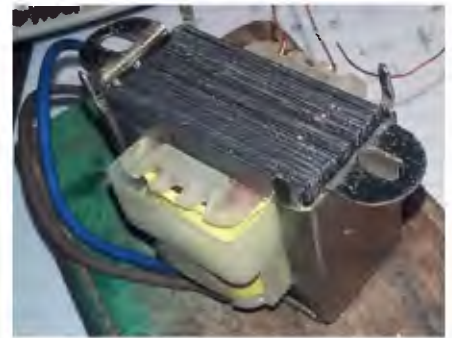
A Jaycar Cat. MM2007 transformer was rewound to act as the matching transformer for the speaker unit.

I painted a couple of layers of my favourite water-based latex over the cracked outer ring of the speaker, left that to dry and turned my attention to sourcing a matching transformer. I had an old Jaycar MM2007 240:30V AC transformer from a junked power supply. That gave me a primary winding capable of handling hundreds of volts, and a secondary that I could rewind to suit the speaker and radio.

Having rewound it, I restacked the lamination with an air gap.

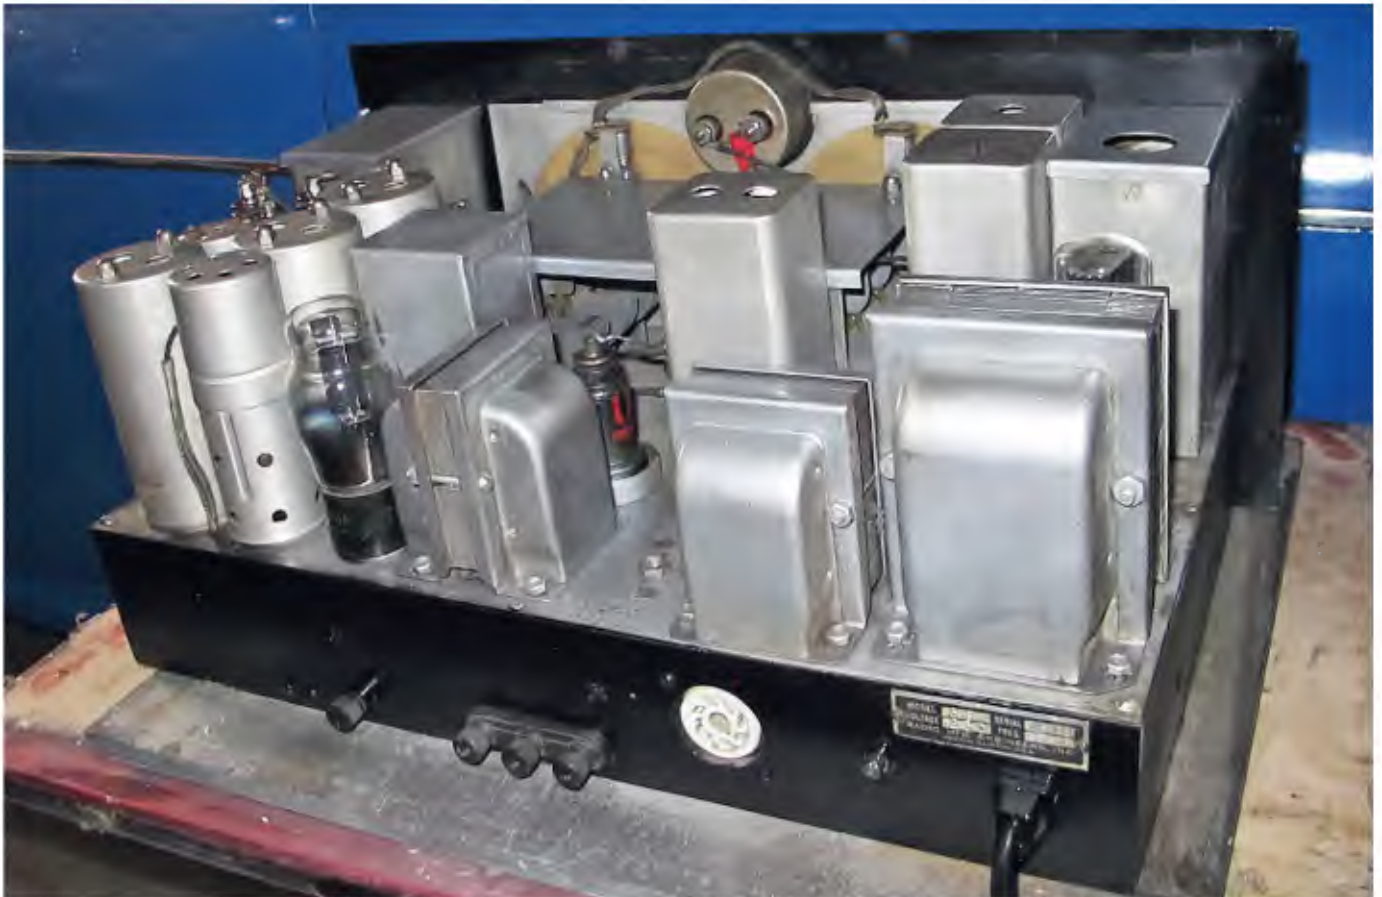
The 'restored' underside of the chassis can be seen above, with the topside shown below. This receiver was manufactured by RME at 306 First Avenue, Peoria, Illinois USA as stated on the label on the rear of the set. Around 1953, RME merged with Electro-Voice who are still around today.
