## Technics SLP8

This machine came into the workshop with the complaint that the tray operation was intermittent. It opened all right, so we inserted a disc. When the open/close button was pressed the tray shut partially then opened again. This happened several times before the tray finally shut. The TOC was read and all functions worked normally, including open/close.

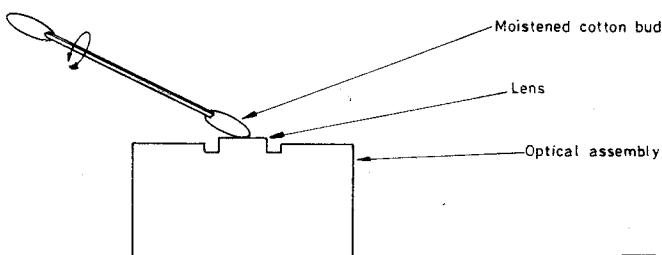
Fig. 1: Recommended method of cleaning a laser lens.

I've discussed cleaning the optical assembly with several engineers. Some use a fine soft brush while some use a soft cloth with some sort of cleaning liquid, all with varying degrees of success. It's difficult to clean anything without applying pressure, but too much pressure can damage the optical lens, rendering it useless. The safest method I know of is as follows.

First try to remove the disc clamp which can get in the way. Then slightly moisten one end of a cotton bud in alcohol and lightly roll the bud over the lens. When the lens is clean, use the other end of the cotton bud to dry it completely to avoid smears etc. I've found this to be a very effective method as it requires very little pressure. See Fig. 1 **M.L.**

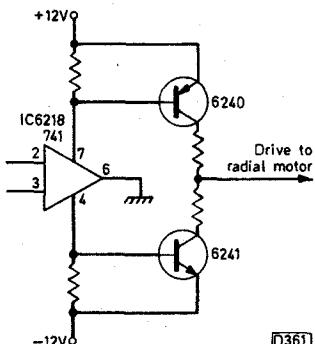
Fig. 1 (left): Radial motor drive circuit used in the B and O CDX player.

showing the ? figure. On examination we saw that the radial arm didn't swing to the centre of the disc to try to read the table of contents. The cause was loss of drive to the motor. The reason for this was evident when we looked at the servo PCB: there was a dry-joint on a through-the-board earthing link, a problem these units suffer from on the decoding board. When this particular link goes open-circuit the earth connection for the radial motor driver operational amplifier chip is lost. As you can see from the relevant bit of circuit (Fig. 1), the i.c.'s output pin is earthed, the two supply connections being used as the outputs to drive the push-pull output transistors. Remove the solder from the hole and insert a single strand of wire through it. Bend the wire over at each end and solder to the print on both sides. I.B.

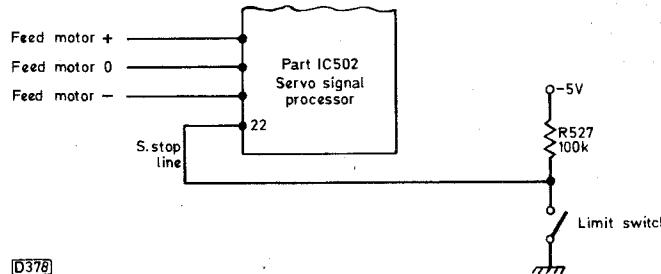
My attention was drawn to the VC4090S servo signal processor chip IC502 which provides the feed motor plus and minus signals. Comparative voltage checks were made with a similar, working machine (we all cheat sometimes!) after which I decided to replace the chip. This made no difference. I studied the circuit for a good twenty minutes before I noticed the s-stop line to pin 22 of the chip. This pin detects the position of the laser for TOC reading: if necessary, the laser is returned to the centre of the disc. A switch initiates this action. It

Fig. 1: Connections to pin 22 of the servo signal processor chip IC502 in the JVC Model XL-E300.

normally earths pin 22 (see Fig. 1). When the switch is open -5V is applied to pin 22 via R527. The problem was that R527 had never been fitted! The machine must have been new, because it could never have worked without R527. Fitting a 100kΩ resistor in this position cured the fault.

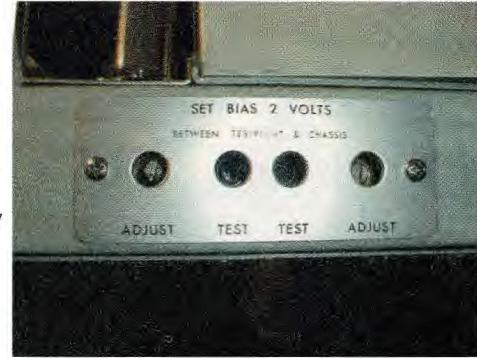
This particular model has a facility for setting the bias for the output valves, see Photo 3. All you have to do is to connect an accurate meter (a DVM is best for this job) between a test point and chassis, then adjust the accompanying potentiometer for a reading of exactly 2V. This procedure has to be carried out for all four valves, with the amplifier fully warmed up. The grid-bias reservoir capacitors, dated 1966, were obviously the originals, so I replaced them with new long-life ones – good for another forty years perhaps!

**Photo 3: The grid bias adjustment test points/potentiometers.**

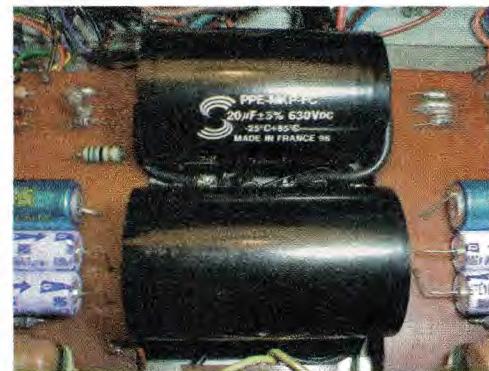
The smoothing capacitors in this amplifier had been replaced with the largest polyester-film capacitors I've ever seen, 20 $\mu$ F at 630V! See Photo 4.

**Photo 4: The replacement polyester-film HT smoothing electrolytics.**

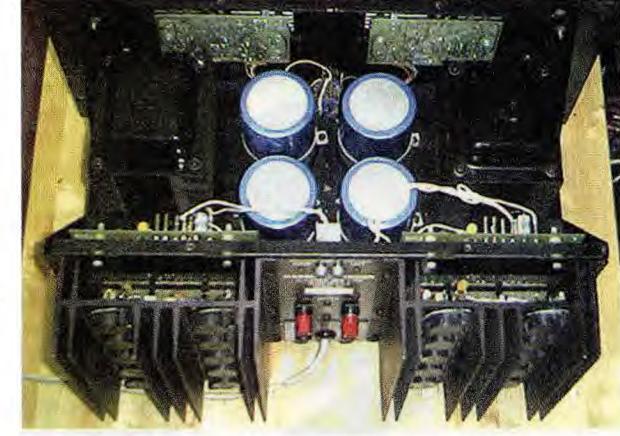
The Harman Kardon Citation 16 amplifier.

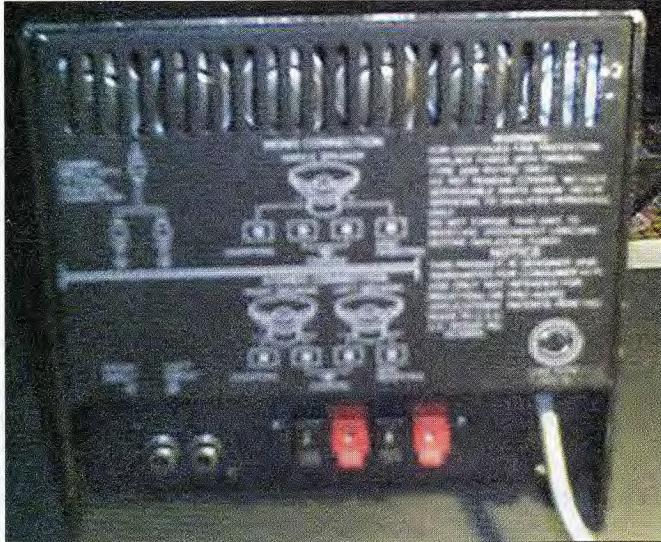
*Left - The Carver Cube's rear panel.*

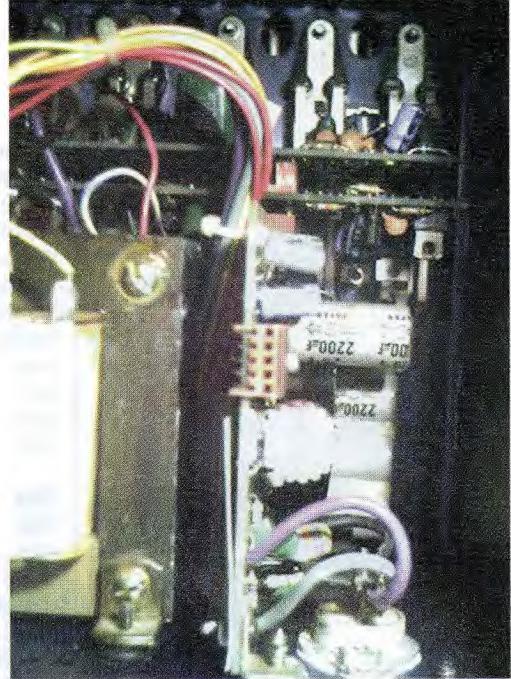
*Right - Internal view of the Carver Cube.*

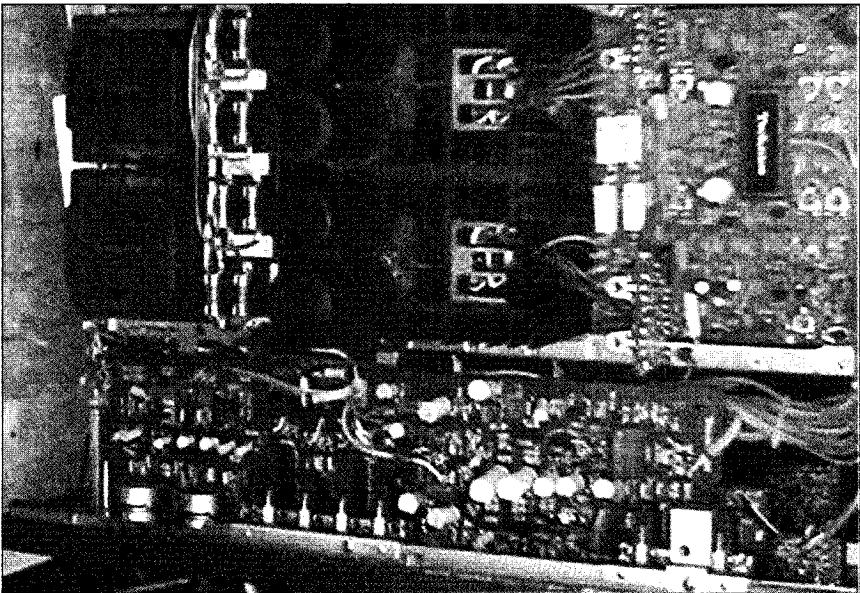
A common complaint is no sound from any input. Check that the preamplifier-main amplifier links are present! There's a bunch of fuses under a plate to the right of the transformers (see photo). These may be missed if you don't know they are there. P.R.

Inside the Technics SU8080 amplifier.

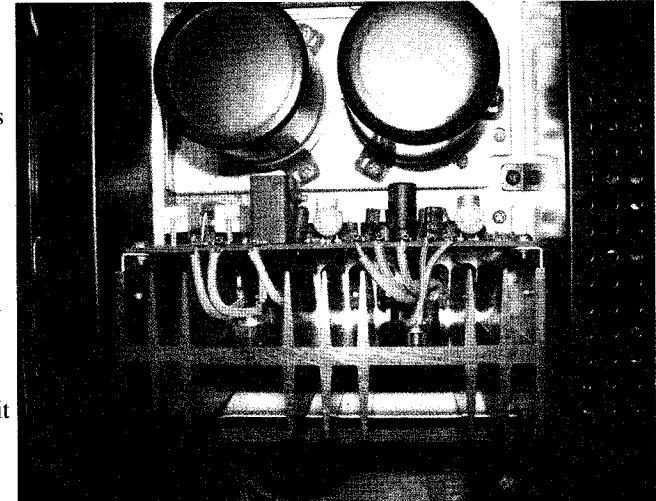
Regulator PCB in the Pioneer SA9100 amplifier.

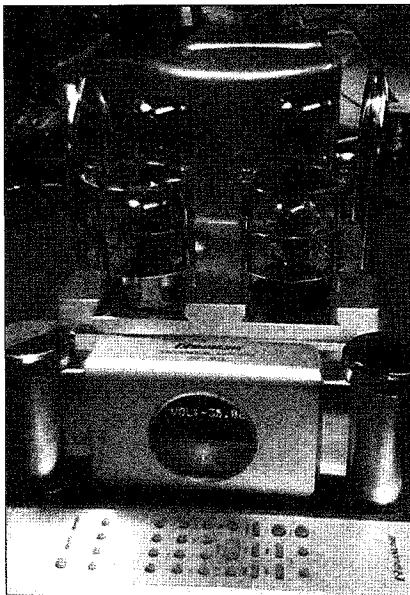
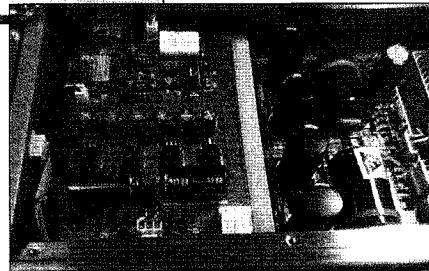
### Shanling SP-80

This beautifully presented, and very well made, monoblock amplifier – see photos – originates in China. It is a very high-end item, and carries a price tag that not so long ago, you would have expected to see on a decent second-hand car !

The described fault was " Whistles ". When powered, as the valves warmed up, it produced what can only be described as an air raid siren 'all clear' sound. I also noticed that the VFD was producing no display. It should produce a welcome message, followed by a dB display for the volume. If you have a pair of the amps for stereo use, they are coupled together by a thin data cable. One amp is then set to "master" and the other to "slave" by rear panel miniature switches. The master receives infra red data via a sensor co-located with the VFD, and passes this to its own processor, and the remote processor in the

My first move was to check all of the supply voltages. This quickly led me to U10, a 7805 regulator IC, which had no output, and was very hot. Removing the
