Vintage Radio

Restoring a 1946 HMV Model 456A mantel radio

Built into an attractive up-market timber cabinet, the HMV 456A is a mid-price large mantel set from 1946. The circuit uses just four valves and covers the AM broadcast band only.

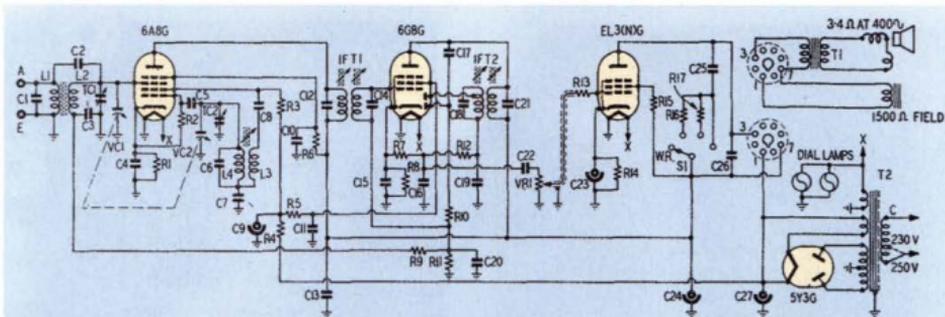
Fig.1: the circuit uses just four valves in a fairly conventional superhet arrangement, with AGC applied to the first two stages. The valve line-up includes a 6A8G mixer/oscillator, a 6B8G IF amplifier/detector/first audio stage, an EL33A/EL3NG audio output stage and a 5Y3G rectifier.

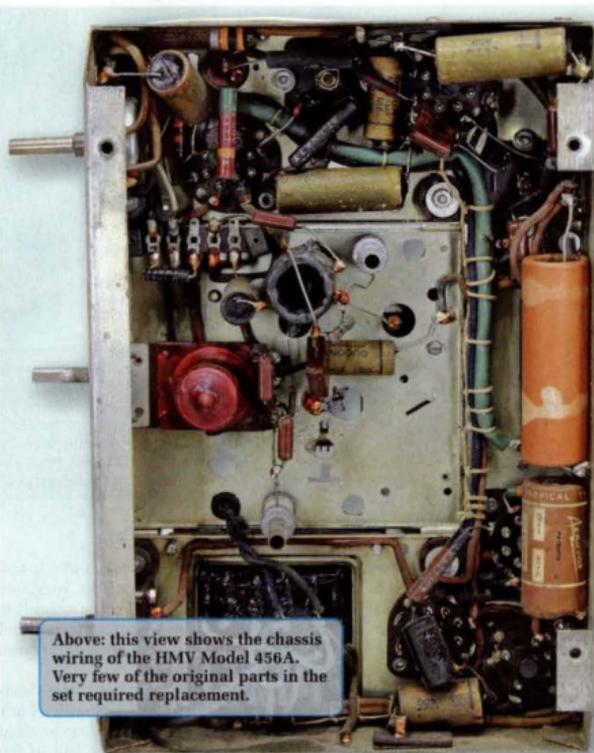
Above: this view shows the chassis wiring of the HMV Model 456A. Very few of the original parts in the set required replacement.
