Toshiba V8700

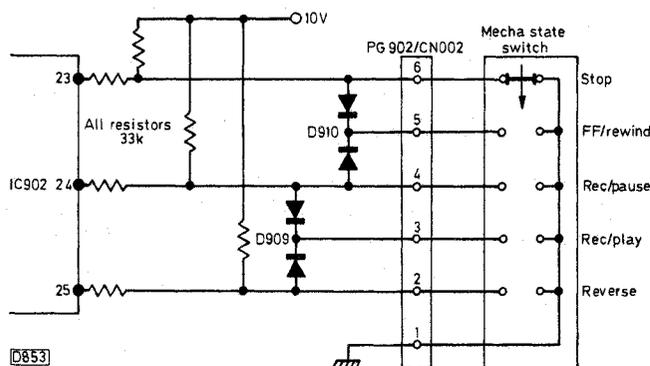
Fig. 1: Mecha state switch connections, Hitachi VT14.

This machine would intermittently fail, with the "operate" light not lit. Voltage checks during the fault condition revealed that the regulators Q101, Q102 and Q103 were all off. These regulators are controlled by IC902 on the system control panel, via an inverter. IC902's power

control pin 3 was low instead of high as it should have been, but changing IC902 made no difference. Further checks with the machine in the stop mode under the fault condition revealed that pin 24 of IC902 was low instead of high (pin 23 should be low, pins 24 and 25 high, see Fig. 1). The mecha state switch was checked and found to be in the correct position, the fault being due to D910 being leaky. Incidentally PG902/CN002 are numbered incorrectly in the official circuit – Fig. 1 is correct.

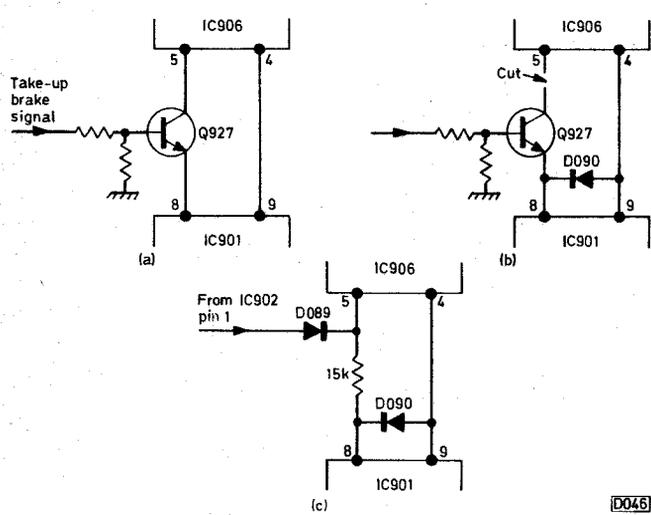
Fig. 2: Modifications to the control circuit: (a) original version; (b) version in the faulty machine; (c) the later version.

on for fast forward: as Tr1 heated so Tr4 turned on more until eventually Q902 turned on. At this time the only circuit I had for the machine was one that didn't show Q927: telephone calls to Hitachi confirmed that there had been modifications to this part of the control circuit.

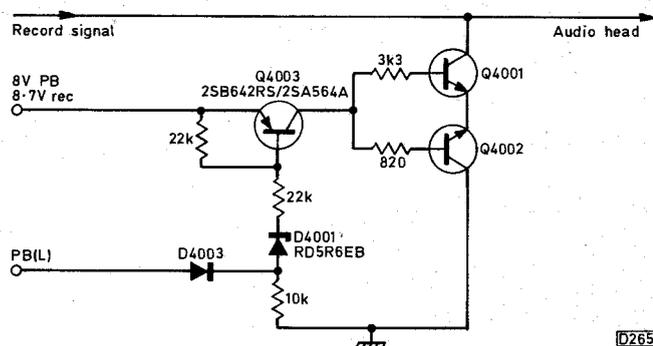
Fig. 1: Audio record/playback switching circuit used in the Panasonic NV333.

The problem was occasional failure to record the audio track, though erase was o.k. It caused some difficulty as the fault was intermittent. In fact we checked with Panasonic's technical department to find out whether there were any problems in the audio record section. A man told me that the modification to overcome intermittent recording was to short out R4049. Ah! But this is the bias oscillator transistor's emitter resistor, and there were no erase problems. The man insisted that in the event of intermittent audio recording this modification would provide a cure. For anyone else's information, after checking D4001 and then Q4003 by replacement the fault went away.

The circuit operation here is not obvious (see Fig. 1). In the playback mode line PB is low. Zener diode D4001

conducts and so does Q4003 since the emitter of this pnp transistor is at 8V and its base is returned to chassis via D4001. Thus Q4001 and Q4002 are on, earthing the record drive side of the audio head. In the record mode line PB is held high at 6V. This, via D4003, cuts off D4001 and all three transistors. If Q4001/2 are on in record then either D4001 or Q4003 is leaky. S.B.

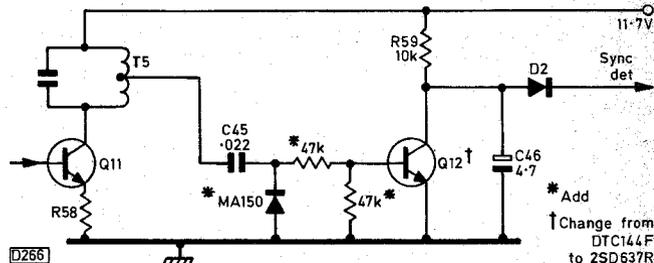
Fig. 2: Modifications to the sync detect circuit on the i.f. board, Ferguson Model 3V36.

Ray was having problems with a search tuning fault on this 3V36. It wouldn't stop when it found BBC-1 though it would stop on the other stations. Investigation revealed that the sync detect line wasn't going low when BBC-1

was found, so attention was turned to the sync detecting circuit on the i.f. board. Adjusting coil T5 made the line go low on BBC-1 but then it didn't go low on BBC-2 – we also found that if the coil was tuned too far a buzz developed on sound! When I looked through past issues of *Ferguson Feedback* I found a modification for sound buzz – change Q12 to type 2SD637 and add the components shown in Fig. 2. Doing this cured the fault. What a team! P.B.

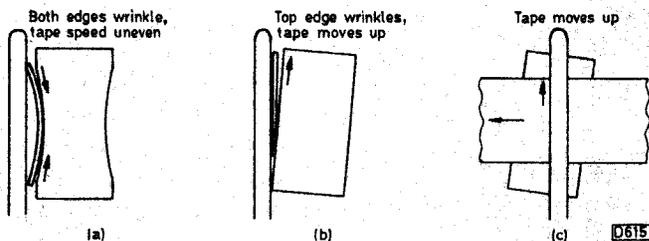
Fig. 5: Pinch roller problems (exaggerated).

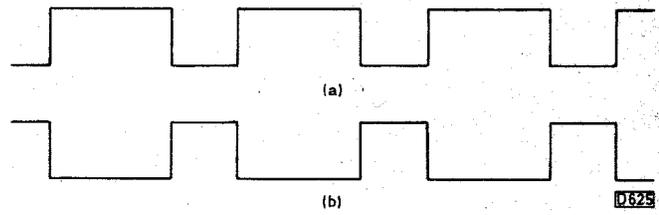
Check the waveform at the collector of Q9003 (see Fig. 2) with a 10:1 probe. If it's missing, check transistors Q9003/4 and Q9001/2 in that order, then zener diode D9006 and diode D9005. If all seems to be in order but the oscillator circuit won't start up suspect the start-up capacitors C9009/C9010. One or other may have dried up. So far we've had no problems with IC9001.

Fig. 2: Waveform at pin 1 of IC9001 (a) and at the collector of transistor Q9003 (b).

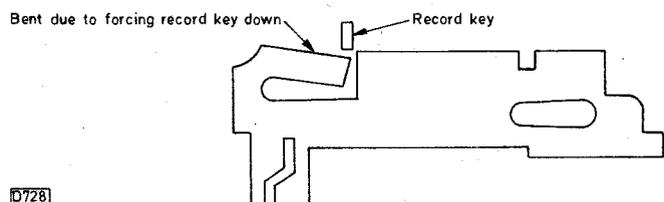
So much for the good news, now for the bad – though it's not all that bad. The key assembly suffers from a few problems that are not too difficult to put right. The most common problem applies mainly to the 3292/HR3300. It shows up when the machine apparently trips out on completion of the loading sequence. What might at first appear to be an electronic fault is actually due to wear on the play key lever (see Fig. 2) as a result of which the lock plate has a very precarious hold on it: when the loading mechanism clunks to a halt the shock jars the play key free. The cure is to replace the lever or swap it over with either the stop or pause key, as the locking latch is not used with these. The key colour will be different of course. The trouble may recur when this latter course of action is taken, as its root cause is the soft material used for the key levers. This point was put right with the

Fig. 4: Problem that occurs with function plate E.

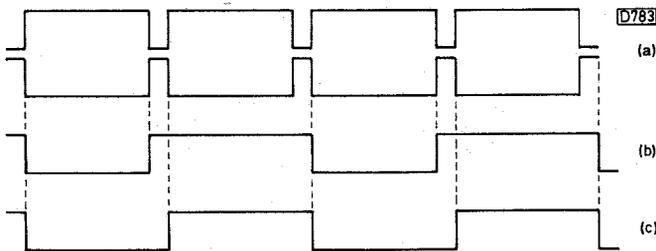
Fig. 1: Audio f.m. waveform with dropout between the head switching points (a). Incorrect 3:5 ratio audio flip-flop signal (b). Correct audio flip-flop signal (c).

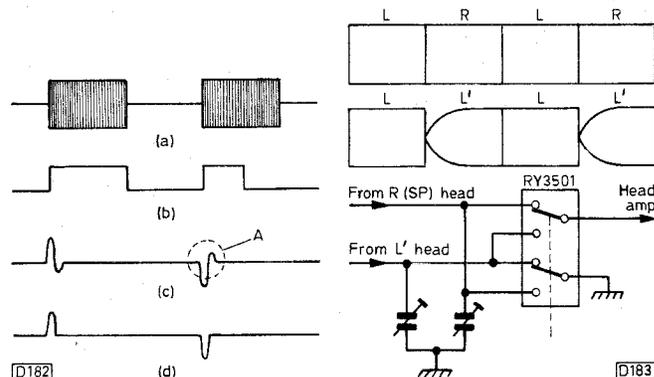
Fig. 1 (left): Waveforms associated with the Hitachi VT11 fault described above.

Fig. 2 (right): F.M. output waveforms and head switching relay, see the Panasonic NV788 fault.

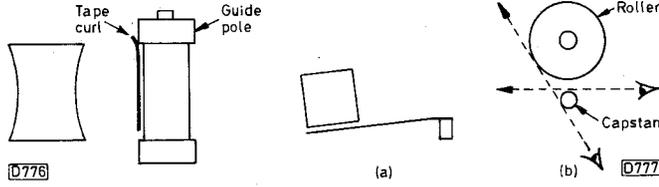
Fig. 2 (left): A concave pinch roller results in uneven pressure on the tape, which will slip up or down on the exit guide pole. It's best to check the pinch roller by removing it.

Fig. 3 (right): It's essential that the pinch roller is vertical. A distorted pinch roller mounting bracket is shown at (a). The pinch roller can be checked, see (b), by pressing the roller towards the capstan with a finger, leaving just a narrow gap through which the roller can be sighted. Use the capstan as a reference. Check from two angles, as shown, for zenith and azimuth distortion.

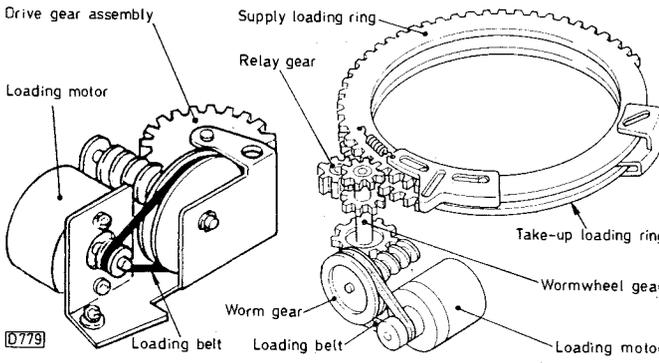
The loading belt in this machine is notorious. When it stretches it will either fail to close the after-load switch, as a result of which the machine will unload after about ten seconds, or it will fail to close the unload switch, with the result that the motors continue to rotate after unloading and the cassette housing won't open. Both symptoms may be intermittent.

Fig. 5: The loading block and loading rings. The simplest way to replace the belt is to remove the block, but note that the rings are then free to move and can thus become unmeshed.

(see Fig. 5) and release the circlip. But beware: when the motor assembly has been removed the two loading rings are free to move and, after reassembly, may be out of mesh. This problem can occur even when you take great care as you remove and replace the assembly. What usually happens is that the gears on the motor block rotate as you change the belt. Thus when the motor block is reinserted the gear teeth no longer locate with those in the rings. One's natural instinct is to gently juggle the motor block until the teeth are aligned, but this is when the rings move out of mesh. What you should do is to lower the motor block on to the rings and, if the teeth don't engage immediately, gently rotate the motor pulley until they do. The operation isn't difficult: I've managed it successfully in a customer's front room on many occasions.

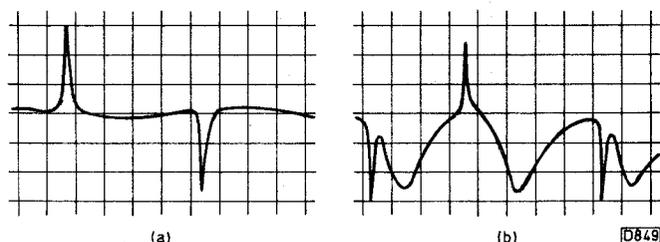
We finally came across a machine that produced the symptom all the time. Only then were we able to scope the CTL pulses and see what the cause of the trouble was. The pulses were riding on a large 50Hz ripple (see Fig. 6). As a result of this the servo was being triggered at different time intervals. The same ripple was present (see Fig. 7) when we scoped the switched 5.1V supply. We suspected the main reservoir capacitor C105 but the culprit turned out to be bridge rectifier D506.

We've now had this complaint with numerous VXL8s and its clones. The cause has always turned out to be either a dirty CTL head or a defective bridge rectifier (D506). So

Fig. 6: CTL waveforms. (a) Correct waveform at pin 7 of IC103 (first CTL amplifier output). For reliable operation it should be greater than 1V p-p. (b) Typical CTL waveform when bridge rectifier D506 is defective. Scope settings Y 0.2V/div, X 5msec/div.

whenever we service one of these machines we clean the head and replace D506 as a matter of course.

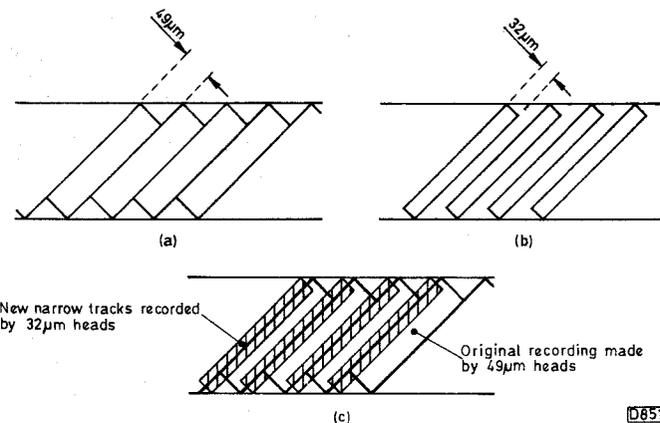
Fig. 8: Standard track pattern for VHS SP recording (a). Track pattern with a machine (e.g. VXL8) that has thinner head cores (b). Effect of over-recording 49µm tracks with thinner heads in the event of failure of the full erase head (c) – the original tracks are only partially removed.

As mentioned earlier, the VXL8 is a budget machine. Thus although it has LP operation there are only two heads. To optimise these for both speeds the cores are 32µm instead of the usual 49µm for VHS. This gives a rather unusual recording pattern on the tape in the SP mode. In effect, a small guard band is left between tracks – see Fig. 8.

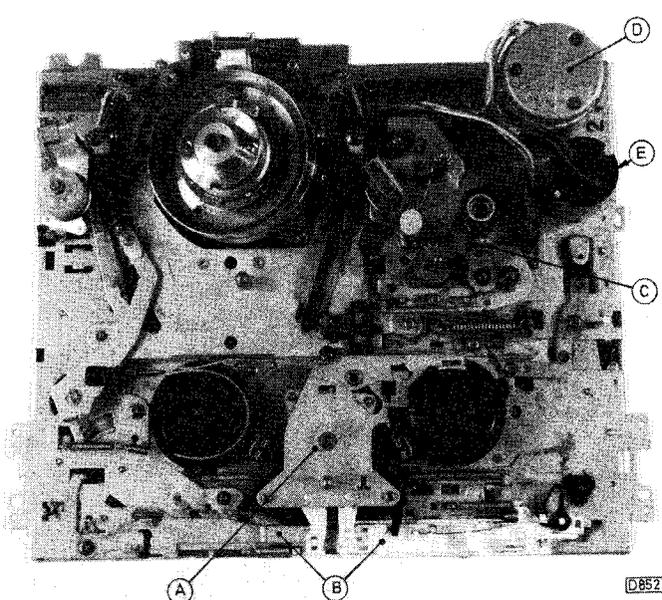
Fig. 9: Upper deck with the cassette housing and head drum removed. The loading arms are in the half-laced position. Key: A forward/reverse drive idler assembly; B slide bars (operating levers); C reverse guide arm; D capstan motor; E loading motor.

A problem we've had on a couple of occasions is where the reverse guide arm located near the pinch roller (see Fig. 9) is bent, probably due to abuse by the owner. This results in the tape riding up or down the capstan, crinkling

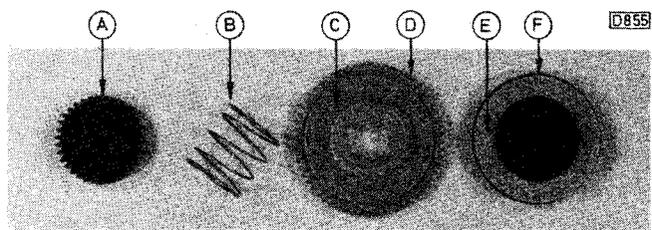
Wow on sound, perhaps during only the first quarter of an hour of a tape and more pronounced in the LP mode, is one of the most common complaints with these machines. There are several possible causes, e.g. the pinch roller slipping or the capstan motor binding, but experience has shown that excessive take-up torque is the most common cause. Excessive take-up torque can also lead to the tape riding up or down the capstan with the result that one edge of the tape is chewed. As set up by the manufacturer the take-up torque is unusually high, around 200g-cm. It can be reduced to around 100g-cm by dismantling the take-up clutch assembly, taking about one and a half turns off the tension spring then cleaning the assembly, including the two felt pads, with isopropyl fluid.

Fig. 12: Dismantled clutch assembly. Key: A upper gear; B tension spring; C clutch plate; D central gear; E friction pad; F lower gear.

The clutch is beneath the spool drive pulley (itemised in Fig. 10). To remove it you must first take out the spool drive pulley and the forward and reverse drive gears. Take care not to mix up the two gears when reassembling them as they are different. The clutch can now be extracted. A gentle pull on the smaller black gear will separate the clutch assembly, but take care that the spring doesn't launch itself into orbit at this point! Fig. 12 shows the

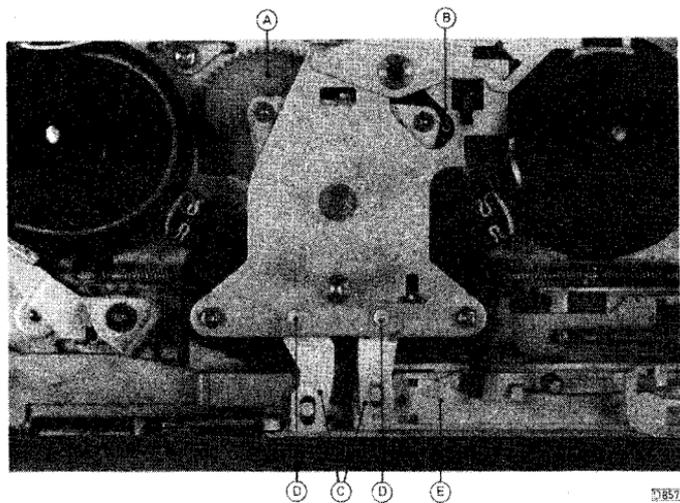
Another problem we've had on a number of occasions is where the machine refuses to go into fast wind or rewind after coming out of the play mode though you can hear the motors running. The fault is often intermittent. It's caused by seizure of the operating levers at the front of the deck. Fig. 14 shows these levers in closer detail. There are two white nylon gear levers operated by slide bars located centrally between the supply and take-up spools. These gear levers are slotted to locate on to pins on the slide bars. The fault occurs when the pin in the left-hand gear lever sticks in the slot.

Fig. 14: Operating levers and drive-gear assembly. Key: A reverse drive gear; B forward drive gear; C gear levers; D gear lever pivots; E slide bars/operating levers.

We used to rectify the fault by dismantling the gear assembly and widening the slot on the left-hand lever fractionally, using a needle file. More recently however we've noticed that the pivot on the left-hand gear lever (D in Fig. 14) has a very small amount of play when this fault is experienced. We now feel that filing the slot simply counteracts the effect without removing its cause. So we've taken to replacing the left-hand gear lever which we obtain from CPC under part no. HN62D085909305. Should you encounter this fault condition you should inspect this whole area, looking for signs of wear.

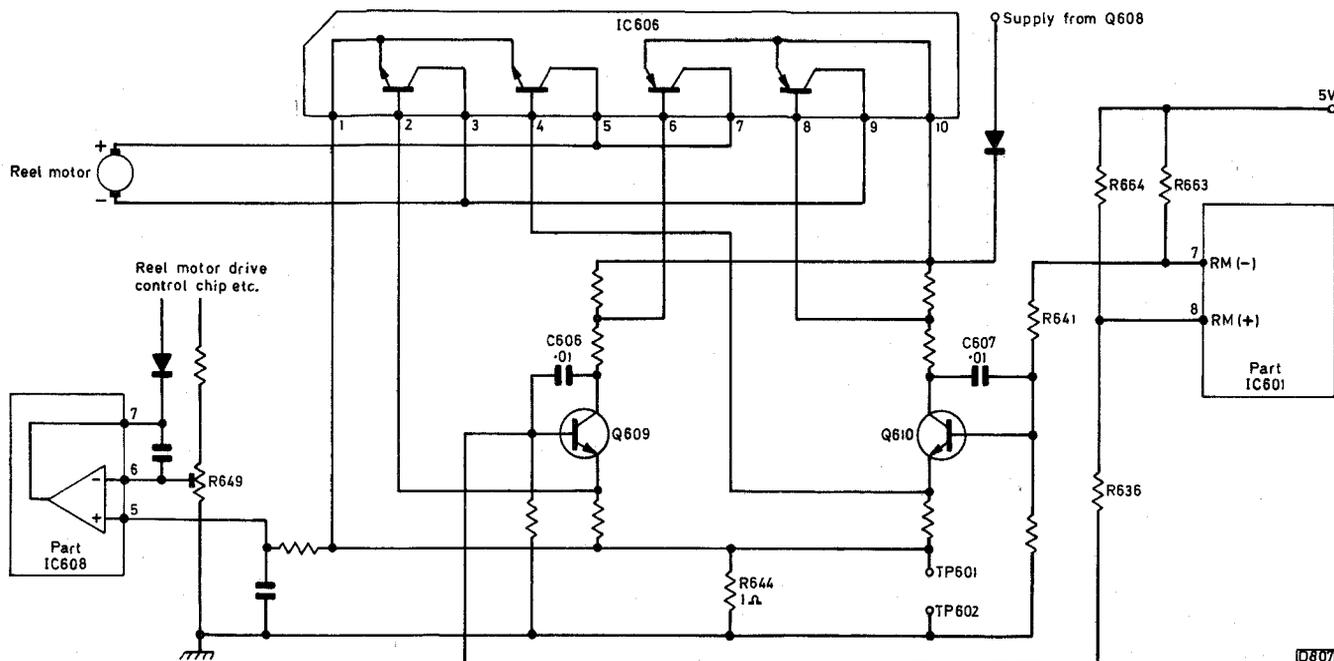
Suspecting the reel motor, I noticed that it was a special "fat-looking" type. The day was saved however when I discovered that the manual mentions a "reel motor current" (torque) adjustment. So I connected the meter's positive lead to TP601 and its negative lead to TP602, i.e. across the 1 Ω , 1W reel motor and drive circuitry current sampling resistor R644 on the servo-logic PCB, put the machine in the still mode and adjusted R649 for a reading of 190mV.

Fig. 1: Reel drive circuitry used in the Solavox Model NCVR5000.

was rewarded with good take-up torque plus powerful fast forward and rewind. Potentiometer R649 is at the right-hand edge of the board and can be tweaked without removing the tuner/i.f. panel.

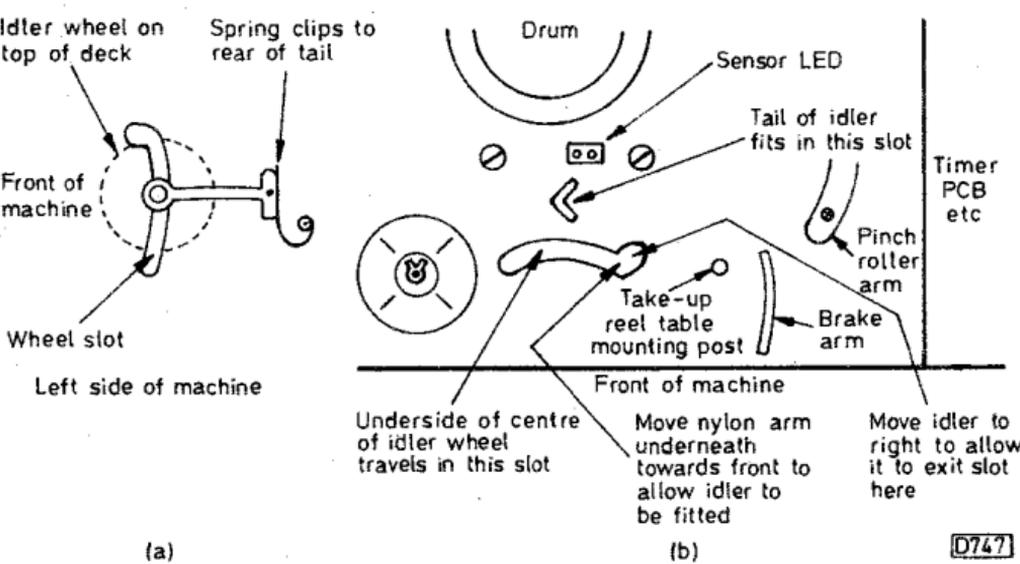
Fig. 1: Replacing the idler. (a) Underside of the mechanism (simplified) showing the nylon arm and spring positions when fitting the idler. Machine is on its left-hand side. (b) A simplified view of the upper side of the mechanism, with the take-up reel table and the idler removed.

Idler replacement is a bit more involved and tricky than one would like. Remove the top and bottom covers, then the front and the cassette carriage. The metal plate has to come out next. Remove the retaining circlip at the top of the take-up spool, after which the spool can be pulled off – take care not to lose any washers underneath it. Next remove the reel motor underneath in its plastic frame. This is done by taking out the three brass reel bolts/screws that hold it. At this point take a careful look at the idler from underneath: note the position of the spring at the rear of its arm. Use a screwdriver blade to move the nylon lever to

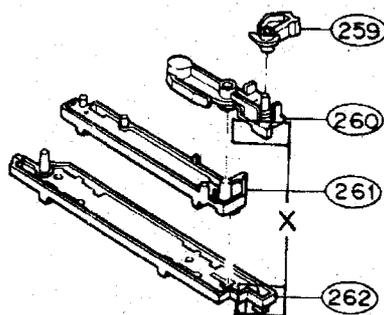
command, this lever must have returned to its rest position. Instead, it tends to remain protruding about 1mm towards the front of the deck. To improve reliability:

Fig. 1: Trigger/brake components, 259 trigger hook, 260 trigger lever, 261 brake plate, 262 brake actuate base. Round off the edges of items 260 and 262 in the areas marked X.

(1) Carefully round off the sharp edges of the trigger lever and brake plate mouldings in the areas indicated by an X in Fig. 1, using a sharp knife in a scraping action.

(2) Increase the spring torque by bending the bottom end of the spring an extra 60°.

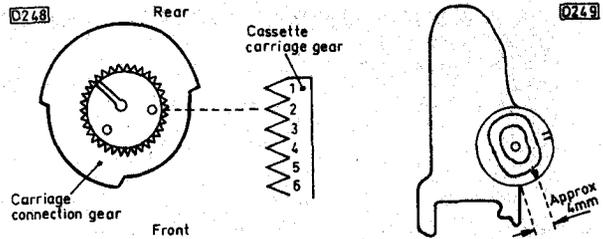
Fig. 1 (left): Carriage connection gear phase alignment.

Fig. 2 (right): Mode switch alignment.

The mode switch causes its share of problems, many of which are intermittent. No play, fast forward in play and no rewind for example. If any of these operations works intermittently, try cleaning the contacts on the switch and the PCB before resorting to mode switch replacement.

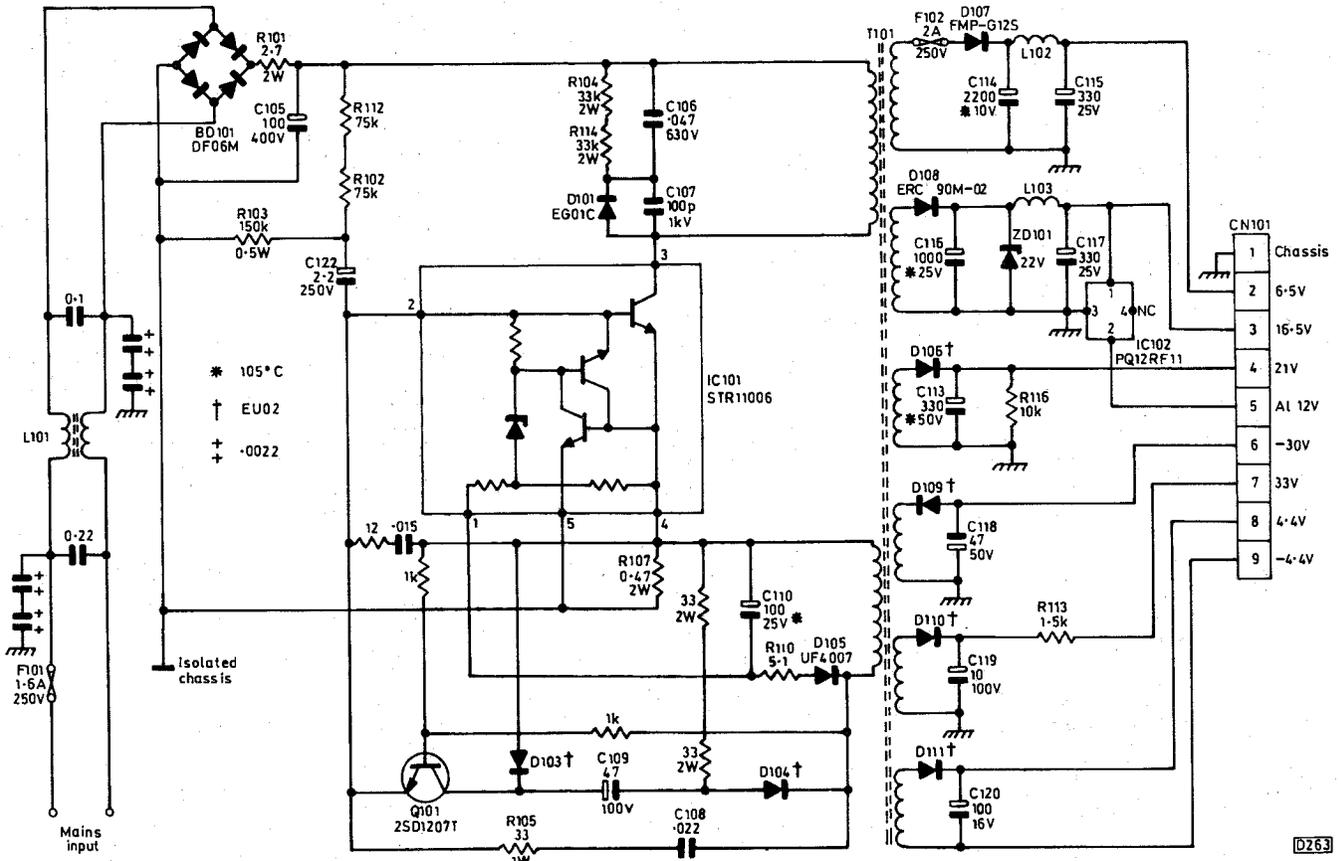
Fig. 1: Circuit diagram of the chopper power supply used in the Samsung Models VIK310, VIK320 and VIK350. Model VIK375 uses an almost identical circuit, the difference being that a single 68k Ω , 5W resistor is used in the R104/R114 position.

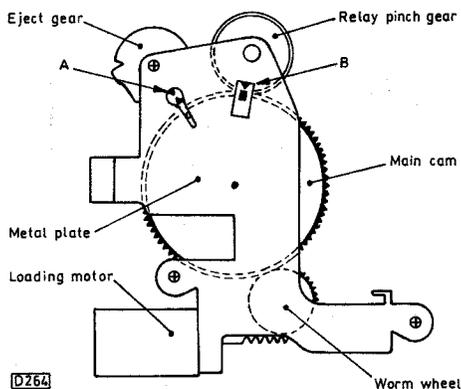
The review arm is critical. If in doubt, replace it. At least you know that a new one will be right. I say this because

Fig. 2: The loading block assembly, shown in the correct position for the eject mode. Broken lines indicate the cam and worm wheel hidden beneath the metal chassis plate. A and B: the timing arrows on the eject gear, relay pinch gear and main cam, also the hole in the latter, should line up as shown for correct mechanical synchronisation.

there's no review arm height adjustment, and if the old one is only slightly bent there will be tape wrinkling problems.

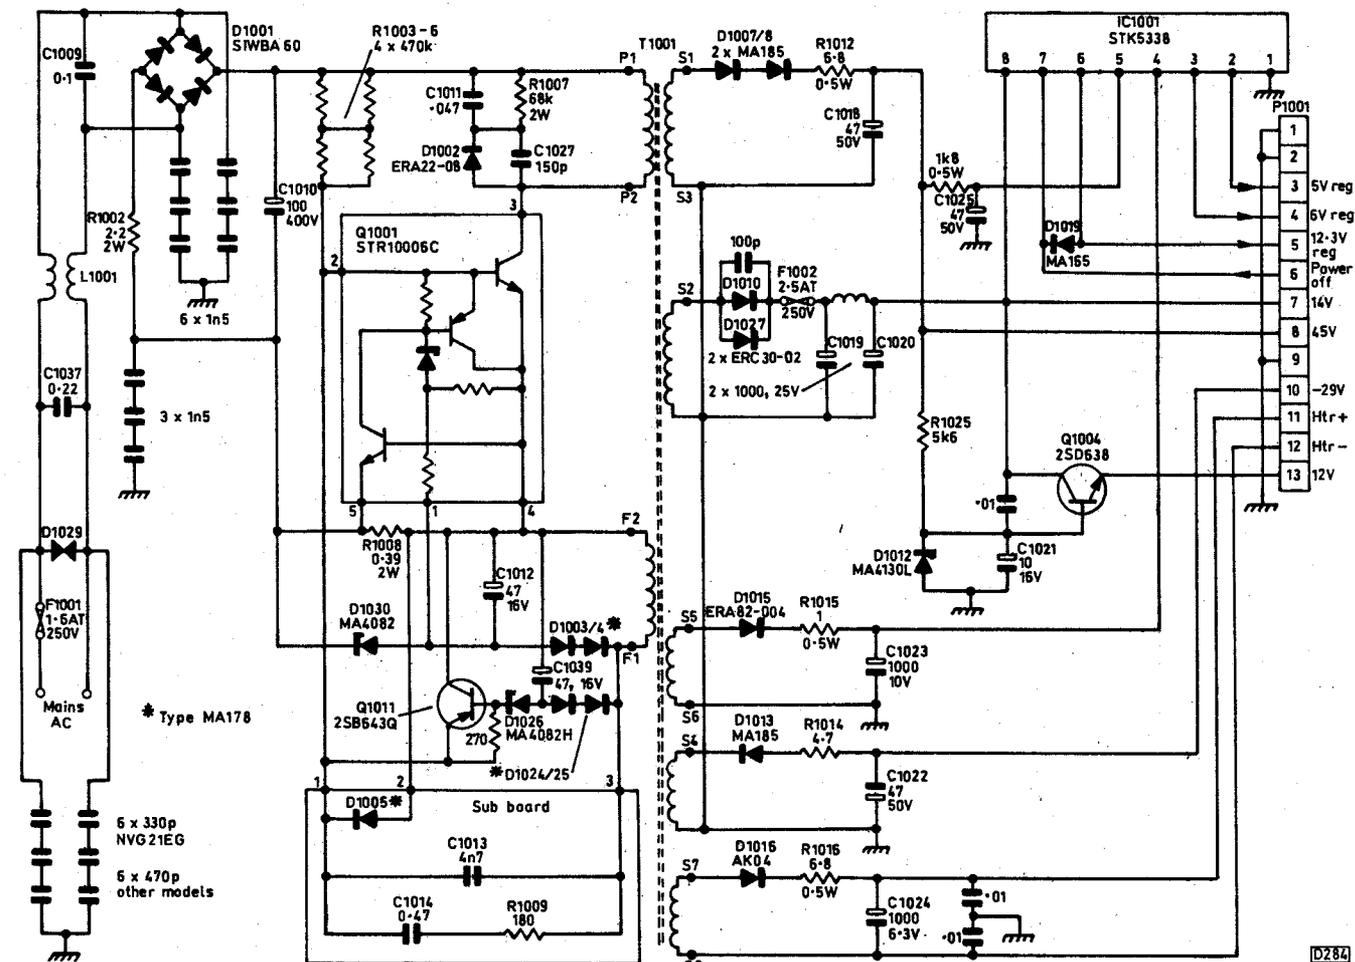
Fig. 1: Power supply circuit used in the Panasonic Models NVG21 and NVG25. D1029 is type ENB461D-05A.

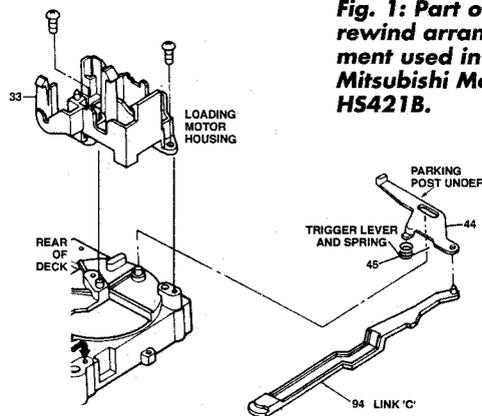
Fig. 1: Part of the rewind arrangement used in the Mitsubishi Model HS421B.

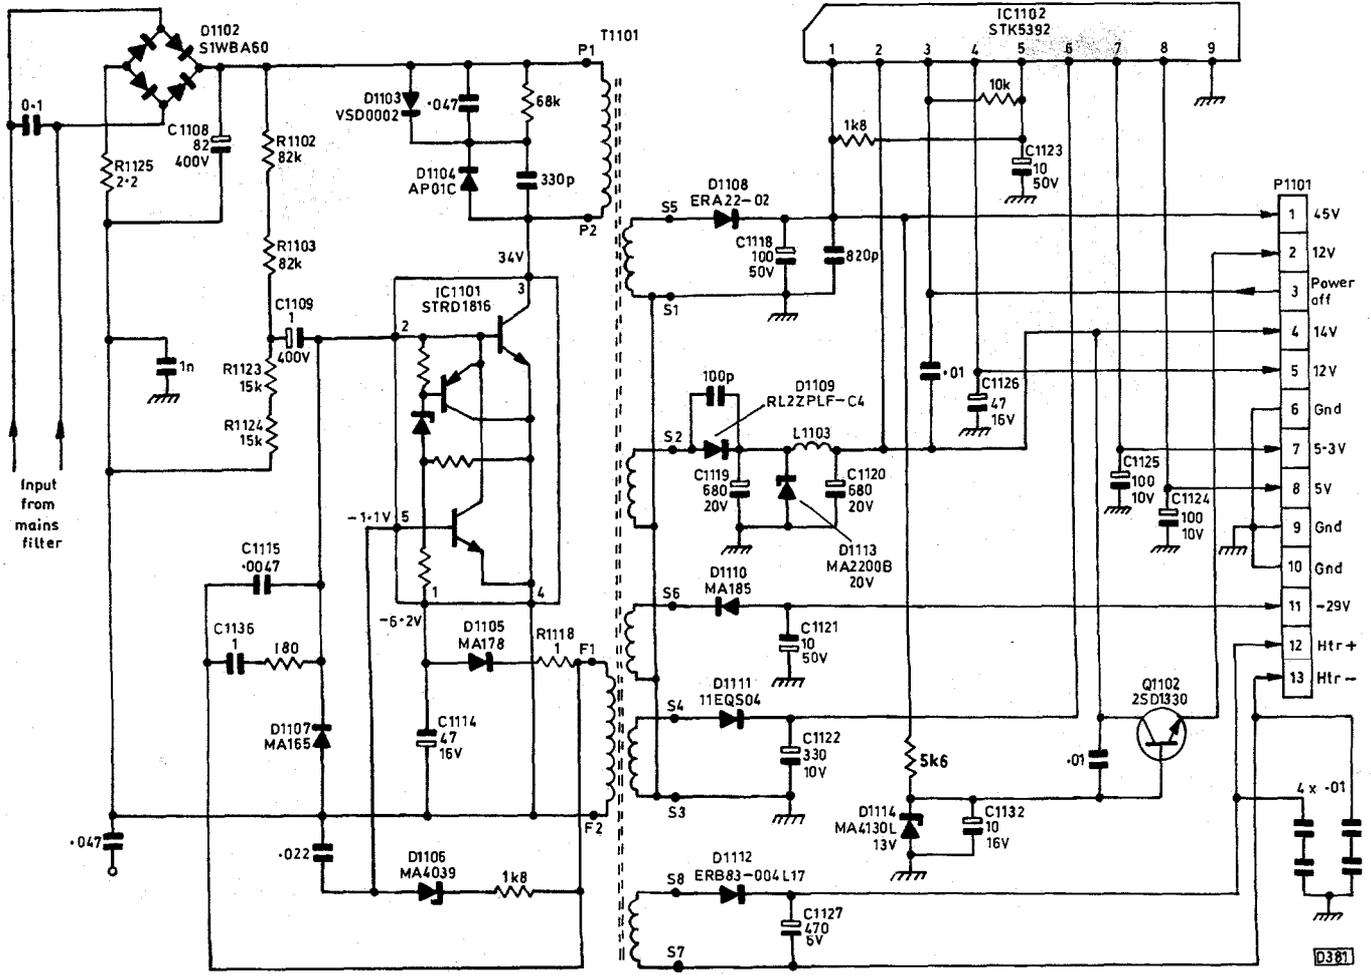
Fig. 1: The basic power supply circuit used in Panasonic VCR Models NVL20, NVL25 and NVL28.

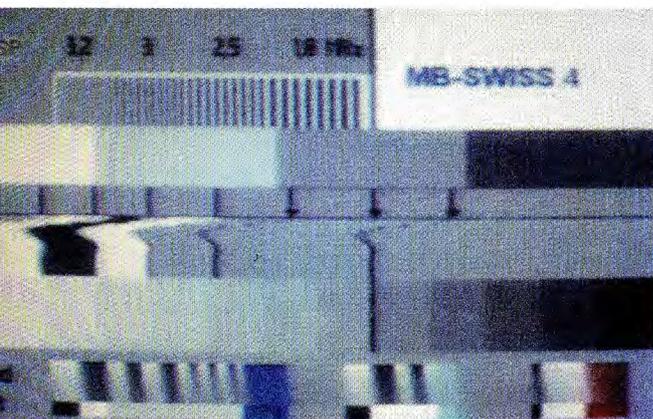
The most common symptoms produced by insufficient back tension are noise on the picture and/or picture judder/roll because of poor head-tape contact at the beginning of the head's tape scan. The effect is worse with a recording made by the same machine. Too much back tension can cause hooking and bending in the picture, and excessive tape and video head wear: in extreme cases the capstan and pinch roller skid on the tape, which becomes taut then stops moving or slows, with mistracking and wow on sound in the latter case.

Fig. 5: Use of a test tape to check the back tension. Pulling to the right in the middle of this off-screen TV shot shows that the tape tension needs to be increased.

adjustment. There is generally a setting screw. A typical back-tension figure for a modern deck is 35g/cm, measured at the beginning of SP tape playback using a cassette-type torque meter. It's easier however to use an on-screen indication, of the type provided by a test tape such as the MB Swiss-4, to check the back tension – see Fig. 5.

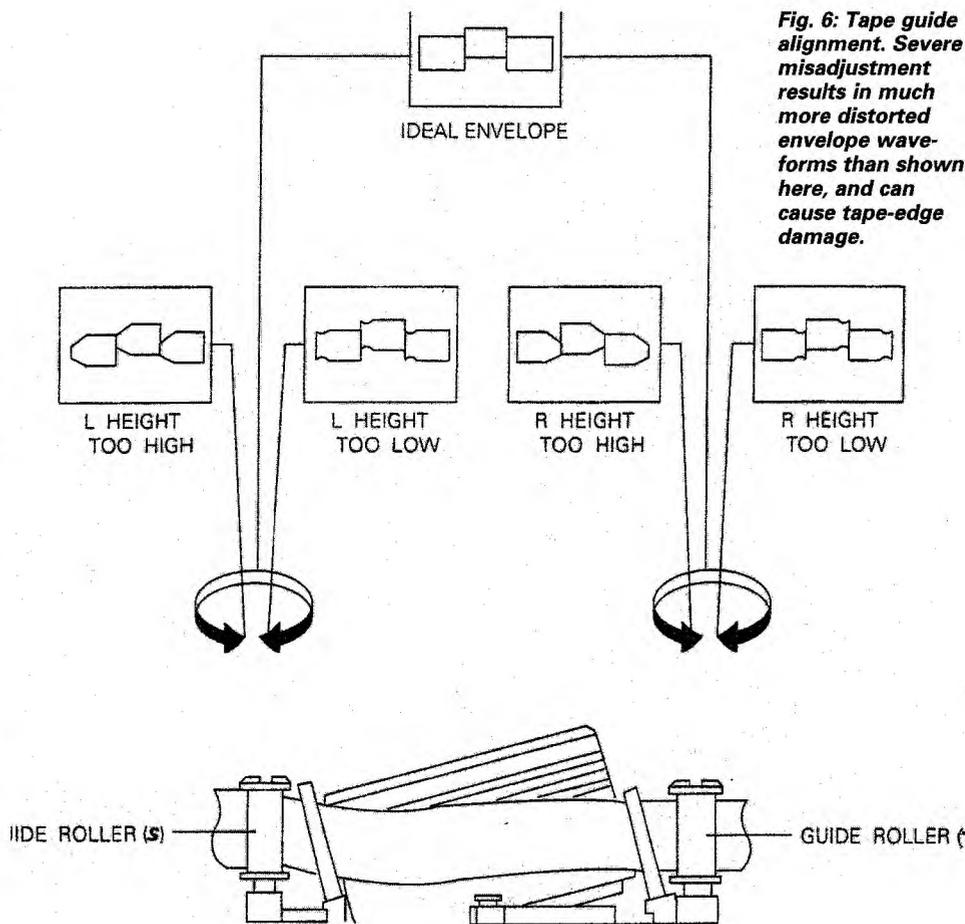
Fig. 6: Tape guide alignment. Severe misadjustment results in much more distorted envelope wave-forms than shown here, and can cause tape-edge damage.

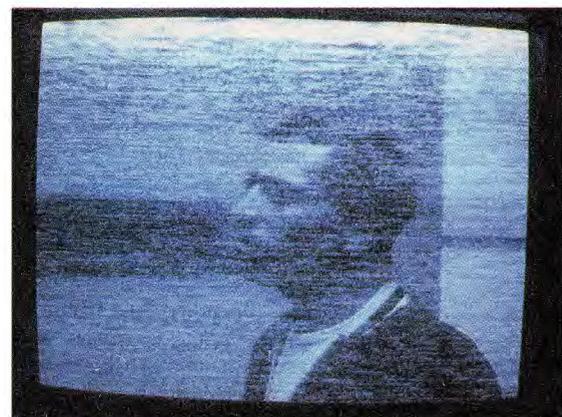
Fig. 7: Effect produced by dirty video heads.

To clean the rotary heads use a soft cloth or buckskin or a proprietary cleaning stick, stroking only in the heads' normal direction of travel, see Fig. 9. In stubborn cases, and with care (and perhaps nothing to lose!), try the effect of a piece of card, similar in thickness and finish to a business card, soaked in isopropyl alcohol: press it hard against the upper drum's periphery while you rotate the drum anti-clockwise by hand. Make sure that the drum surface is dry before testing with a tape.

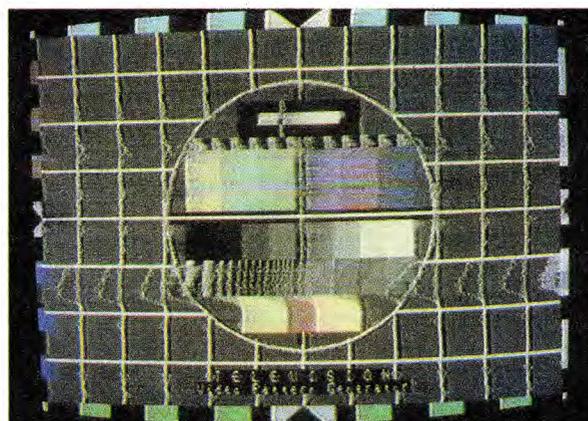
streaking from vertical edges in the picture. Fig. 8 illustrates this effect. When this occurs with only the machine's own recordings, some temporary relief can be obtained by reducing the luminance signal writing current. But head drum replacement is the only lasting cure.

Fig. 8: The ragged picture, image pulling and 'worms-and-dots' streaking effects shown in this off-screen shot are caused by worn video heads.

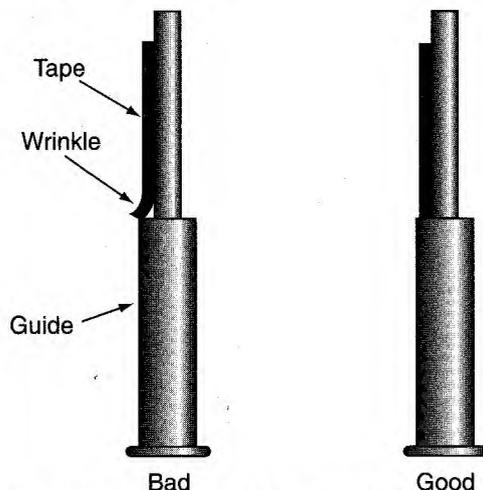
Fig. 13: Tape damage at the flange of a guide: the same can happen at the top edge if the tape rides upwards and a flange is present there.

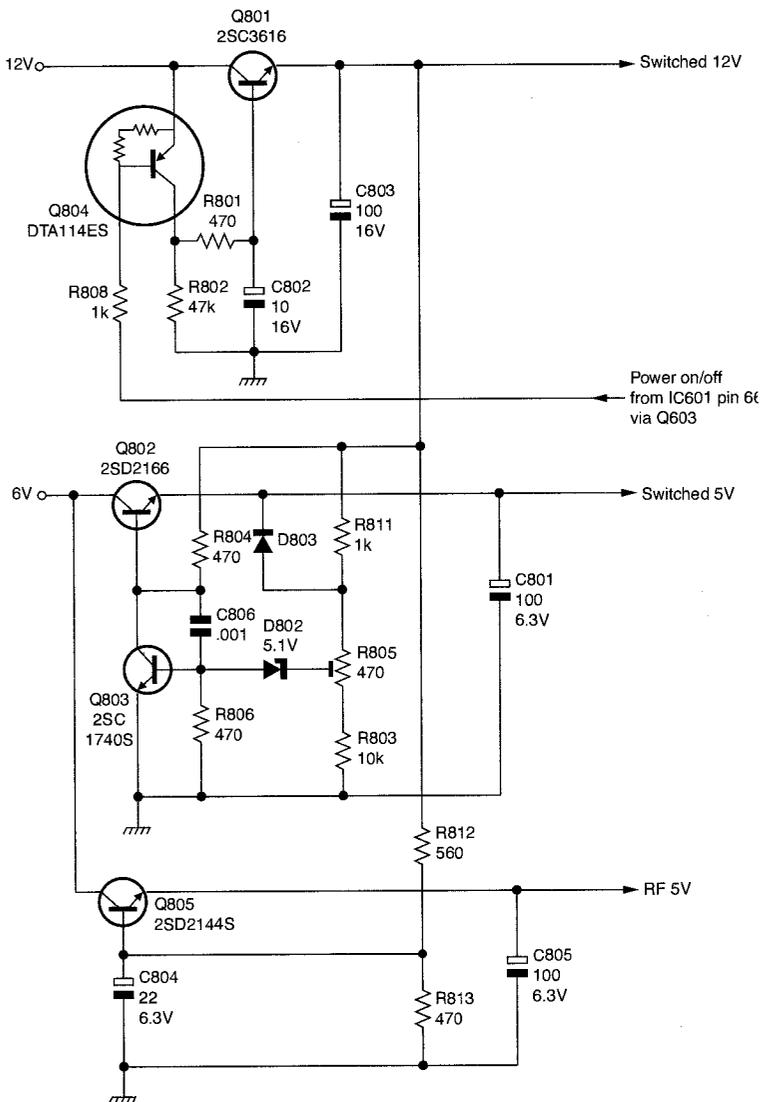
Figure 2: The regulator and power-switching circuits on board 03.

conditions at the two ICs are correct, check the relevant IC by replacement. Mode switch S3 can be the cause of incorrect operation. It can sometimes be dismantled, cleaned and relubricated. Then reassemble and soak test.

Start switch S1 on the cassette housing can cause problems. Check that it is producing a start pulse at pin 39 of IC601. If not, check it by replacement.

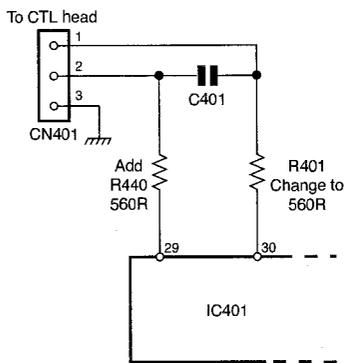
Figure 3: Modification to the control head circuit to prevent intermittent failure of CP1.

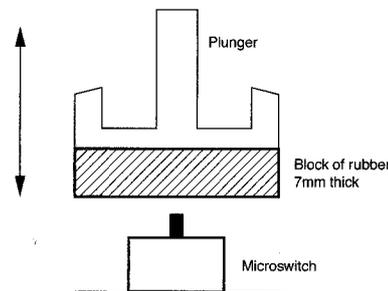
This machine would accept a cassette then, after a few seconds, eject it. The cassette-down microswitch is on a little sub-panel and is operated by a white plastic 'plunger' on the carriage. The bottom part of this plunger is made of very thin, flexible plastic, and this had broken away completely. If a complete new carriage had been required the repair would have been uneconomical (from the customer's point of view anyway). But the rest of the machine appeared to be in showroom condition, so I decided to have a go at repairing the broken part.

Fig. 1: Repair to the carriage-down microswitch operating system in the JVC HRJ420.

Two large blocks of thick foam rubber material are stuck to the screening cans. I cut away a small square, 7mm thick, and glued it to the underside of the plunger (see Fig. 1). This provided a complete cure and, six months later, the machine has not been back to me again. **M.McC.**
