Technics SLP8

This machine came into the workshop with the complaint that the tray operation was intermittent. It opened all right, so we inserted a disc. When the open/close button was pressed the tray shut partially then opened again. This happened several times before the tray finally shut. The TOC was read and all functions worked normally, including open/close.

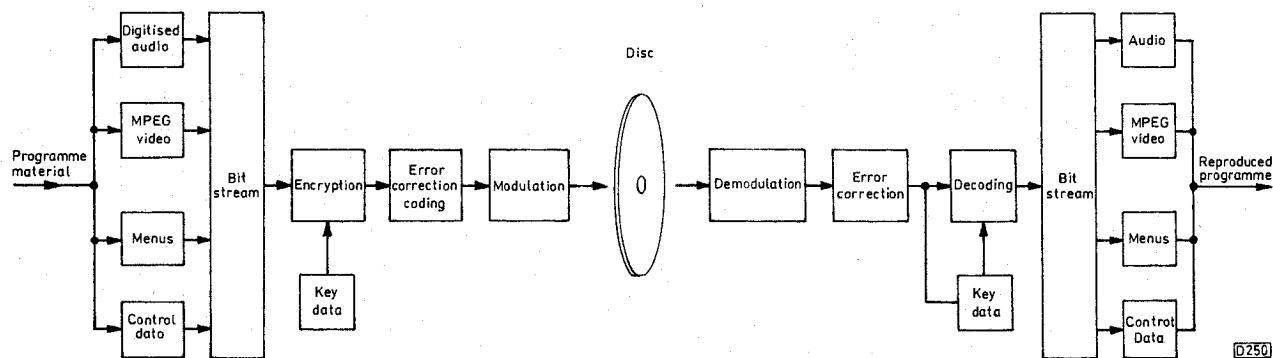
Fig. 1: The DVD Video record and playback processes.

DVD Video discs will be protected in the following way, see Fig. 1. The original programme material is first digitally encoded, producing a bit stream that contains a mix audio, video, control and other data. This is then encrypted, using a 40-bit key system. The Disc Encryption System (DES) has been developed largely by Matsushita. Error correction coding and modulation are then applied, after which the encrypted data is recorded on the disc.
