Vintage Radio

The 1948 AWA model 517M mantel radio

Designed for the budget end of the market, the AWA model 517M is a conventional 4-valve radio that was produced just a few years after the end of WW2. Restoring this one proved to be quite a challenge.

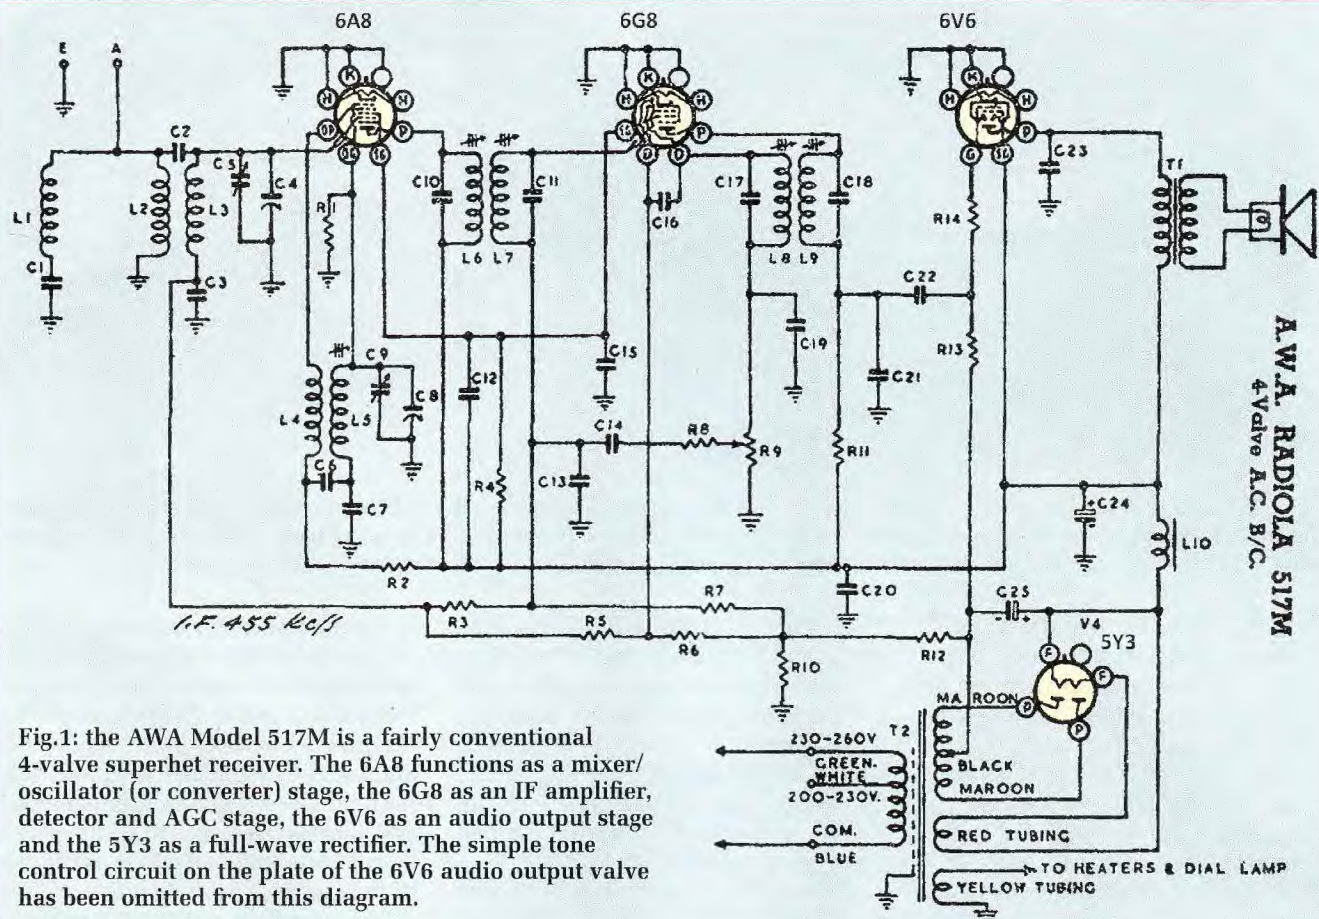
Fig.1: the AWA Model 517M is a fairly conventional 4-valve superhet receiver. The 6A8 functions as a mixer/oscillator (or converter) stage, the 6G8 as an IF amplifier, detector and AGC stage, the 6V6 as an audio output stage and the 5Y3 as a full-wave rectifier. The simple tone control circuit on the plate of the 6V6 audio output valve has been omitted from this diagram.
