VINTAGE RADIO

The Armstrong C5 dual-wave console receiver

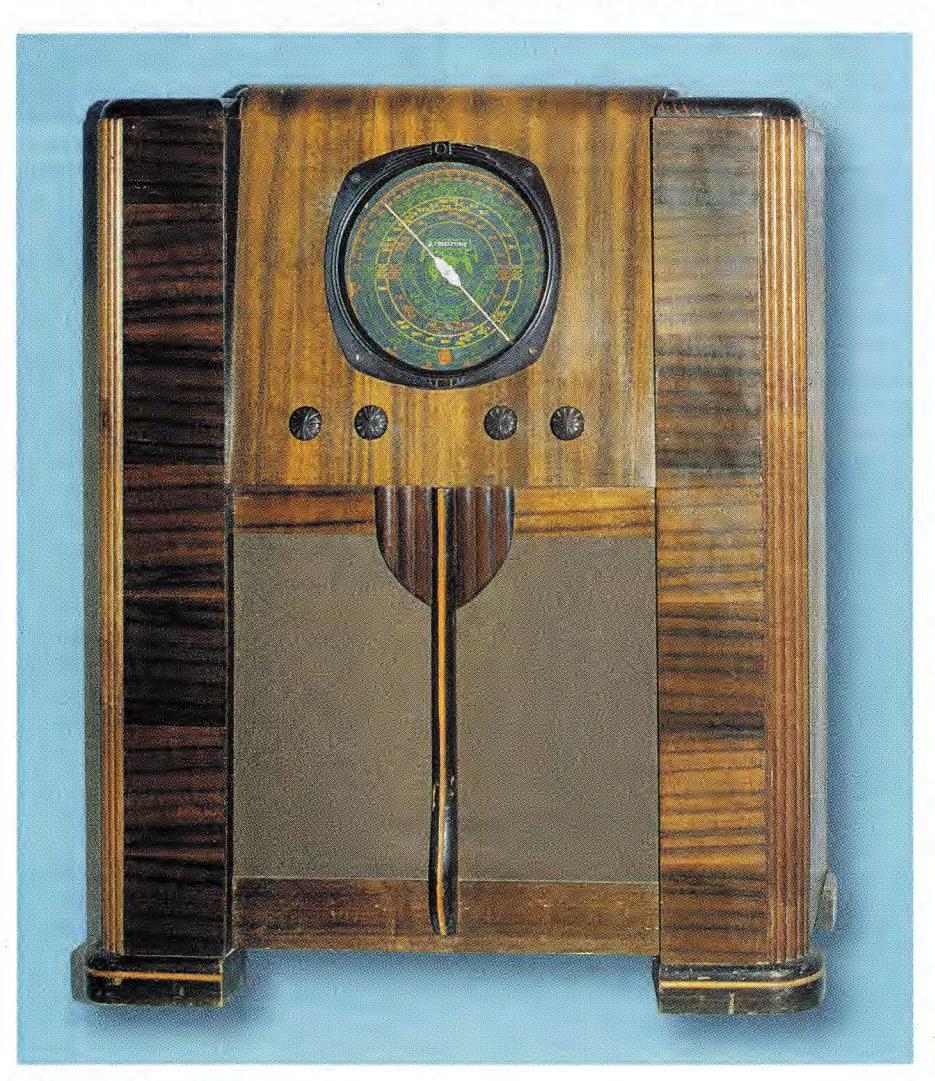
As can be seen from the photos, the console cabinet housing the receiver is quite an attractive piece of furniture. The timber used is lighter than that used on some of the HMV consoles of the same era but this has one advantage – it makes the set much easier to lift!

Another difference is that the dial slopes back at a slightly greater angle than on most other consoles, which makes the set easier to operate when the operator is standing up. It also means that the chassis is mounted on a sloping shelf, although (fortunately) the angle is not high enough so that the chassis slides out by itself when the retaining screws and knobs are removed.

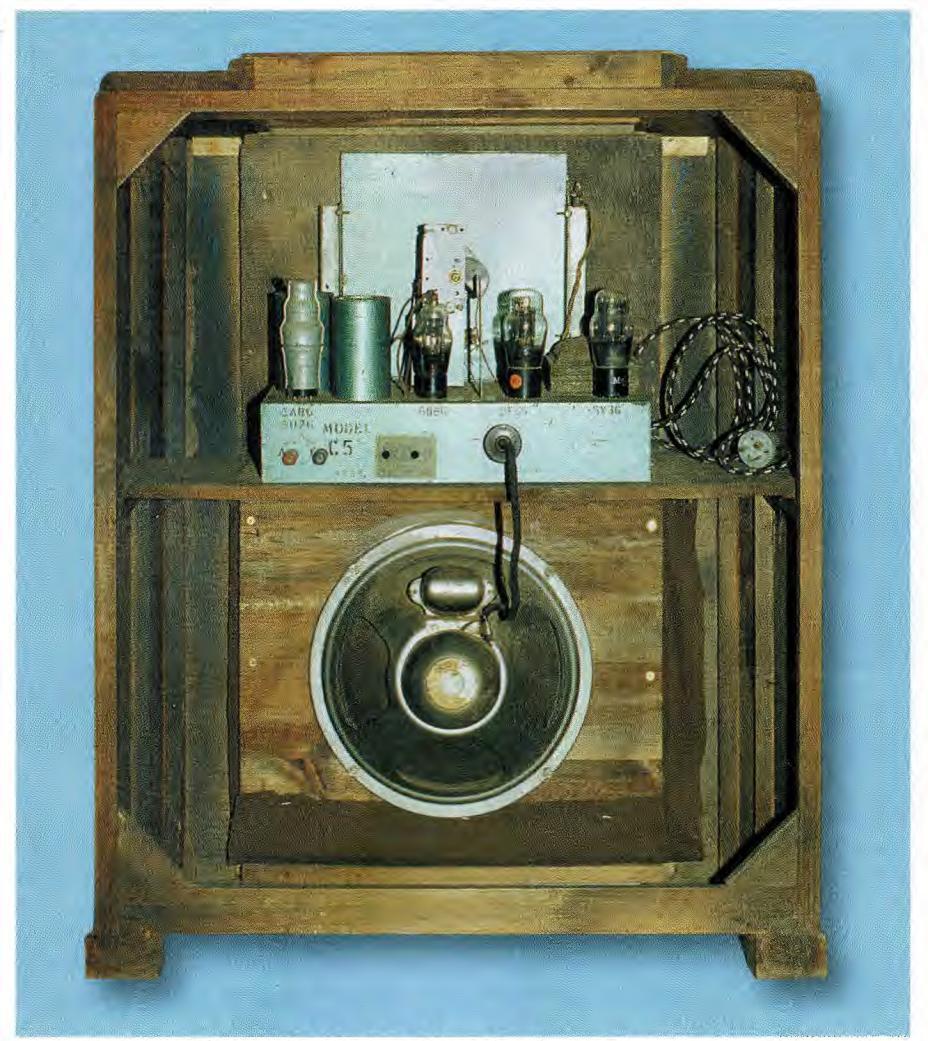
There is plenty of space inside the cabinet for the 5-valve chassis and the large electrodynamic loudspeaker. The loudspeaker's field coil also acts as the filter choke for the HT supply.

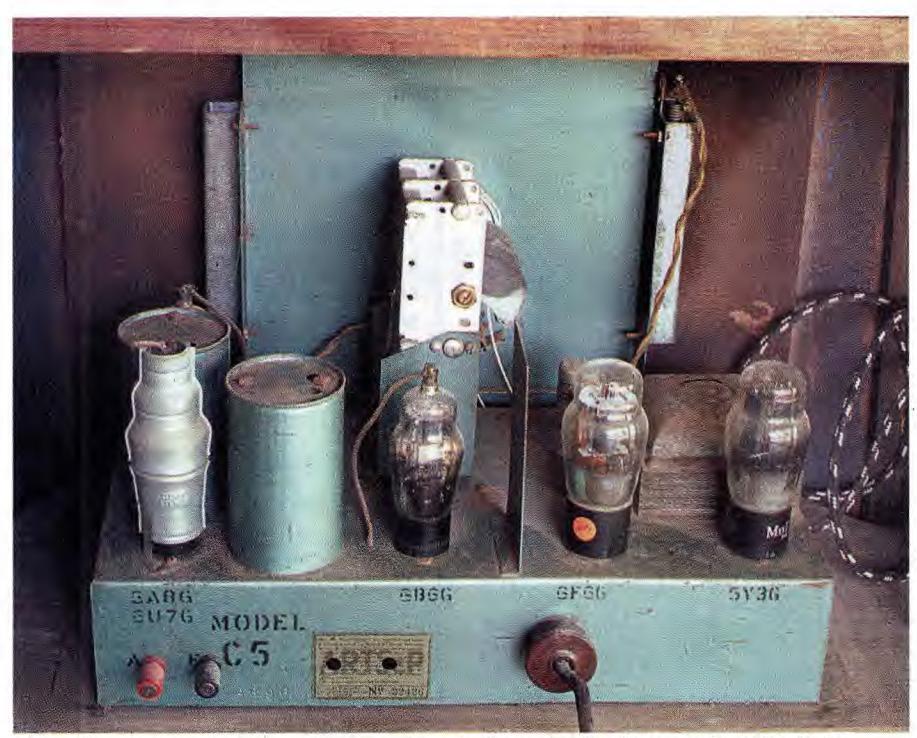
This close up view shows the C5's chassis from the back. Note how high the tuning gang sits so that the large tuning dial can easily be accommodated. The holes in the tops of the IF cans provide access to the alignment trimmers.

A glance in the back of the set reveals that the dial drive system and the tuning gang are mounted several centimetres proud of the chassis. This was necessary because the large dial would have otherwise interfered with the chassis. But despite being

The IF amplifier stages are tuned to 455kHz which is quite conventional. However, the IF transformers are different from most others, as they are tuned using two trimmer capacitors at the top of each unit. At that time, most manufacturers had changed over to fixed capacitors, with slugs (iron dust core) used to alter the inductance to tune the IF transformers to the correct frequency.

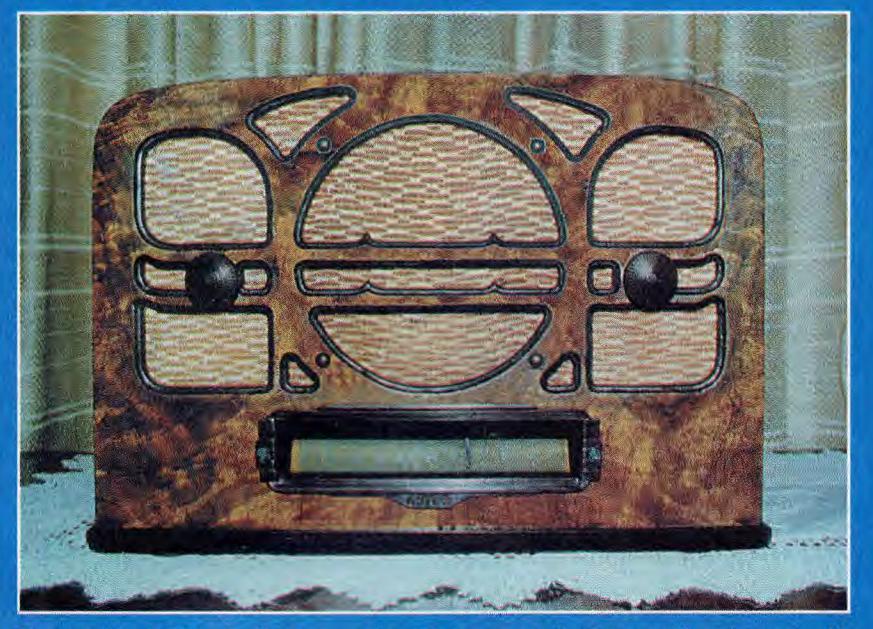
Photo Gallery: Astor "Mickey Mouse" Model BE

Produced in 1936 by Radio Corporation (Melbourne), the BE is another example of a small mantel set carrying the "Mickey Mouse" name. An interesting feature of the set was the provision of a 7-pin socket which enabled a shortwave converter (dubbed the "Oversea-er") to be connected. This unit contained its own 6A7 frequency changer valve and enabled the receiver to tune the 6-19MHz shortwave band. The receiver was fitted with the following valve line-up: 6A7 frequency changer, 6D6 IF amplifier, 6B7 detector & first audio amplifier, 41 audio output and 80 rectifier. (Photo courtesy Historical Radio Society Of Australia (Inc.).

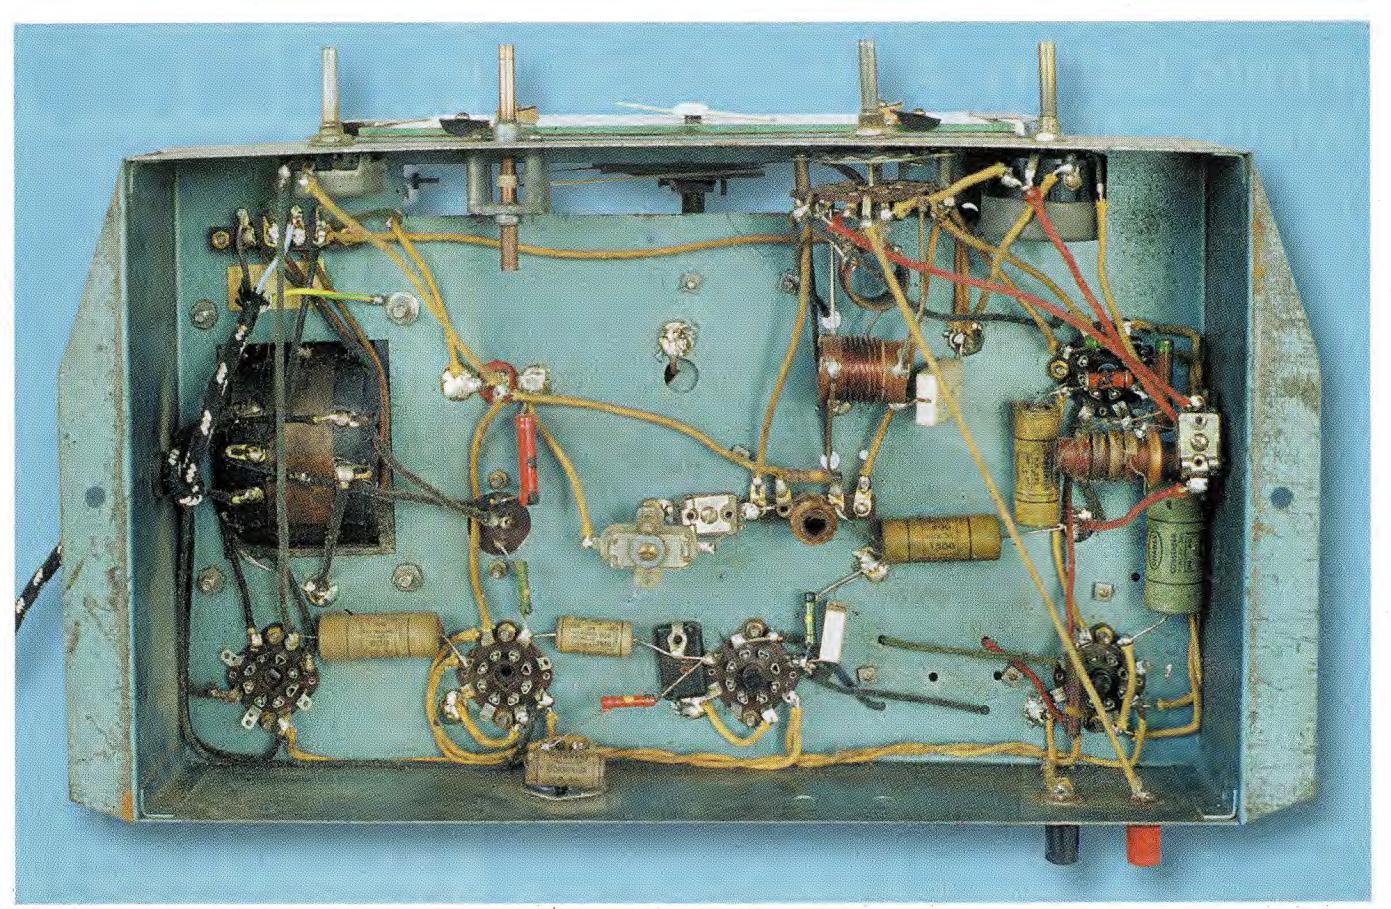
The C9 chassis has a simple layout, with easy access to all parts. Note the knot used to restrain the power cord, which is unacceptable by today's standards.

The painted (green) chassis was in good condition, with the chassis-mounted components arranged logically and neatly. The chassis is easily extracted from the cabinet by first removing the control knobs and the screws holding it to the mounting shelf. The loudspeaker plug is then disconnected from the chassis, after which the assembly can be removed from the cabinet.

A close inspection of the chassis reveals that the mechanical and wiring layouts are quite logical, with good access to most parts. This makes it easier to work on than many other sets from the same era. In fact, Laurie found that there wasn't much to do to get the set up and running.

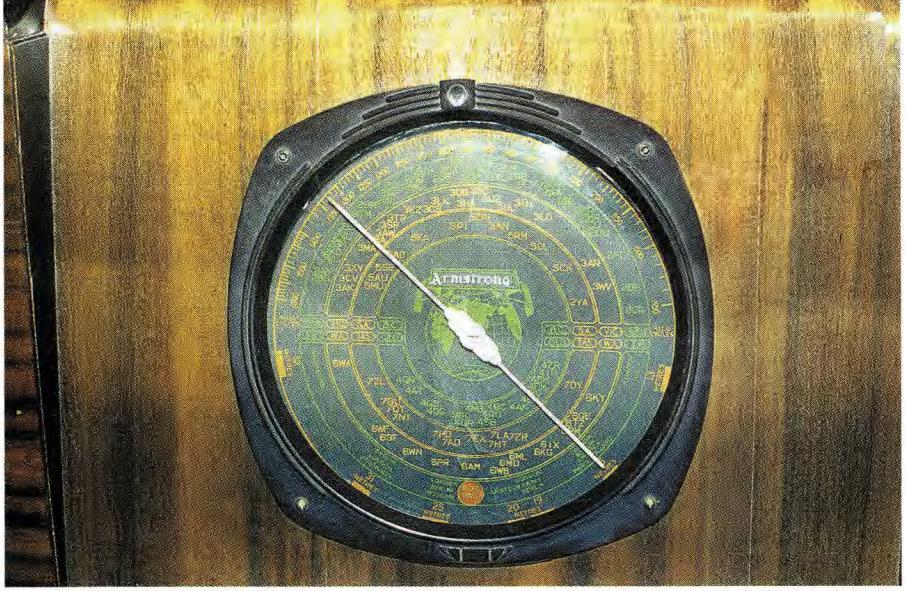
A close up view of the Armstrong C5's impressive dial. The small red circle at the bottom of the dial illuminates when the set is receiving shortwave signals.

A dominant feature of this set is the larger than average circular tuning dial. This is very attractive in appearance and makes the set easy to tune.

As can be seen in the photos, there is a small red circle at the bottom of the dial. This is marked "Short Wave" and has a dial lamp behind it which illuminates when the set is receiving shortwave signals. Certainly, console manufacturers set out to make their sets look special in what ever way they could to impress people.
