VINTAGE RADIO

Repairing an old Heathkit radio frequency generator

A radio frequency (RF) generator is an invaluable test instrument when it comes to aligning and adjusting old radio receivers. But why buy new when you can often refurbish an old unit for just a few dollars?

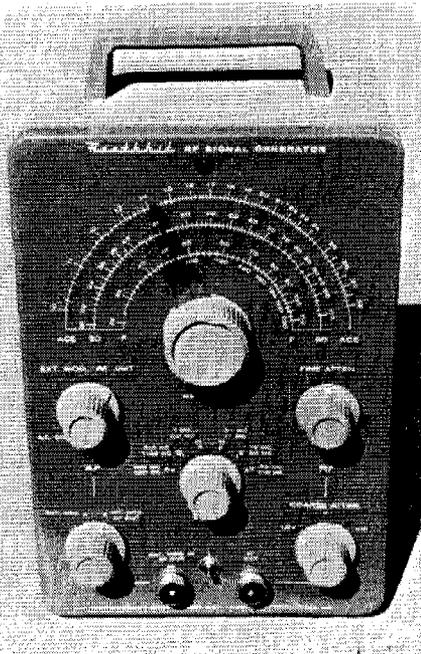
This radio frequency generator was restored to "as new" condition. It is a Heathkit RF-1 of 1960s vintage and was originally marketed in kit form.

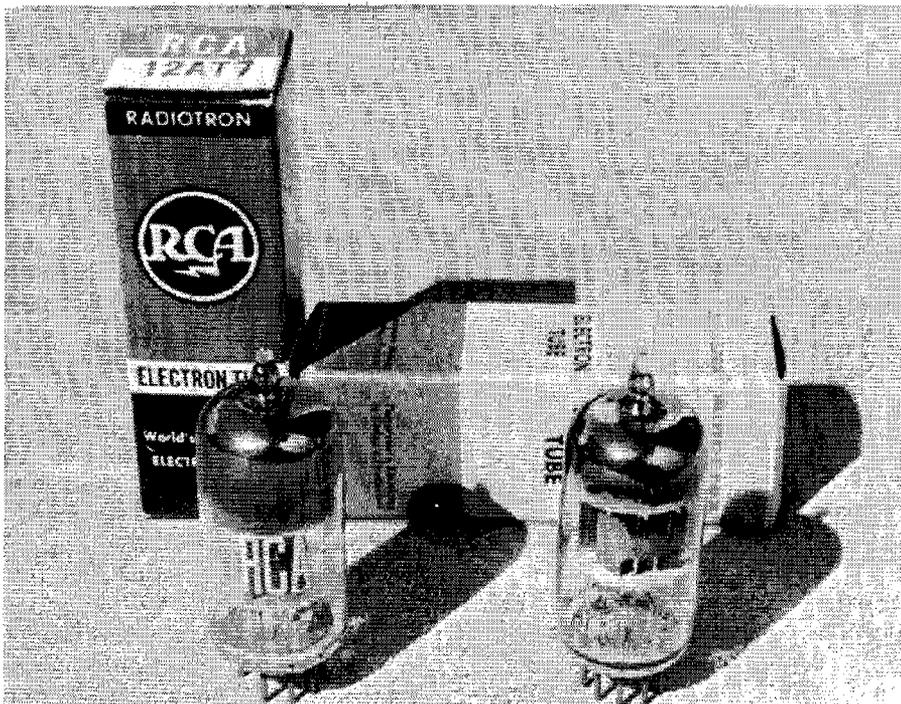
The RF-1 uses two valves: a 6AN8 and a 12AT7. Although the originals tested OK, they were replaced as part of the restoration procedure.

An instrument such as a radio frequency generator does not get a great deal of use and is not the sort of thing that is hard on valves. Even though the valves tested OK, both were replaced as the necessary types were conveniently on hand. If the generator was going to be properly repaired, then two new valves would not go astray.

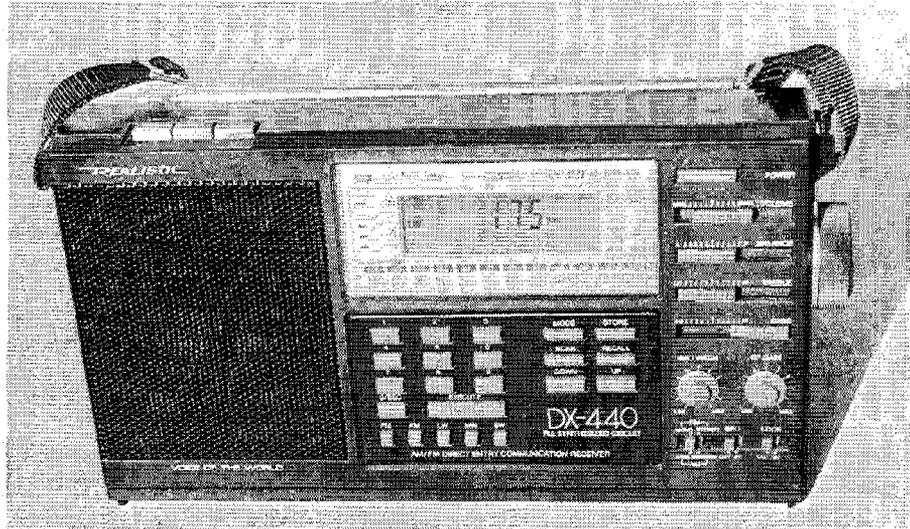
This nifty little radio receiver with its digital dial solved all of the problems associated with the realignment of the generator.

help from an unexpected quarter. David, a young vintage radio collector friend, lent me a radio that solved all my problems. David's receiver is one of those new-fangled types that has a digital frequency display. Almost any mongrel frequency can be keyed in and that is precisely what you get.

Wow! Did this little receiver make bands A, D and E easy to adjust. It's marvellous what the right equipment can do!
